MODEL: Karma Revero**DATE:** December 2017**TITLE:** Front Door Glass Fitment Inspection and Adjustment**Revised March 2018****PRIORITY:** On Complaint**APPLICABILITY:** MY17 and MY18 Revero**MARKET REGION:** North America**PURPOSE:** Remedy for possible wind noise complaint

Technical Service Bulletin

TB-17-76-21

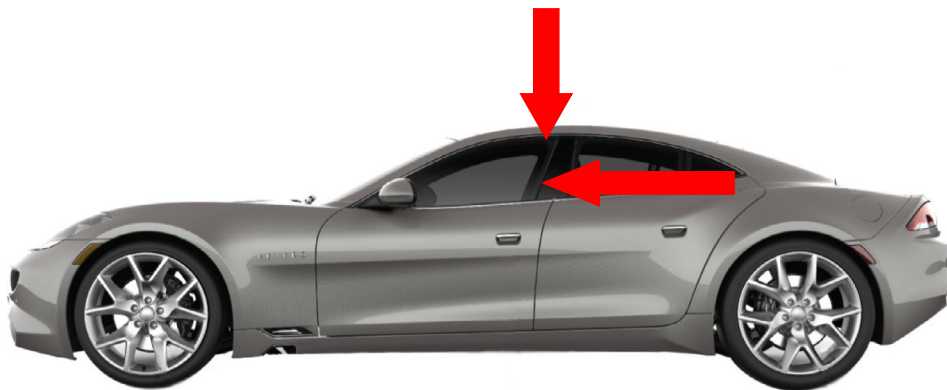
fig 1

The front door glass may not sit flush at the DLO and B-pillar location. The following procedure is to highlight the possible adjustments to correct this concern (fig 1).

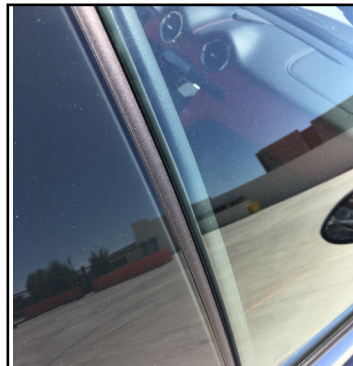
1. Verify condition of window glass, it must sit flush against the seals on the body when in the full up position and the door closed. The gap to appliqué should be 10 to 11.5mm and parallel along the glass edge.

Adjustment requires the glass clamp screws to be loosened, glass adjusted and re-tightened to 10Nm.

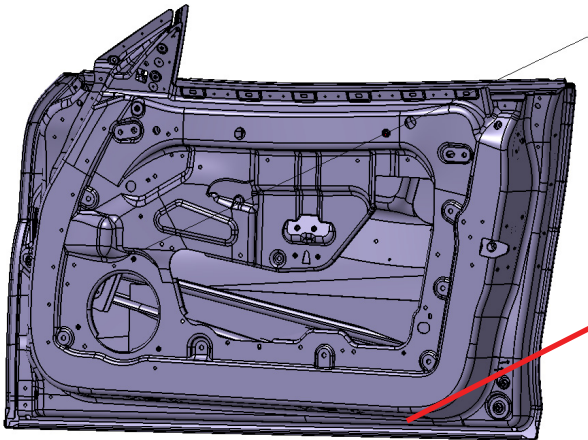
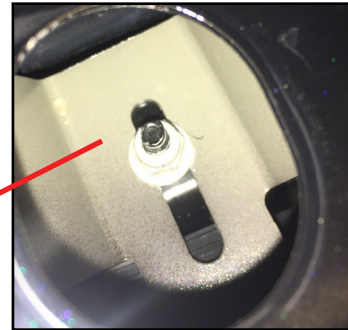
There should be no rattles when the door is closed or slammed with the glass up and glass down.

- 4) Adjust rear regulator mount, outboard as far as required to ensure proper glass alignment (fig 4a, 4b). Maintain clearance from the side impact bar, to avoid any interference (contact) or rattles.

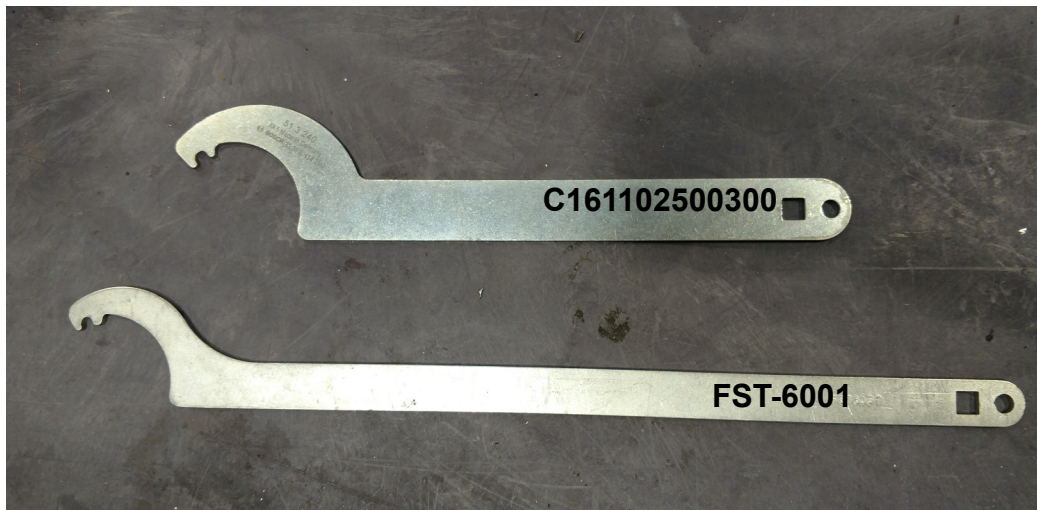
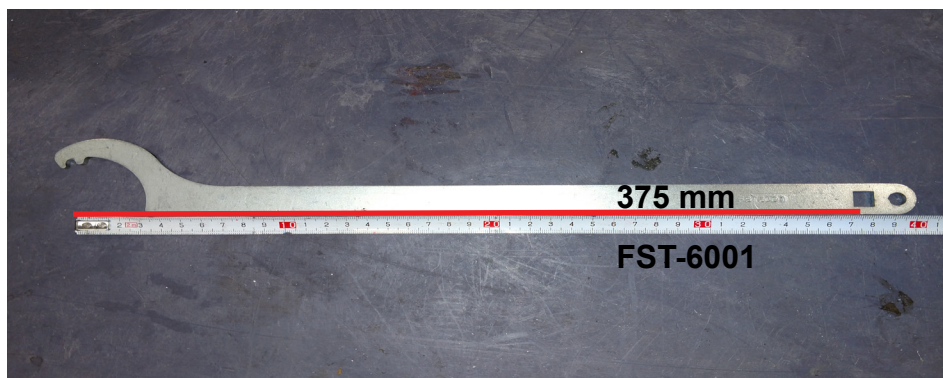
If you have an old style window spanner with the “FST-6001” marking this is longer than specification.

Please note the size difference of the two spanners the correct C161102500300 is the shorter correct tool (fig 8a, 8b).

The respective torque value will be altered to match.
