**Title (customer effect)** Volvo Chassis - Equipped With An Automated Manual Transmission Model F ( AMT-F, I-Shift ) - Inconsistent Or Out Of Range Parameters Preventing/Blocking Programming; Road Speed Parameter Discrepancies ( P1ALV ) Following Software Update; Road Speed Limit Incorrect - **OBD16 And Newer Chassis**

**Cause** Software updates to the Transmission Electronic Control Unit ( TECU ) of AMT-F transmissions added parameter P1ALV to the TECU, previously only an Engine Control Module ( EMS ) parameter. The parameters in each module may not match following a software update and must be verified and corrected.

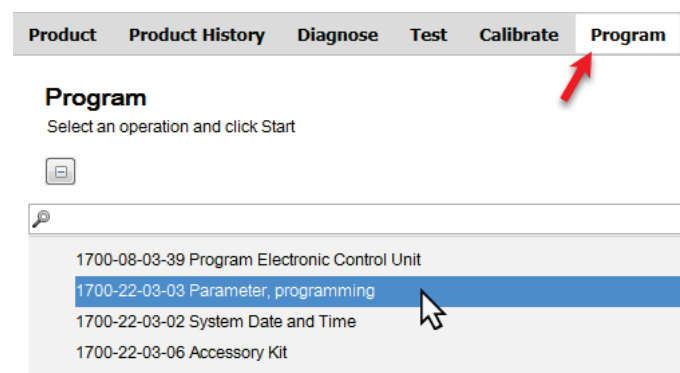
- If any Parameter inconsistencies are identified, an extra button will appear on the bar at the top of the programming screen as shown below:

- Inconsistencies can be found by running Operation [1700-22-03-03 Parameter, programming](#) under the Program tab of Premium Tech Tool (PTT).

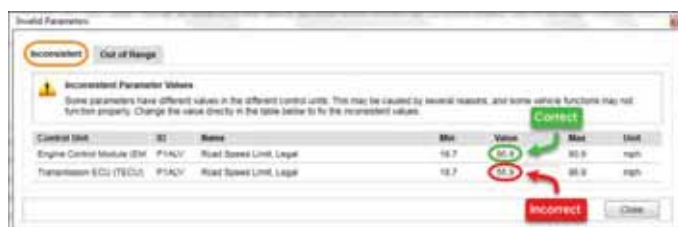
- Clicking the Invalid Parameters button opens a new window. The window will show parameter values that are inconsistent, which means the value of one or more parameters does not agree with the value of a related parameter or parameters. Inconsistencies can occur within the same ECU or between multiple ECUs. A mismatch of parameter P1ALV is shown below:

- Both P1ALV values should be reviewed, and the parameter with the incorrect value should be set to **the same value** as the correct one.
- Any other Inconsistencies that are listed should also be corrected.
- There is a second tab in the Invalid Parameters window that lists parameter values that are set outside of the allowable range. Verify that there are no parameters on this list after correcting Inconsistent values.
