# Technical Service Bulletin

## 34 Oil leak from the ATF sump area

34 18 29 2050215/2 February 16, 2018. Supersedes Technical Service Bulletin Group 34 number 18-27 dated January 30, 2018 for reasons listed below.

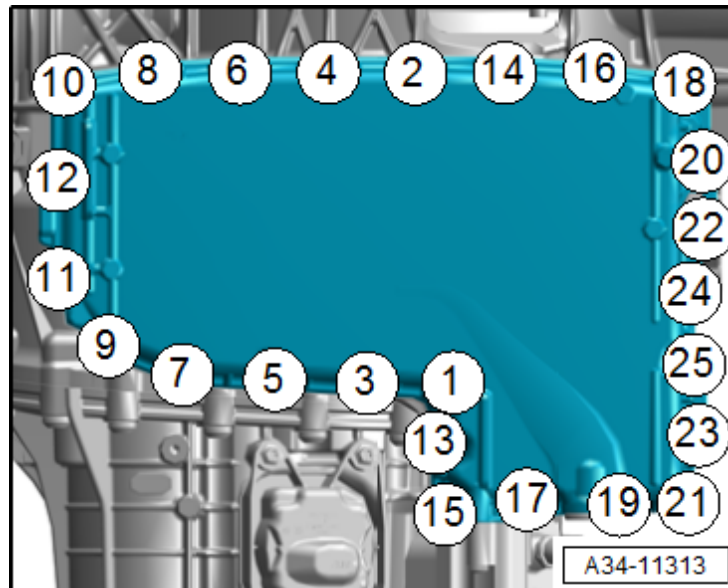
**Figure 1.** Tightening sequence.

1. Take photos of the actual condition and attach to the Repair Order.
2. Retighten the ATF sump bolts with a torque of 5 Nm. Make sure to follow the correct tightening sequence (Figure 1).

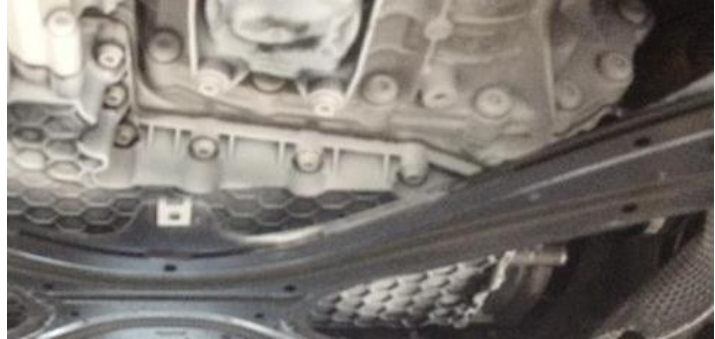
**Figure 2:** Transmission with oil leak detection spray applied.

4. Apply oil leak detection spray (Part # G 001 900 A1 or a locally available talcum based oil leak detection spray equivalent) to the sealing area of the sump, ATF cooler, drain plug, and the case half seam (Figure 2).

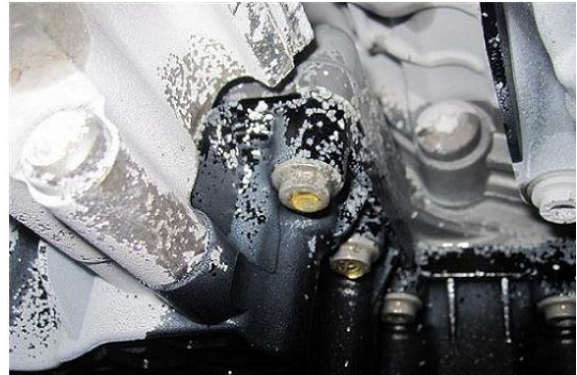
**Tip:** If there are drips after the test drive as shown (Figure 3) you should be able to determine if the leak is from the ATF sump gasket or if the leak is from elsewhere. Make sure to check for leaks above the sump gasket. Check the seam of the transmission case split and the weep hole of the double seal (Figure 4). Both of these leaks can be confused for an ATF sump gasket leak.

**Figure 3.** Oil leak.

**Tip:** If the ATF sump has been diagnosed to be leaking after the all the above checks, replace the ATF sump according to the Repair Manual and recheck for leaks. Use Warranty Table 2 if the ATF sump is replaced. If the repair manual is followed using the special tools, the required wheel alignment should not be necessary.

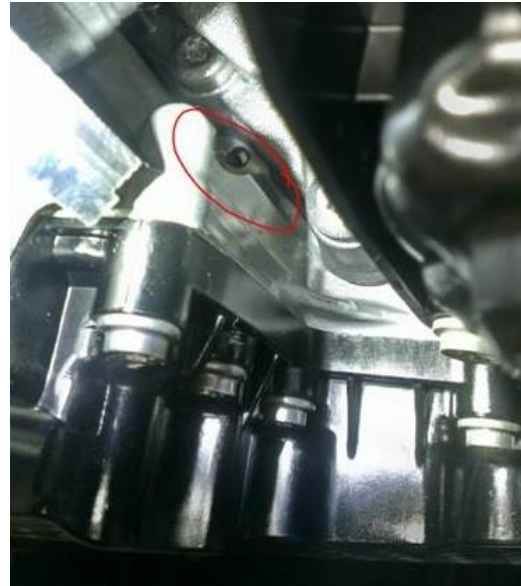
**Figure 4.** Double seal weep hole location.

If the oil leak is not from the ATF sump gasket please open an Audi Technical Assistance contact with the pictures of the leak attached to the ticket and contact Audi Technical Assistance for repair authorization.
