Technical Service Bulletin

87 Faint noise heard in cabin from air conditioning circuit

87 18 85 2044717/7 February 13, 2018. Supersedes Technical Service Bulletin Group 87 number 17-84 dated December 12, 2017 for reasons listed below.

Model(s)	Year	VIN Range	Vehicle-Specific Equipment
A6, A7	2012 - 2015	All	2.0L or 3.0L gas engine

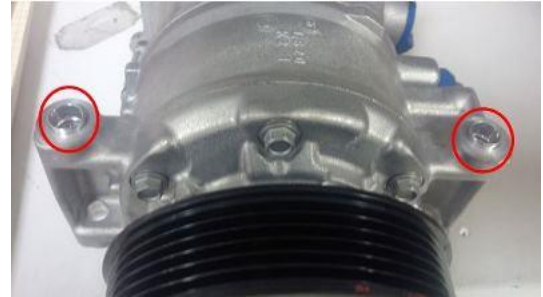
Figure 3. Mounting bolt centering sleeves on the air conditioning compressor housing.

It is imperative that the compressor mounting bolt centering sleeves be reinstalled with the compressor (Figure 3). Failure to reinstall these sleeves will result in compressor failure (as well as possible engine and/or ancillary component damage) in a short period of time. If any sleeves were misplaced during the removal and reinstallation process, new sleeves should be ordered and installed on the compressor housing before reassembly. Compressor or consequential component damage resulting from a failure to install the centering sleeves will not be accepted under warranty.

2. Remove the air conditioning compressor, empty the compressor of the PAG oil completely, then reinstall it to the vehicle. The compressor does not need to be replaced.

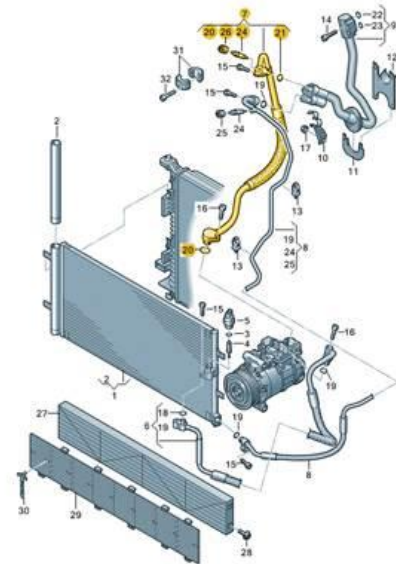
Figure 4. Low side line to be replaced.

3. Replace the low side refrigerant line that connects the air conditioning compressor suction port to the hybrid refrigerant line to the expansion valve (Figure 4). Be certain to use new O-rings at these and all refrigerant circuit joints that are disconnected.

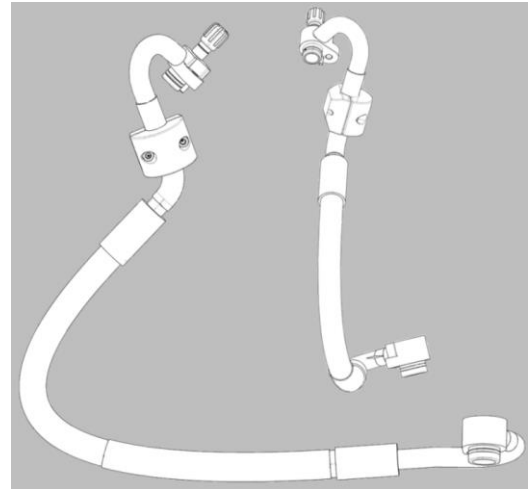
Figure 5. Balance weight position on low side line.

4. Install the balance weight (part number 4G0513621A) with 2 bolts (part number N 10653601) to the line in the position shown in the illustration (Figure 5).
