Technical Service Bulletin

91 Rearview camera intermittently inoperative (DTC 2203)

91 18 70 2041430/5 February 1, 2018. Supersedes Technical Service Bulletin Group 91 number 17-00 dated January 11, 2017 for reasons listed below.

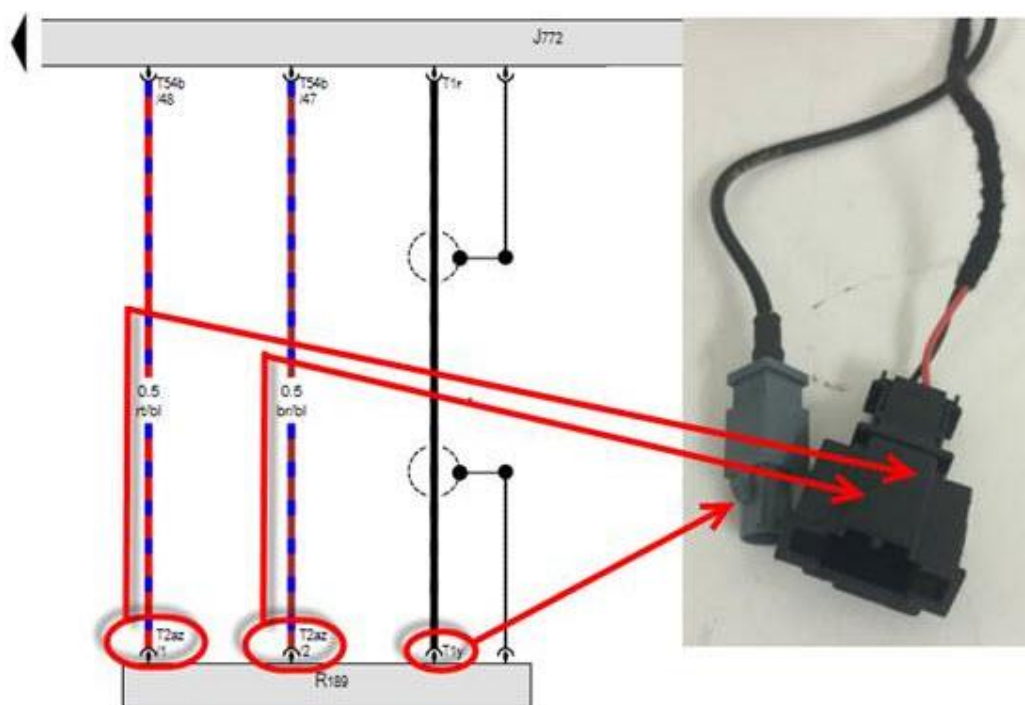
Figure 1. Check the wiring of the R189 reverse camera at connector T2az and T1y.

1. Before proceeding, confirm that the DTC and one of the fault symptoms listed in the *Condition* are logged in the rearview camera system control module, J772 (address word 006C). If the DTC is not listed with one of the fault symptoms, this bulletin does not apply.
2. Check the wiring of the R189 reverse camera at connector T2az and T1y (Figure 1). Repair any loose connectors or pins, corrosion, or any other physical damage.

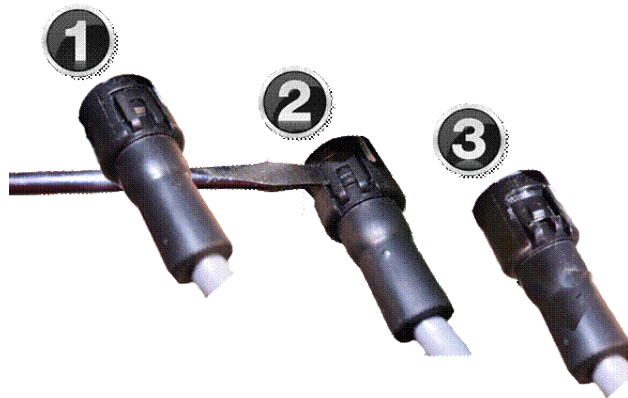
Figure 3. Locate locking tab (1), lift up on tab with screwdriver (2), snap tab off (3).

4. Remove the original harness from the reverse camera (Figure 3):

- First, locate the locking tab on the reverse camera harness.
- Next, using a small flat head screw driver, lift up on the locking tab.
- Finally, snap the old locking tab off the defective harness to prevent reuse.

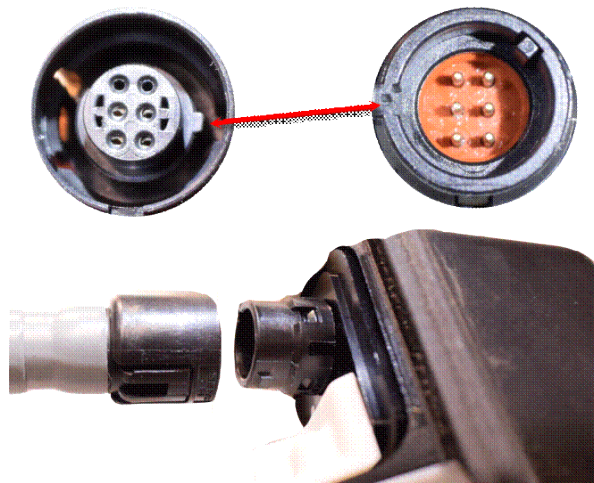
Figure 4. When installing the new reverse camera harness onto the camera assembly, ensure that the connectors are correctly aligned.

5. Carefully install the new reverse camera harness onto the camera assembly, as the harness can only be installed one way. The connector is keyed on both the camera and the electrical harness to prevent incorrect installation. Ensure they are correctly aligned during installation (Figure 4).

6. When the harness is fully secured to the camera, there will be an audible click sound. The sound is caused when the locking tab falls into place.
