# Technical Service Bulletin

## 91 MIB2 MMI Bluetooth quality at the other end of call is distorted; caller cannot hear driver or hears only an echo

91 18 72 2041925/5 February 1, 2018. Supersedes Technical Service Bulletin Group 91 number 17-64 dated December 7, 2017 for reasons listed below.

Model(s)	Year	VIN Range	Vehicle-Specific Equipment
A6, A7	2016	All	MIB-2 Navigation

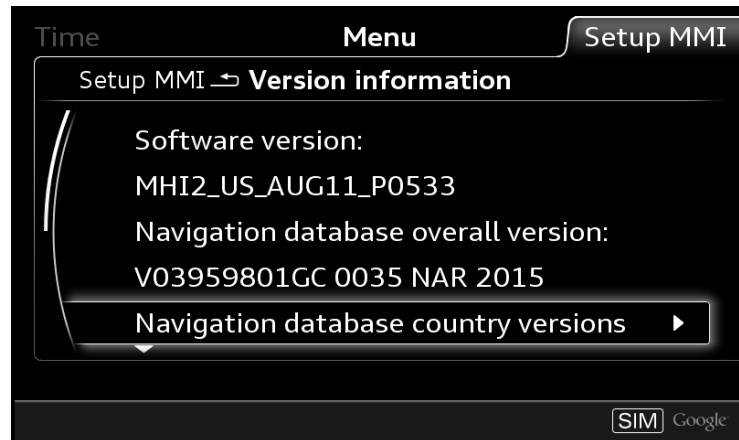
Figure 2. MMI Version Information.

1. Verify that the customer's MMI requires the software update by going to the *Main Menu* >> *Setup MMI* >> *Version Information* (Figure 2) and ensure the Software version is less than 0539 (Can be P0533 or K0533, where P = production software and K = Kunden or Customer update).

The service solution is to update the MMI software to SW1062 (K0539).
