Technical Service Bulletin

91 MMI3G+ Audi connect only reaches 2G service - Telephone module replacement instructions for A4,A5,A5 Cab,Q5,Q7,A8

91 18 73 2039476/9 February 6, 2018. Supersedes Technical Service Bulletin Group 91 number 17-57 dated November 3, 2017 for reasons listed below.

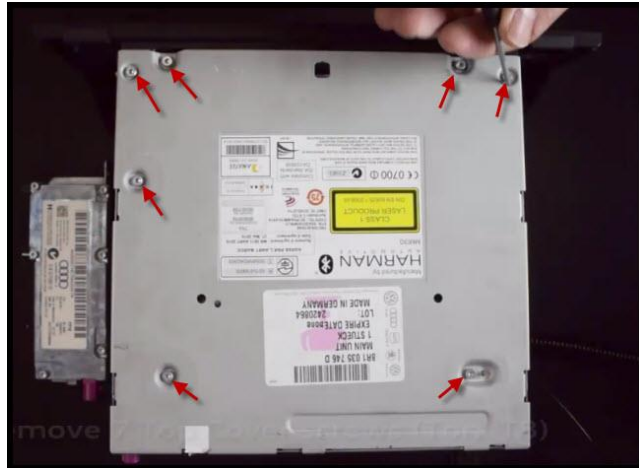
Figure 5. MMI main unit with screw locations for top cover indicated by the red arrows.

7. Remove the seven screws that are holding the MMI top cover in place (Figure 5).

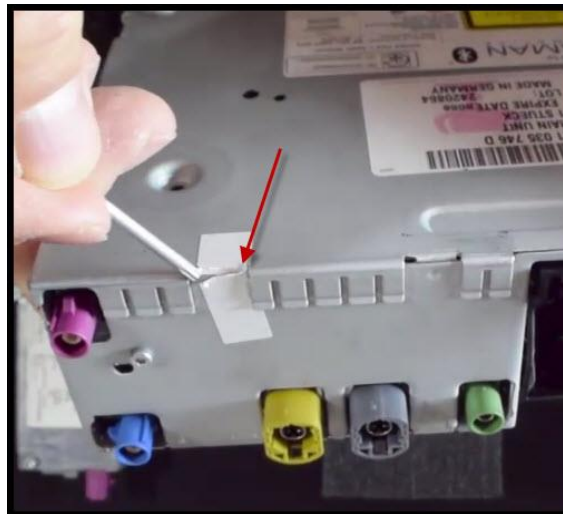
Figure 6. Break white warranty seal.

8. Break the white warranty seal on the back of the main unit (Figure 6).

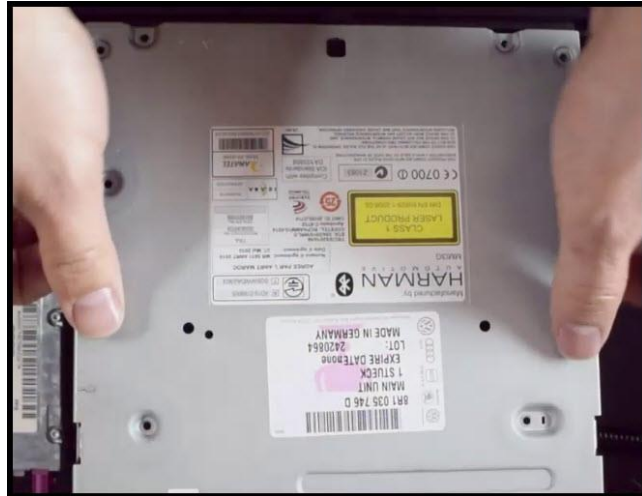
Figure 7. Pry top cover off with fingers.

9. Using a flat head screw driver, your fingers or a plastic wedge trim tool, remove the top cover (Figure 7) by prying it from the back of the cover at the location seen in Figure 8. If a flat head screw driver is used then touch the tool to the ESD mat to discharge the tool prior to touching the main unit.

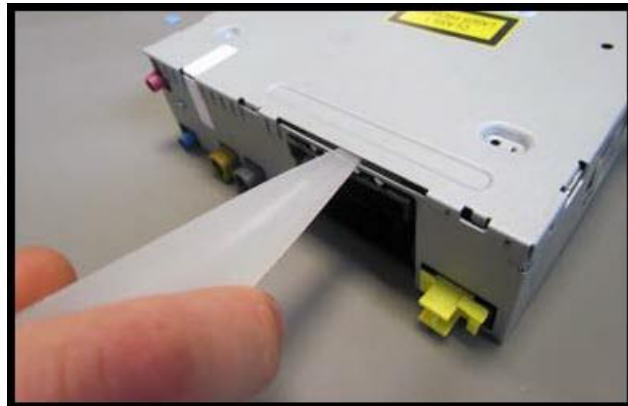
Figure 8. Pry top cover off using plastic trim wedge tool.

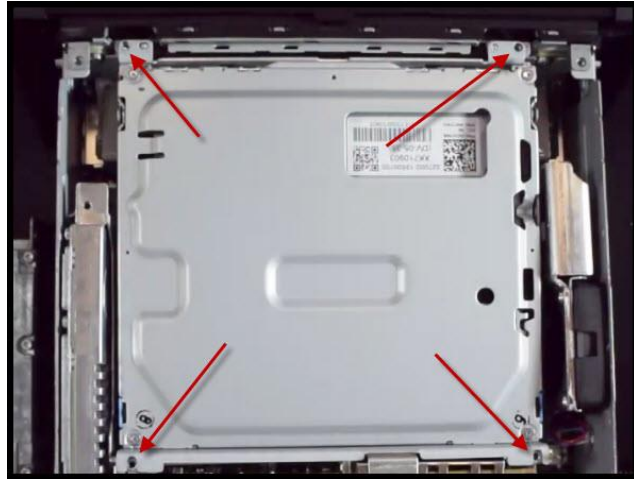
Do not flip the main unit over at this point. The CD drive, which was held in place by the top cover screws, is no longer secured. If it moves significantly, the ribbon cable can detach from the circuit board and disable the CD drive's functionality (Figure 9).

Figure 9. CD drive mounting points are free to move.

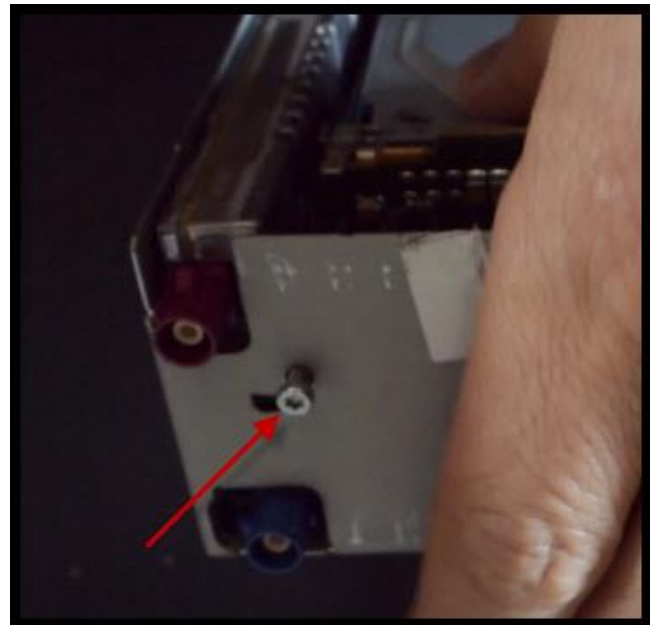
Figure 10. Telephone module retaining screw indicated by the red arrow.

10. On the back of the main unit, remove the retaining screw that holds the telephone module in place (Figure 10).

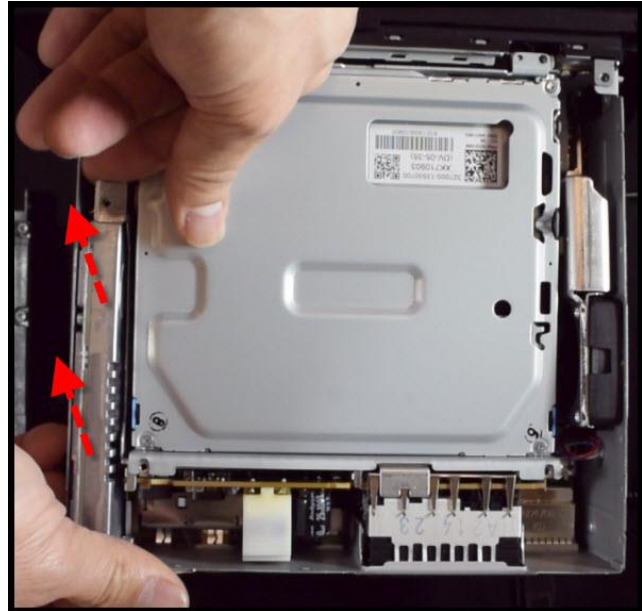
Figure 11. Lift up on both ends of the telephone module as indicated by the red arrows.

- Carefully lift up the telephone module, using both ends as points of contact when pulling up (Figure 11). The module is held in place with a computer socket-type attachment and will release when enough force is used.

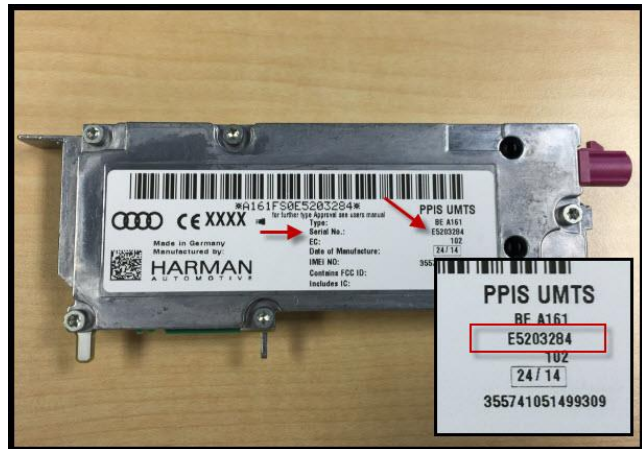
Figure 12. Serial number of the PPIS UMTS telephone module indicated by the red arrows and red box.

- Before proceeding, write the serial number of the new replacement UMTS telephone module on the rework label (Figure 12).

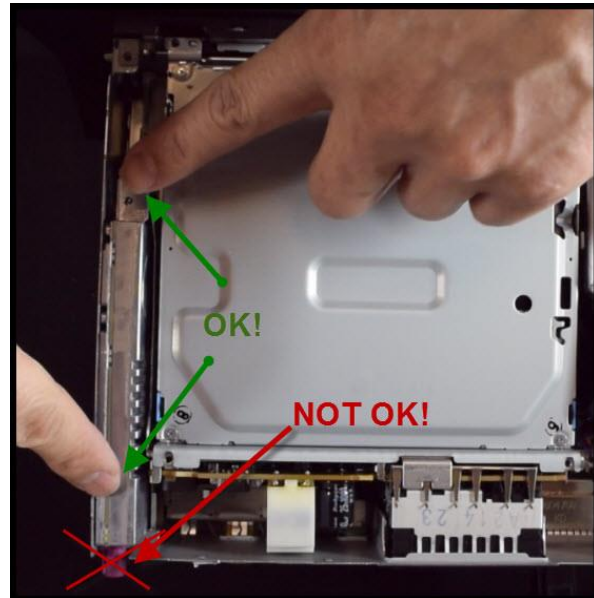
Figure 13. Do not press down using the purple FAKRA connector.

13. Place the new UMTS telephone module into the socket, making sure it is level before snapping it into place. Use both ends of the telephone module when pressing it into place. Do not press down using the purple FAKRA connector (Figure 13).

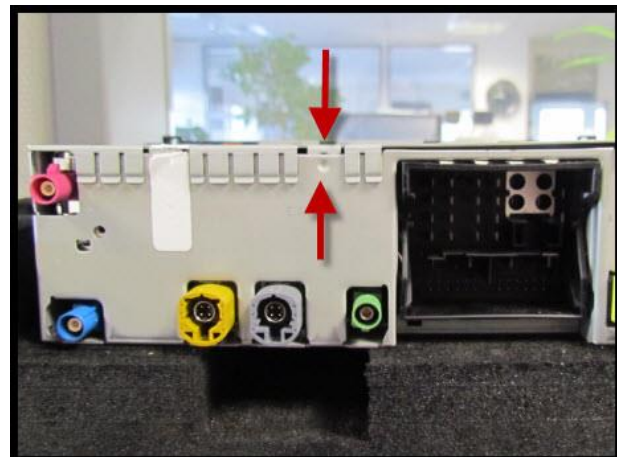
Figure 14. Place the new warranty seal over the location indicated by the red arrows.

17. Place the new warranty seal from the retrofit kit next to the original warranty seal (Figure 14).

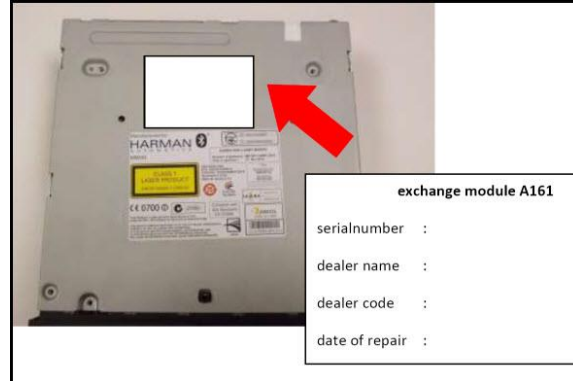
Figure 15. The white area indicates the “suggested” location for the repair label on the top cover of the main unit. Do not cover any existing part number labels.

18. Place the rework label on the top of the main unit cover. Do not cover any part number labels (Figure 15). Fill out all fields on the repair label.
