Technical Service Bulletin

91 MMI3G+ Audi connect only reaches 2G service - Telephone module replacement instructions for A6 & A7

91 18 74 2039515/9 February 6, 2018. Supersedes Technical Service Bulletin Group 91 number 17-56 dated November 2, 2017 for reasons listed below.

Model(s)	Year	VIN Range	Vehicle-Specific Equipment
A6, A7	2011-2013	All	Audi connect

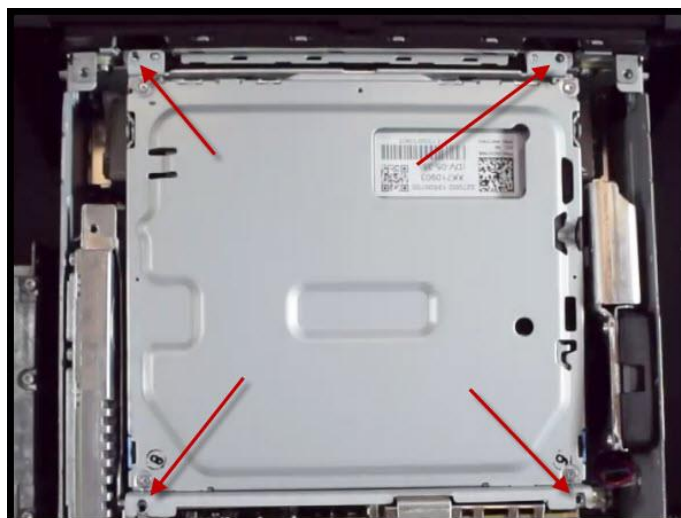
Figure 11. CD drive mounting points are now free.

Do not flip the main unit over at this point. The CD drive, which was held in place by the top cover screws, is no longer secured. If the CD drive moves significantly, the ribbon cable can detach from the circuit board and disable the CD drive's functionality (Figure 11).
