Technical Service Bulletin

PSS 91 MMI screen goes blank after iPhone is connected to USB port

91 18 76 2044130/5 February 20, 2018. Supersedes Technical Service Bulletin Group 91 number 17-13 dated March 10, 2017 for reasons listed below.

Model(s)	Year	VIN Range	Vehicle-Specific Equipment
A4, Q7	2017	All	Audi smartphone interface

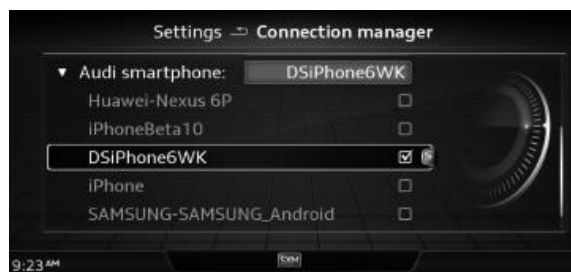
Figure 1. iPhone is selected for ASI (CarPlay).

3. Create a PSS record in the PSS application through the Pending Service Solutions (PSS) link in AccessAudi (under *App Links >> Service >> Pending Service Solutions (PSS)*), or through the Technical Assistance page in Elsa.
4. As a temporary workaround, ask the customer to:
 - **If the screen goes blank when CarPlay is accessed immediately after the car is started or if the screen flashes back to the MMI menu after selecting CarPlay:** connect the iPhone after the car is started and while the transmission is still in the park position. If the customer gets into this condition they can fix the concern by going to the connection manager (Figure 1) and deselecting the iPhone (Figure 2) and reselecting under Audi Smartphone Interface (*Settings >> Connection Manager >> Audi Smartphone Interface*; Figure 1). This will force the MMI to start a new CarPlay session with the iPhone.

- **If the screen flashes when selecting CarPlay after using the backup camera:** inform the customer there is no current workaround. If the customer has this issue they can temporarily fix the concern by going to the connection manager (Figure 1) and deselecting the iPhone (Figure 2) and reselecting under Audi Smartphone Interface (*Settings >> Connection Manager >> Audi Smartphone Interface*; Figure 1). This will force the MMI to start a new CarPlay session with the iPhone.

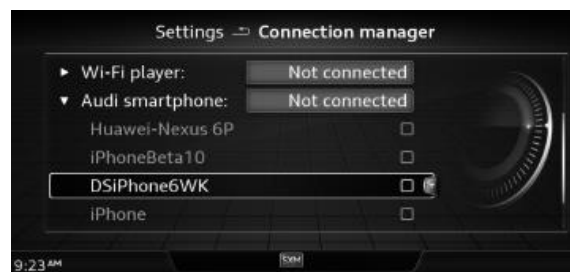
Figure 2. iPhone is no longer selected for ASI (CarPlay).
