# Technical Service Bulletin

## 91 Android Auto navigation shows backwards direction of travel

91 18 80 2050566/1 February 27, 2018.

Model(s)	Year	VIN Range	Vehicle-Specific Equipment
A3, A4, A5, and Q5	2017	All	MIB2 High Scale

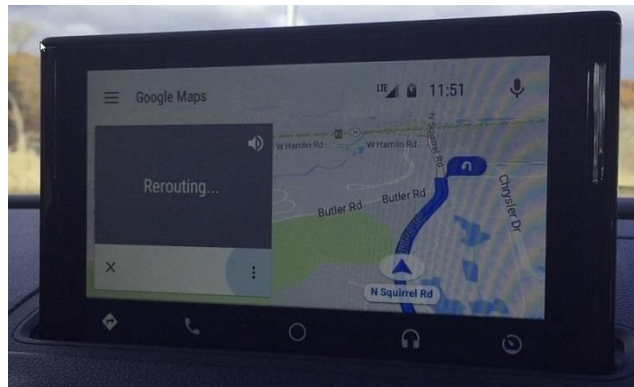
When using the Android Auto function for the navigation, the vehicle direction of travel in the MMI screen appears to be backwards (Figure 1). As a result, the map arrow points in the wrong direction and the system constantly attempts to calculate a new route while showing a message of “Rerouting...”.

*Figure 1. Vehicle position is shown in the wrong direction.*

The MIB2 High Scale infotainment system (PR Code 7UH) has a known software issue which can cause the MMI screen to show the wrong direction of travel when using Android Auto navigation (Google Maps or Waze). The issue was caused by the MMI not utilizing the direction of travel from the GPS antenna. While Google provided a work-around in their Android Auto software, it is still advised to update the customer's MMI system.

Update the MIB2 High Scale infotainment system using either Method 1 or Method 2 according to TSB 2050565: *91 MIB2 High Scale Software Update Instructions (PR Code 7UH)* and use SVM code MHS2US1242AU.
