Technical Service Bulletin

91 Apple CarPlay cannot be started or MMI screen goes blank after iPhone is connected to USB

91 18 81 2050569/1 February 28, 2018.

Model(s)	Year	VIN Range	Vehicle-Specific Equipment
A3, A4, A5, and Q5	2017	All	MIB2 High Scale

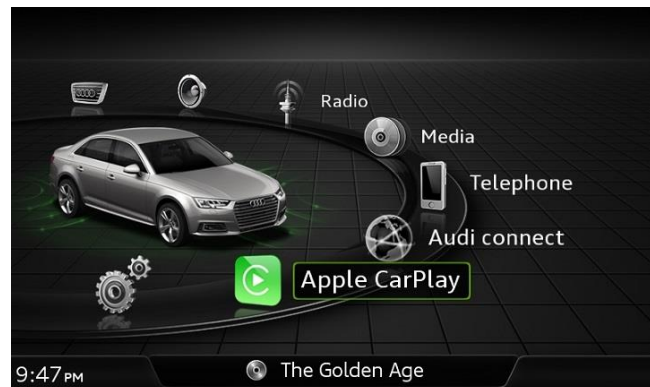
- After reversing the Audi smartphone interface (ASI) menu cannot be selected any more, although the music is still playing (Figure 1). The customer has the MIB2 High Scale infotainment system (PR Code 7UH) and the vehicle is built after CW22/16.

Figure 1. Audi Smartphone Interface menu.

The MIB2 High Scale infotainment system (PR Code 7UH) has a known software issue which can cause the MMI screen to either turn black when Apple CarPlay is initialized or can cause an issue where the user can no longer start Apple CarPlay. When the Apple CarPlay menu option is selected the screen will flash briefly to a blank screen and then return to the main menu as seen in Figure 1. The software update provided only applies to cars built after CW22/16. For cars built before CW22/16, please see the following TSBs:

Update the MIB2 High Scale infotainment system using either Method 1 or Method 2 according to TSB 2050565: *91 MIB2 High Scale Software Update Instructions (PR Code 7UH)* and use SVM code MHS2US1242AU.
