Technical Service Bulletin

97 No start (DTC P068A00)

97 18 60 2036764/4 February 1, 2018. Supersedes Technical Service Bulletin Group 97 number 14-43 dated April 14, 2014 for reasons listed below.

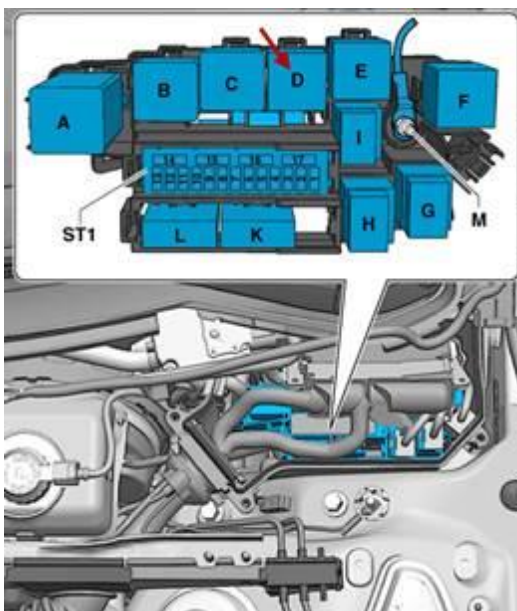
Figure 1. Location of J271 relay (D), as shown in Elsa.

2. Check Elsa for the location of the J271 relay (*Wiring diagrams >> Component locations >> Component Locations: Relays*) (Figure 1).

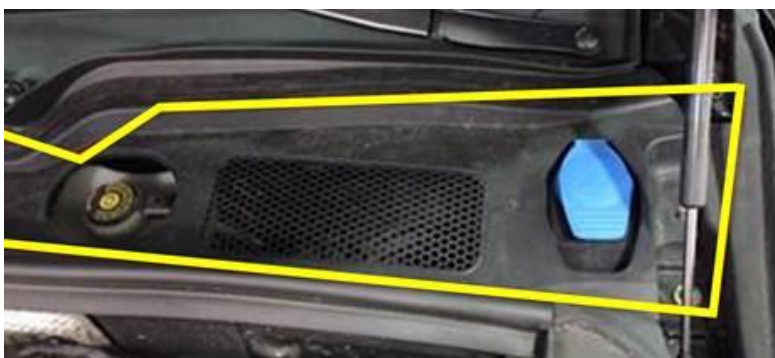
Figure 2. Plenum cover.

3. Remove the plenum cover (Figure 2).

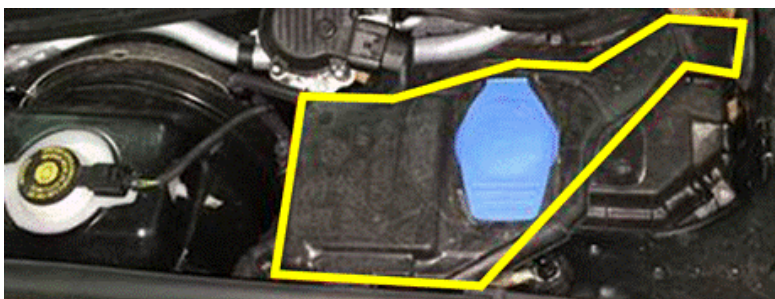
Figure 3. Washer reservoir filler neck.

4. Remove the washer reservoir filler neck (Figure 3).

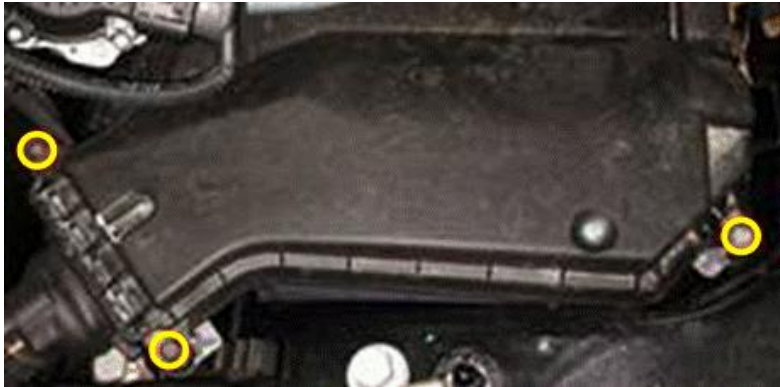
Figure 4. Screws to be removed (outlined).

5. Remove screws to gain access to the relay/fuse panel (Figure 4).

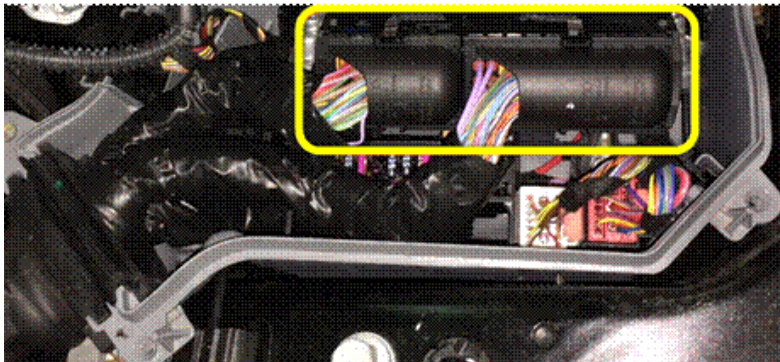
Figure 5. Engine control module (ECM).

6. Remove the ECM (Figure 5).

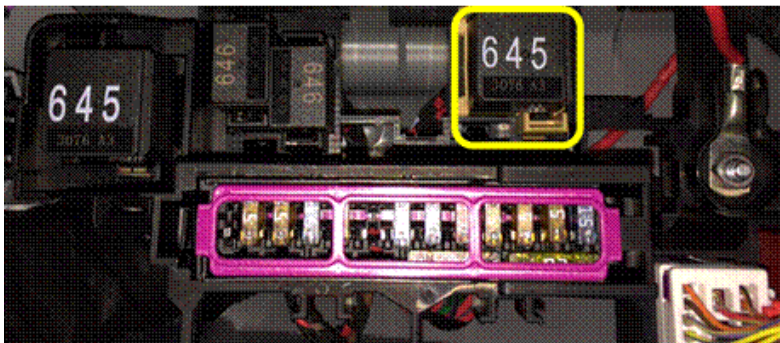
The engine control module power supply relay is not functioning properly. Because the relay controls battery voltage (Terminal 30) via a ground signal sent from the ECM, numerous faults can occur in multiple control modules when it is not functioning properly.

Figure 6. J271 relay (outlined).

7. The J271 relay is now accessible (Figure 6).

11. With the ECM disconnected, check the wiring from J271 relay terminal 2 to the ECM:
 - If voltage and wiring are good, replace the J271 relay.
 - If voltage and wiring are not good, do not proceed with this bulletin. Continue with diagnosis.

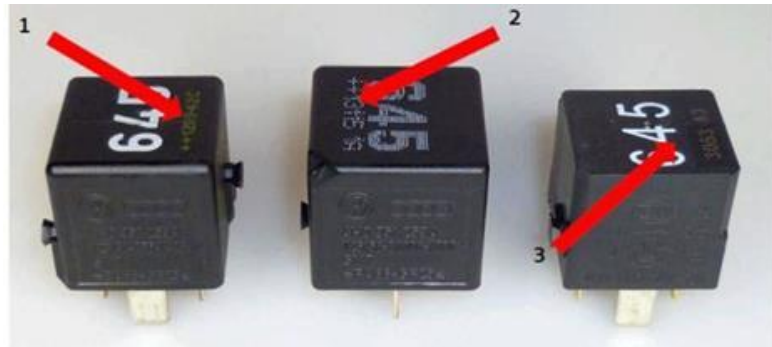
Figure 7. Relay manufacture data: Tyco Electronics relay with a yellow label (1), Tyco Electronics relay with a white label (2), Hella relay with a white label (3).

8. Check the relay manufacture build information on the relay. This information is printed under “645” on the relay:
- If the relay is from Tyco Electronics and has a yellow label (Figure 7, 1), replace the relay and proceed to step 10.
 - If the relay is from Tyco Electronics and has a white label (Figure 7, 2) or from Hella and has a white label (Figure 7, 3), do not replace the relay. Proceed to step 9.

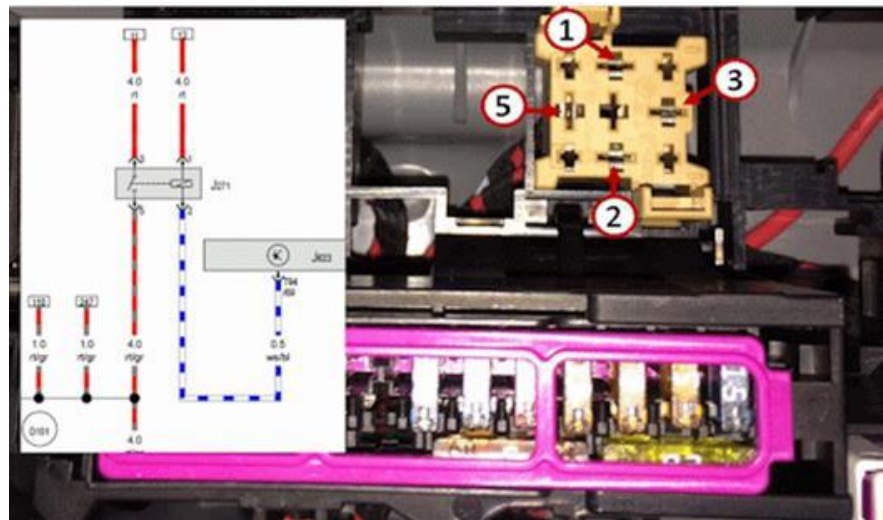
Figure 8. J271 relay pins. Terminal 1: 30 power from SA2, Terminal 2: switched ground from J623, Terminal 3: 30 power from SA2, and Terminal 5: switched power from J271.

9. Check the J271 relay according to the instructions in Elsa at: *Engine >> Generic Scan Tool >> ST Generic Scan Tool >> Diagnosis and Testing >> Diagnostic Procedures >> Engine Component Power Supply Relay, Checking.*
10. Check for battery voltage on J271 relay harness terminals 1 (85 power) and 3 (30 power) (Figure 8 and Figure 9).

If no voltage is found, do not proceed with this bulletin. Continue with diagnosis.

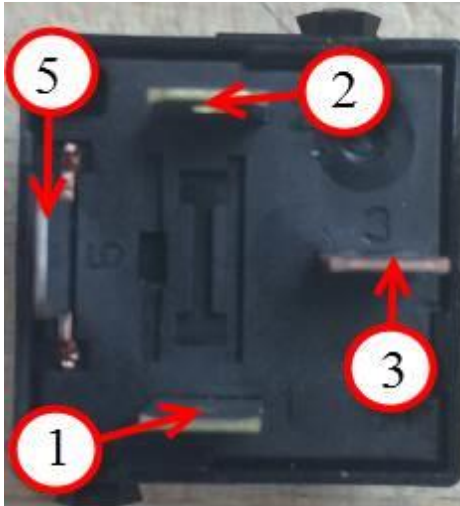
Figure 9. Relay terminal locations. Terminal 1: 85 Terminal 2: 86
Terminal 3: 30 Terminal 5: 87
