## SERVICE BULLETIN

**APPLICABILITY:** 2013-14MY Legacy and Outback Models with 2.5L FB Engines  
 2011-14MY Forester Models with 2.5L FB Engines  
 2015 MY Forester (Manual Transmissions Only) with 2.5L FB Engines  
 2012-13 MY Impreza and XV Crosstrek Models with 2.0 FB Engines  
 2014-15 MY Impreza and XV Crosstrek Models (Manual Transmissions Only) with 2.0 FB Engines

**NUMBER:** 02-157-14R  
**DATE:** 08/28/14  
**REVISED:** 03/06/18

**SUBJECT:** Engine Oil Consumption

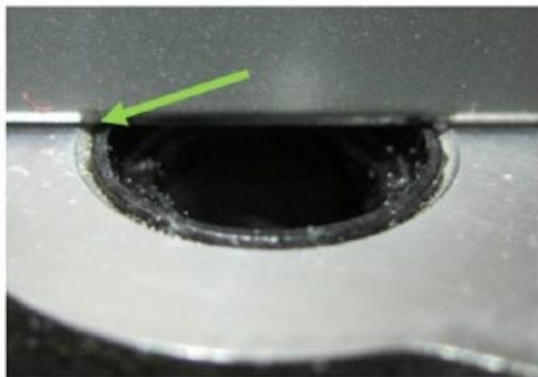
**OK-** Filter Screen flush with machined surface of camshaft carrier.

- **IMPORTANT:** The **one-time use** AVCS filter screens in the cam carriers are available separately (p.n. 14451AA050). **NOTE:** Although the filter screens are not directional, they must be installed flush with the machined surface of the cam carrier as shown in the OK photo below. The NG photo shows the screen installed too deep into the camshaft carrier. Engines with AVCS on both intake and exhaust will have 2 filters in each carrier as opposed to just one (intake only AVCS).

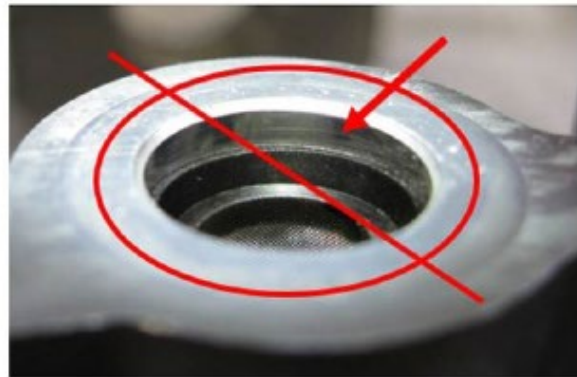
**NG-** Filter Screen installed too deep into the camshaft carrier bore.
