SERVICE BULLETIN

APPLICABILITY: 2014-2018MY Forester
 2012-2016MY Impreza
 2013-2017MY Crosstrek
 2015-2018MY WRX and STI

NUMBER: 12-234-18

SUBJECT: Instrument Panel (IP) Foam Cushion
 Coming Loose

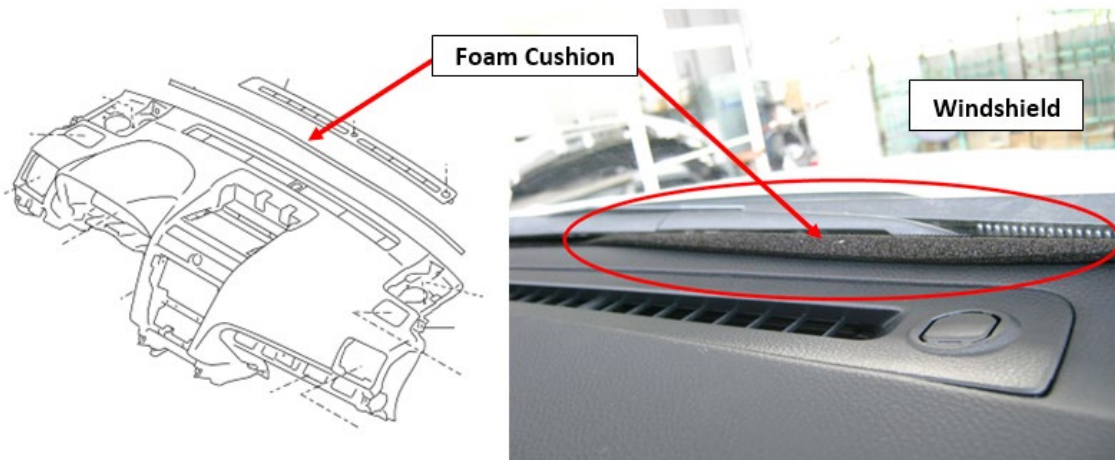
This bulletin provides a repair procedure for replacing the foam cushion installed between the top front edge of the IP and the windshield glass. Use the supplied Service Procedure to address a customer concern involving the foam cushion becoming visible above the IP near the defroster vent outlets as shown below.
