**SERVICE BULLETIN**

**APPLICABILITY:** 2017MY Impreza 4Dr. (Sedan) Models

**NUMBER:** 12-235-18

**SUBJECT:** Trunk Release Difficult to Operate

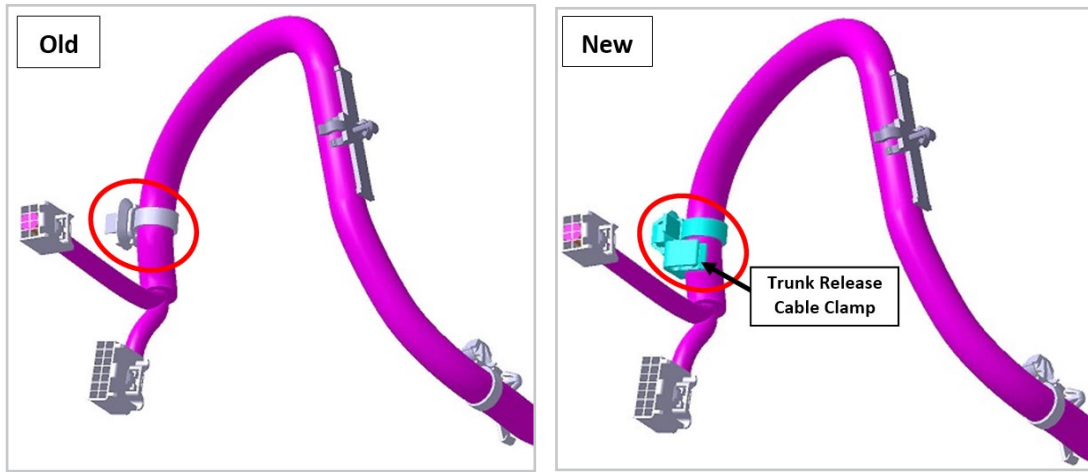
A retaining clamp for the trunk release cable has been added to the new trunk lid cord's retaining clip (it is not serviced separately). The illustrations below show the difference between the old and the new style trunk lid cords.

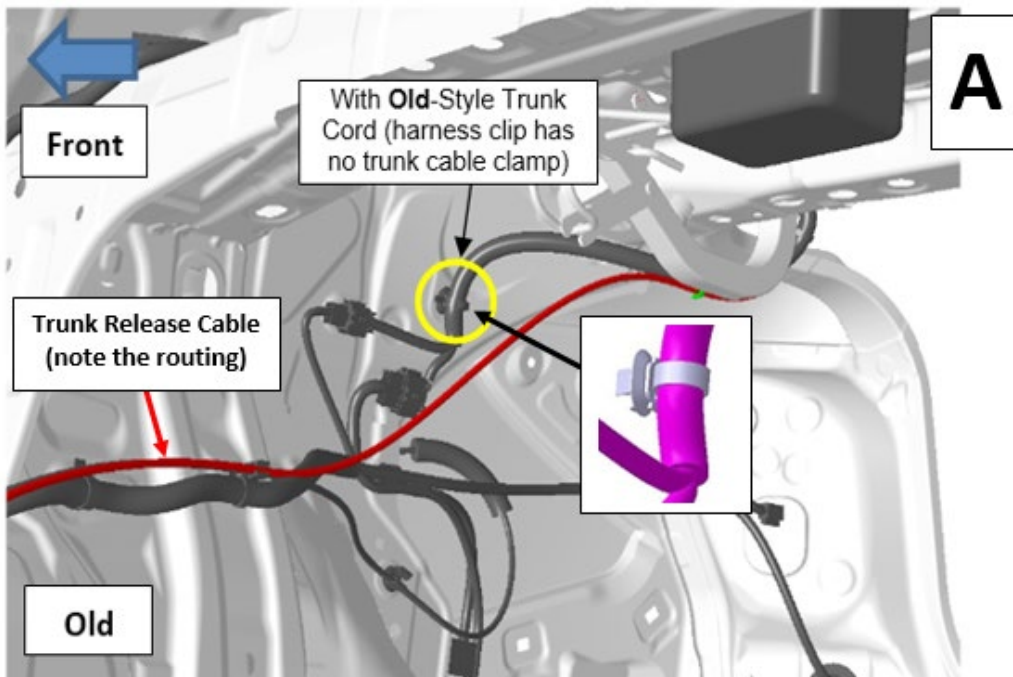
Illustration “A” shows:

- Trunk release cable routing (red)
- Old-style harness retaining clip with no trunk release cable retaining clamp.

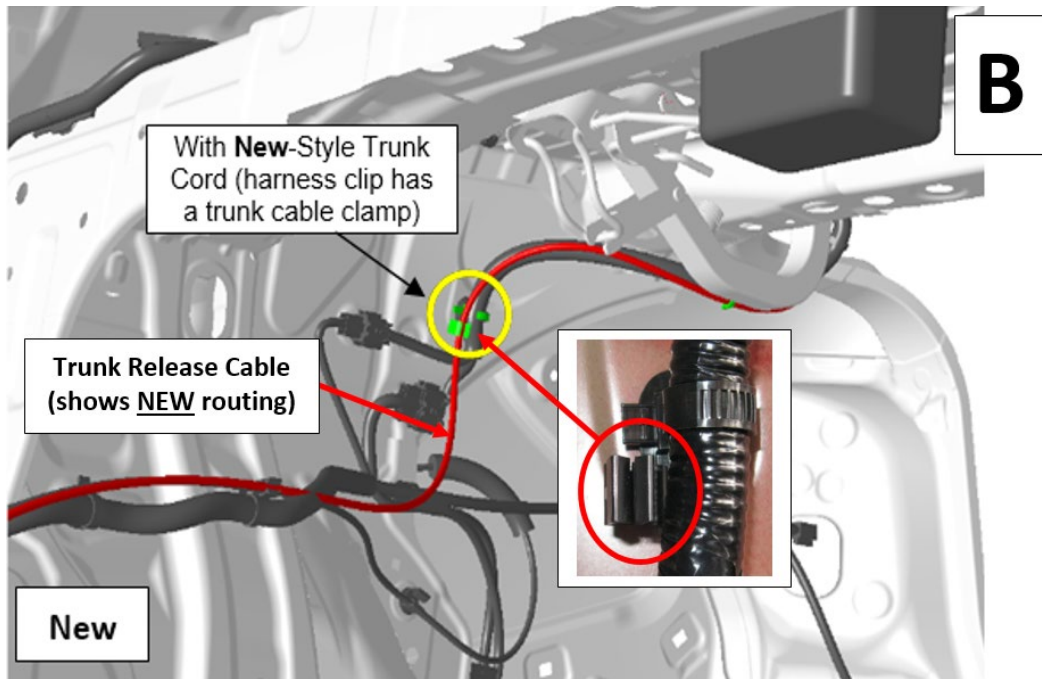
Illustration and photo “B” show:

- New-style trunk cord with release cable retaining clamp
- Trunk cable (red) installed with new routing.

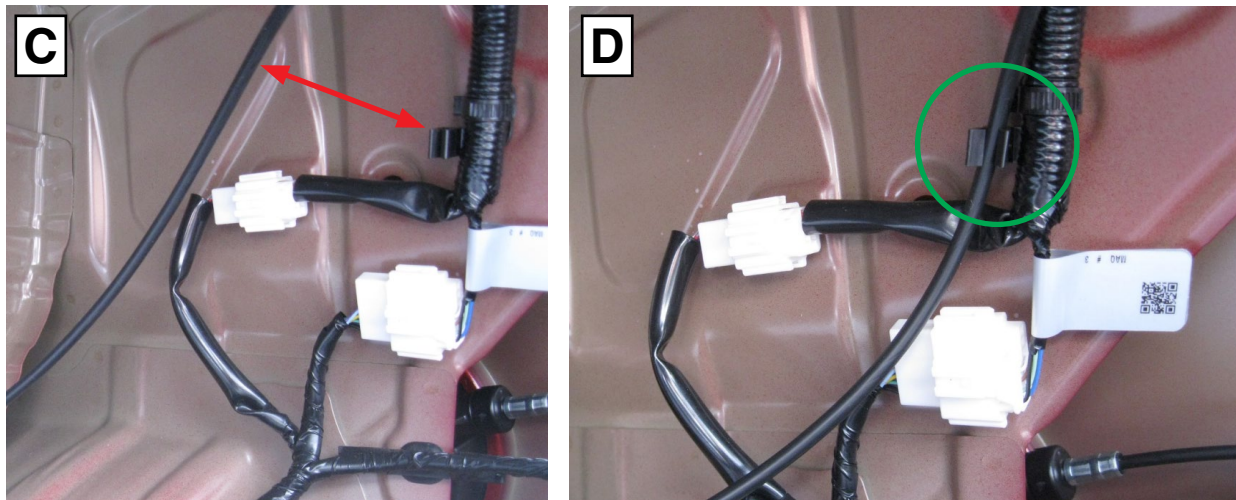
- If inspection reveals the trunk release cable has come loose from the retaining clamp of a vehicle equipped with the new-style deck lid cord (Photo C), clip it back into place and retest for proper operation before proceeding with cable replacement.
