SERVICE BULLETIN

APPLICABILITY: 2017-18MY Impreza
 2018MY Crosstrek
 2018MY Legacy and Outback

SUBJECT: Reprogramming File Availability for Additional Optimization of Harman Gen 3 Audio and Navigation Head Units

NUMBER: 15-211-17R
DATE: 06/13/17
REVISED: 03/28/18

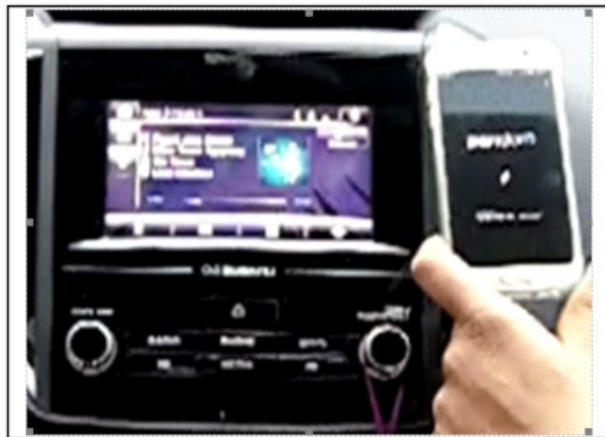
- 1- No streaming audio. When using the Pandora® app, there is no audio output.

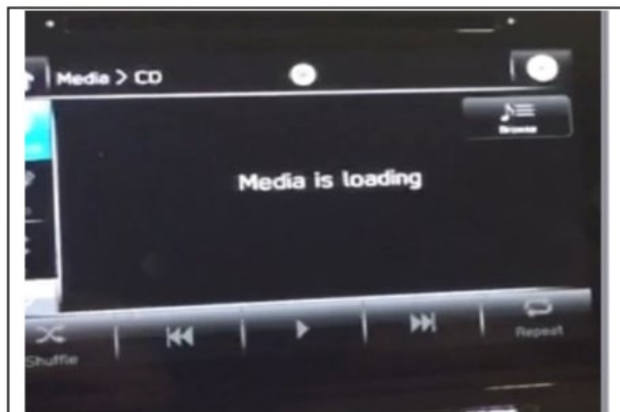
- 2- “Media is loading” is displayed on the screen but, the media never completes loading.

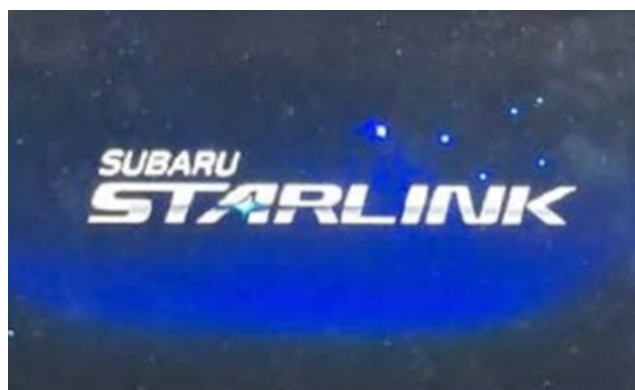
- 3- The screen freezes when the STARLINK screen is displayed.

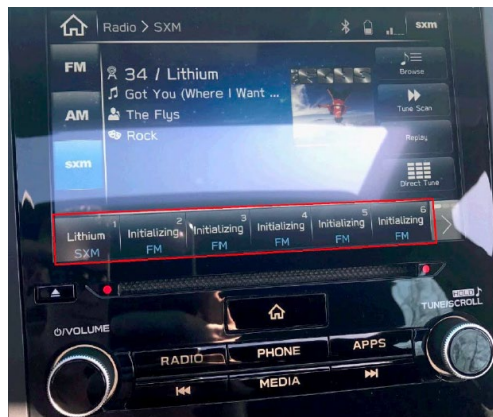
- 1- Radio station presets disappear (touch screen buttons return to “Initializing”).

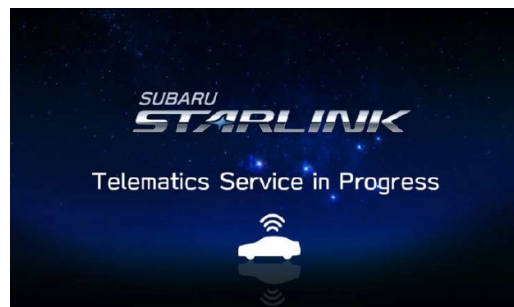
- 2- STARLINK “Telematics Service in Progress” screen freezes.

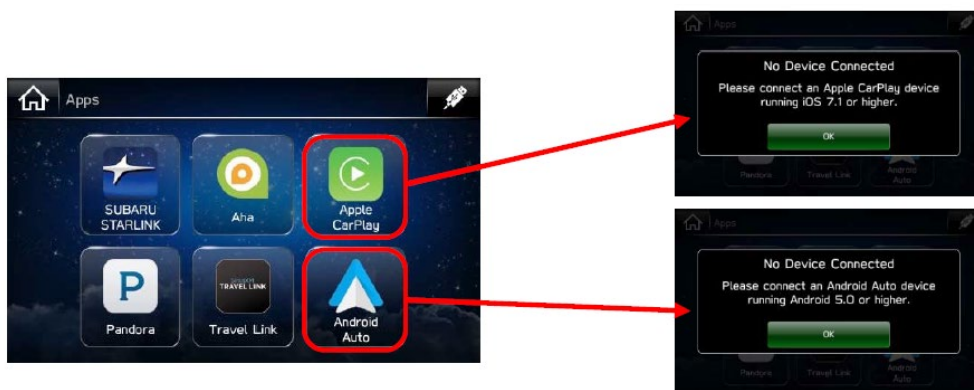
- 3- Apple Car Play / Android Auto function does not operate (“No Device Connected”).

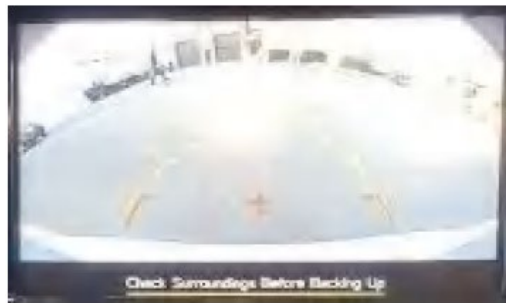
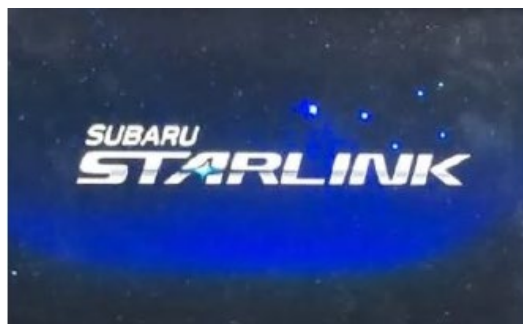
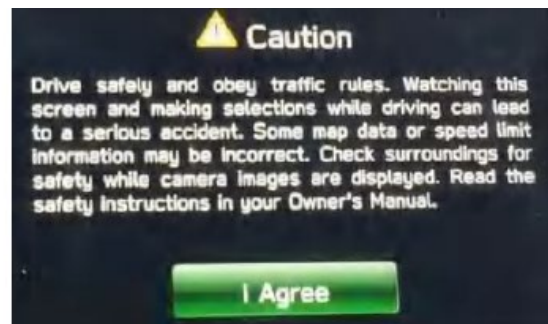
For reference, the previously released WTN-74R symptoms are also provided below. The main purpose of WTN-74R was to address display screen freeze-up during Back-Up Camera display (when the shifter is in “R”). In addition, the screen may also freeze when either the Subaru STARLINK or Disclaimer Caution / I Agree screen is displayed.

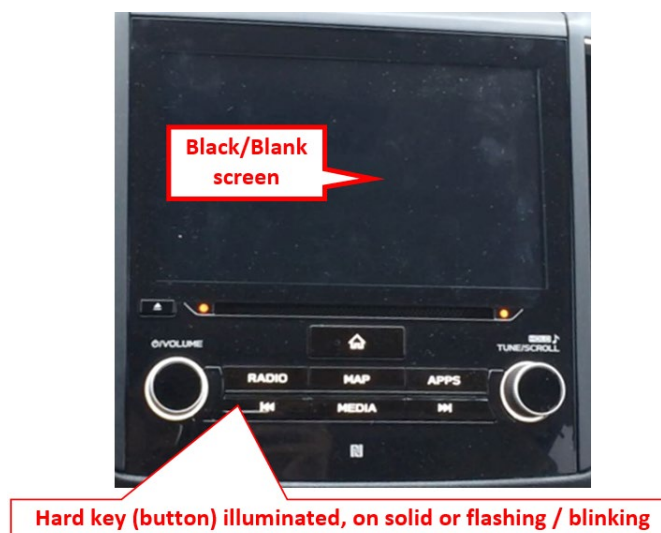
- 1) After switching the vehicle (ACC or IGN) on, the display screen goes black with no audio output and the hard key buttons are illuminated (on solid, or flashing / blinking).

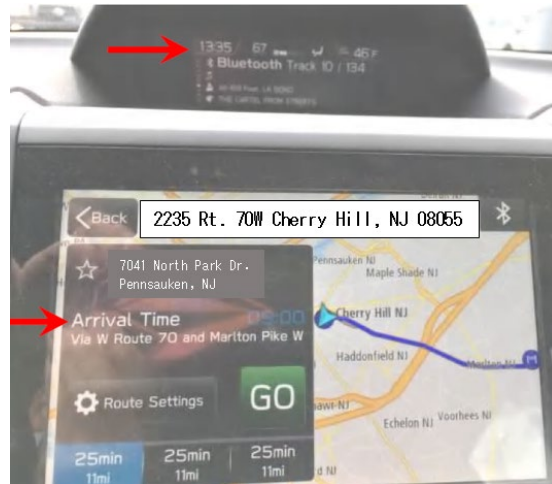
- 2) Time of day displayed in the MFD (Multi-Function Display) is incorrect and the arrival time displayed in Navigation units is also incorrect.

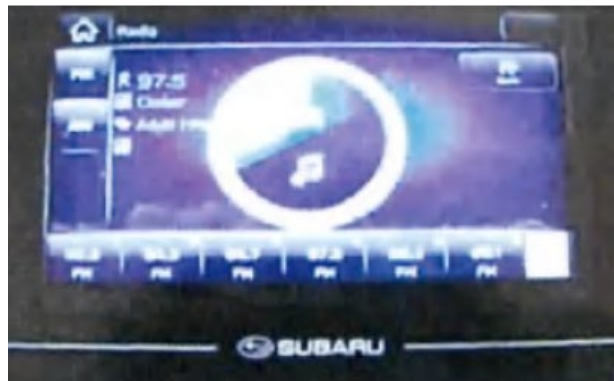
- 3) The time in the MFD automatically reverts to a “default” setting, even after setting the time using “Manual” mode.
- 4) Audio volume goes to maximum automatically after one click of the volume up button on the steering wheel. In some cases, this condition may also occur without input from the operator. Maximum volume is also displayed on the screen.
