Technical Service Bulletin

Subject: VOICE RECOGNITION SYSTEM DOES NOT RECOGNIZE "ADDRESS" OR "NEW DESTINATION" NAVIGATION VOICE COMMANDS	Bulletin No.: 09-003/18
	Last Issued: 03/05/2018

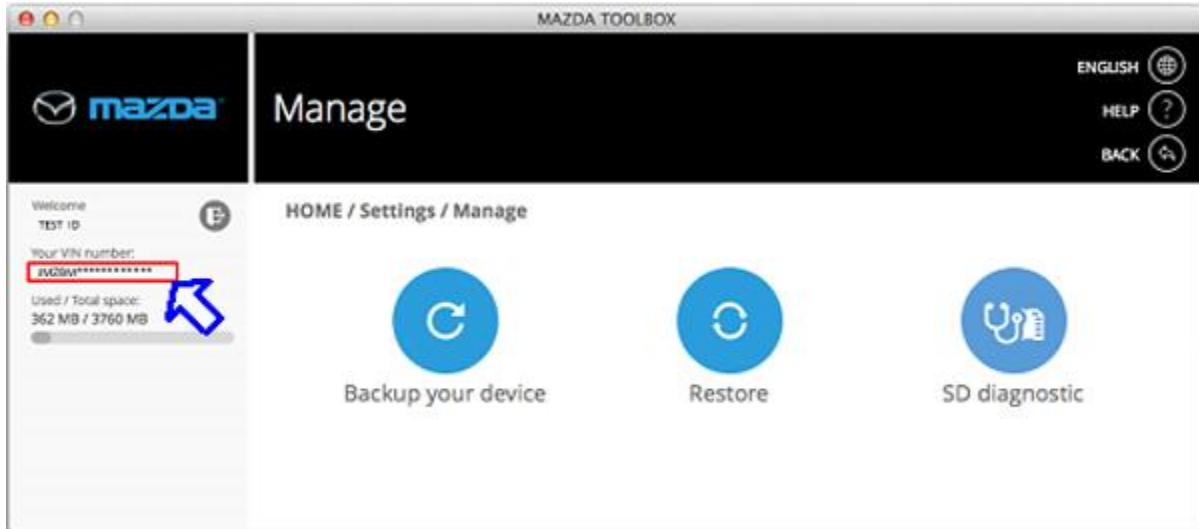
- Yes - Go to next step.
 - No - This TSB does not apply. Refer to MGSS online for normal diagnosis procedures.
3. **Using Mazda Toolbox, verify navigation SD card VIN is recorded (SD card is locked to that VIN).**
 - **SD Card VIN is recorded (VIN is shown) - Go to step 4.**
 - **SD Card VIN is not recorded (No VIN is shown) - Perform VIN Record Procedure.**

- a. Insert the navigation SD Card into the customer's vehicle SD Card port.
- b. Turn the key ON and open Navigation.
- c. Wait 3 minutes or longer.
- d. Turn ignition key OFF and eject the navigation SD Card.
- e. Repeat step 3.

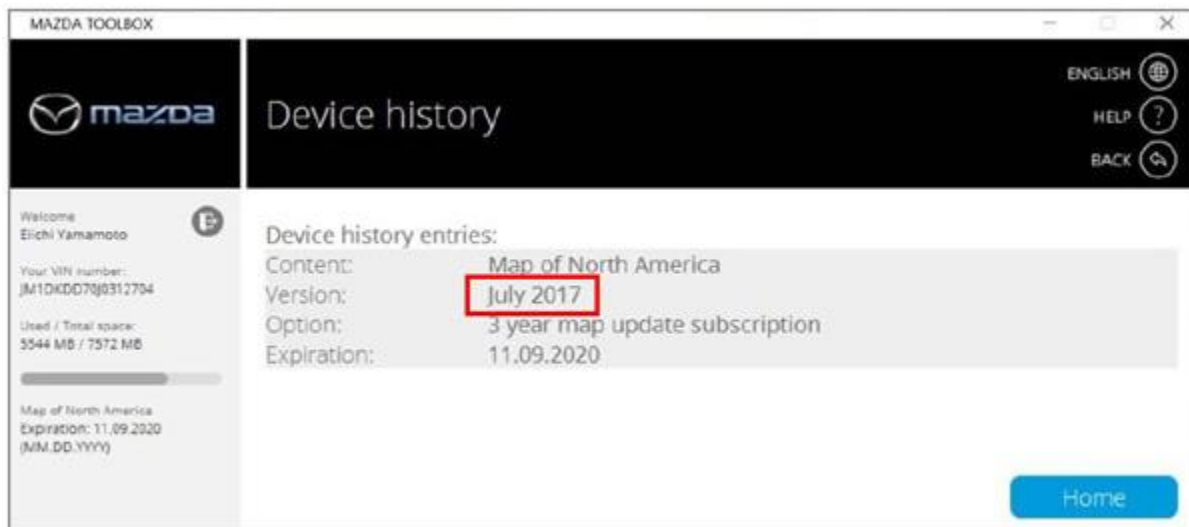
4. Using Mazda Toolbox, open the "Device History" screen and check the SD Card version.

Is the SD Card version before July 2017?

- Yes - Update Navigation SD card to the latest software using Mazda Toolbox.
- No - This service information does not apply. Refer to MGSS online for normal diagnosis procedures.
