Technical Service Bulletin

Subject: ROUGH IDLE AND/OR MIL ON WITH DTC P0300, P0301, P0302, P0303 OR P0304 IN COLD TEMPERATURE	Bulletin No.: 01-006/18
	Last Issued: 03/09/2018

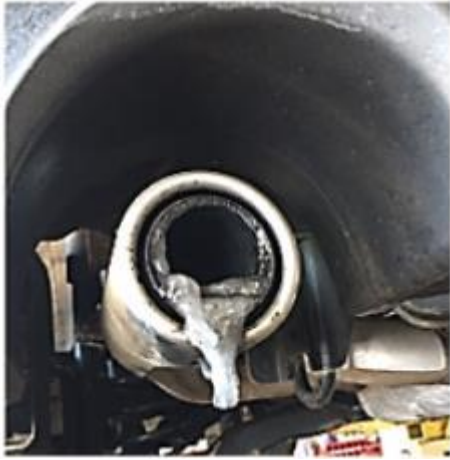
This may be caused by frozen water accumulated in the main silencer, restricting exhaust flow.

1. Verify customer concern of water accumulated and frozen in the main silencer and the tail pipe.

2. Replace the main silencer. Refer to MGSS online or Workshop Manual section 01-15:

NOTE: The modified service parts have two drain holes at the bottom of the main silencer.
