Subject: SECOND-ROW SEAT WALK-IN LEVER DOES NOT WORK	Bulletin No.: 09-009/18
	Last Issued: 03/14/2018

2016-2017 CX-9 vehicles with VINs lower than JM3TC*****142166 (produced before May 22, 2017)

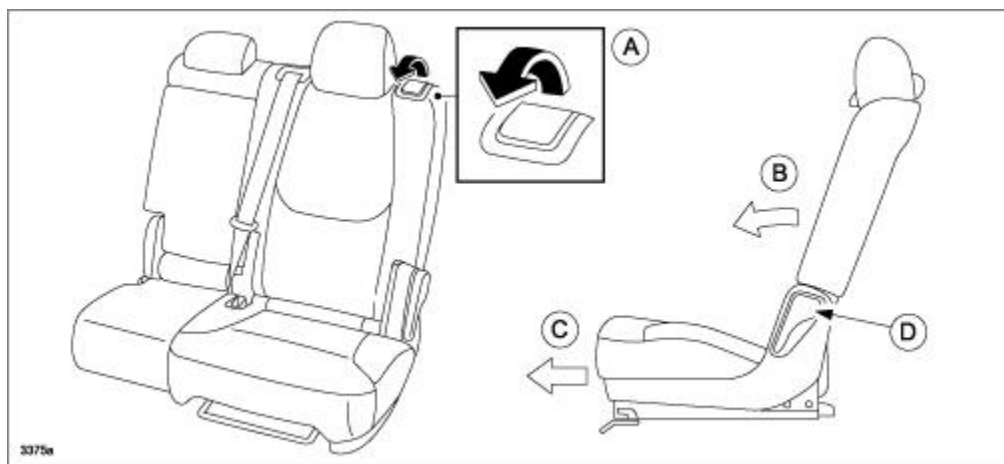
On some vehicles, the second-row seat back does not fold (B) or slide (C) forward when the walk-in lever (A) is pulled up to access to the 3rd row seats. Also, the recliner lever knob (D) may not operate on some vehicles.

These concerns may be caused by a disconnected walk-in lever cable. To eliminate these concerns, the design of the walk-in lever has been changed according to the following:

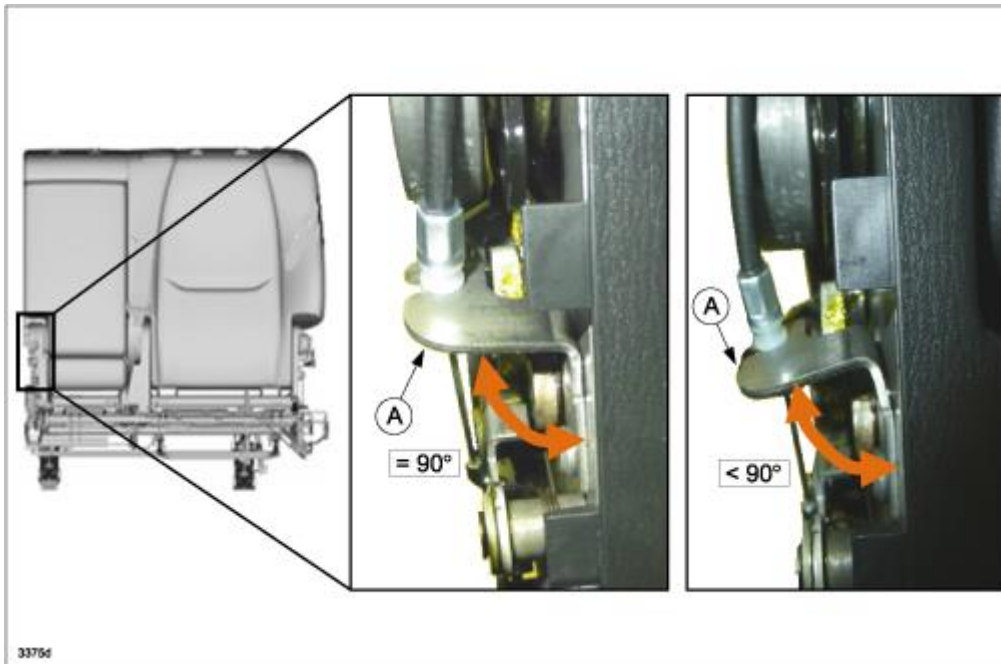
5. Inspect the cable bracket (A) for deformation / bending.

- If the cable bracket is bent (as shown above-right), replace the second-row seat cushion frame assembly with a modified one according to the instructions on MGSS online (SECOND-ROW SEAT BACK COMPONENT REMOVAL/INSTALLATION) and (SECOND-ROW SEAT CUSHION REMOVAL/INSTALLATION).

NOTE: When replacing the frame, check the cable for damage and replace if necessary.

- If the cable bracket is not bent (as shown above-left), go to the next step.

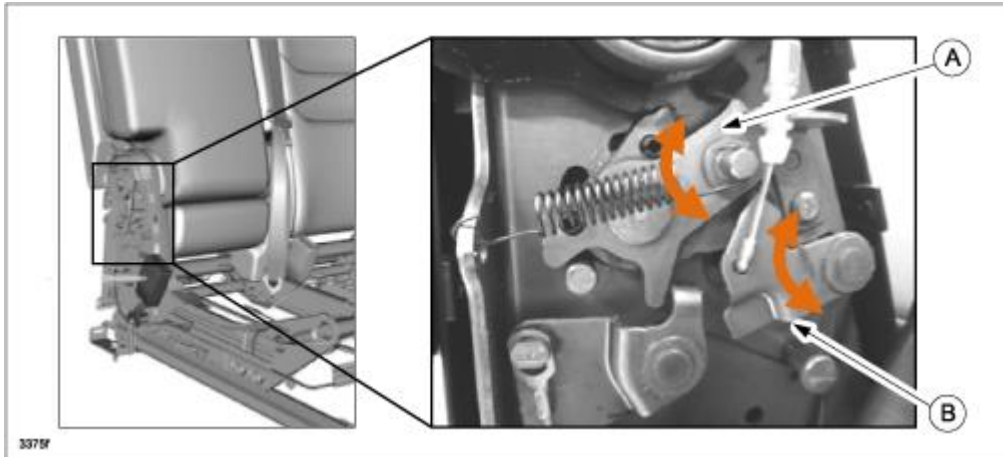
6. Verify links (A and B) move smoothly.

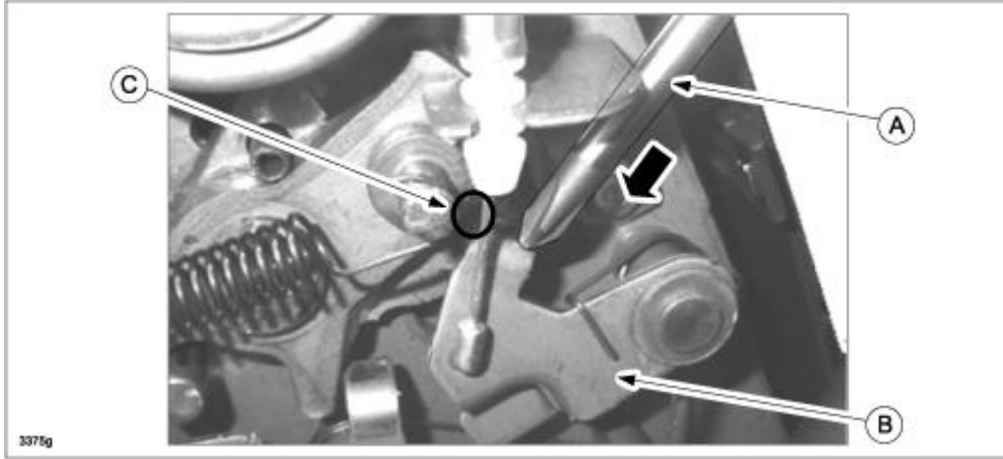
- If the links do not move, they may be binding with each other (C). Push link (B) with a screw driver (A) to release the binding. Verify the links move smoothly, then go to the next step.

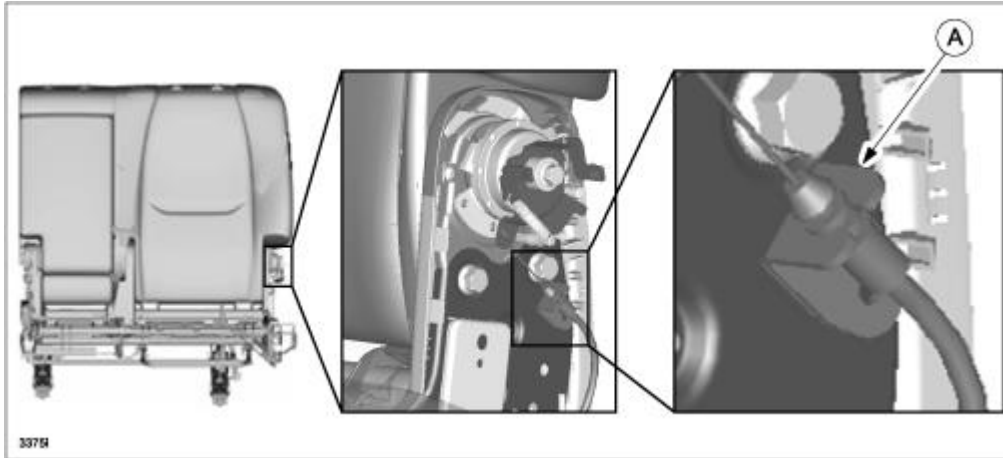
8. Inspect cable bracket (A) for bending.

- If the cable bracket is bent, replace the second-row seat cushion frame assembly with a modified one according to the instructions on MGSS online (SECOND-ROW SEAT BACK COMPONENT REMOVAL/INSTALLATION) and (SECOND-ROW SEAT CUSHION REMOVAL/INSTALLATION).

NOTE: When replacing the frame, check the cable for damage and replace if necessary.

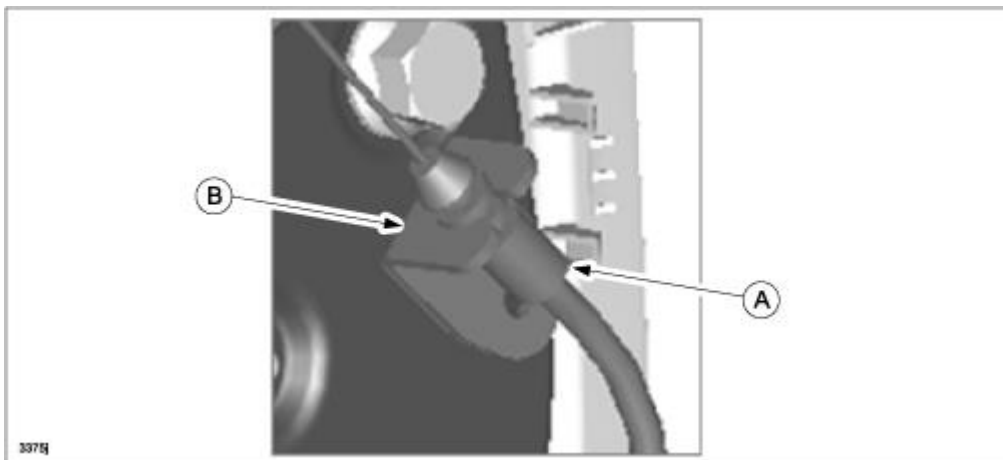
9. Inspect cable (A) for damage / coming out of bracket (B).

- If the cable is coming out of the bracket, check the white plastic part for damage.
- If the cable is damaged, replace it with a new one.
- If the cable is not damaged, install it back to the bracket.

NOTE: Use the same groove position to reinstall the cable.

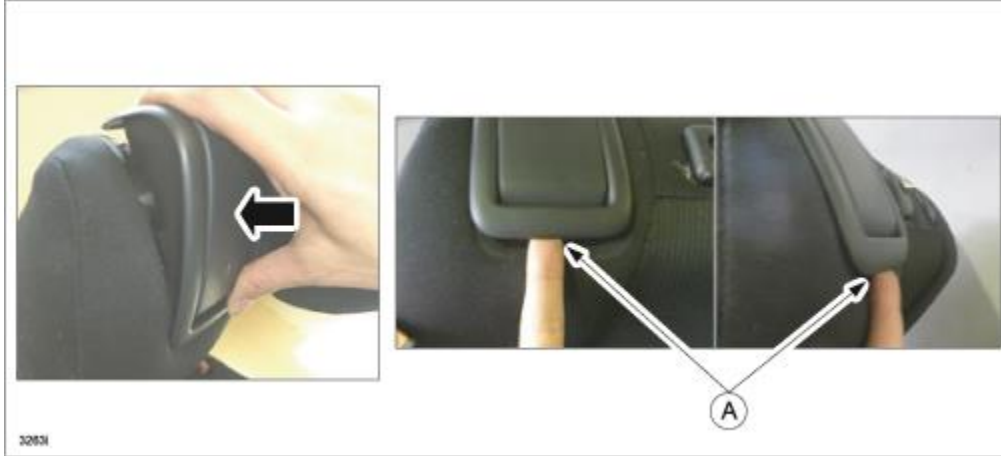
NOTE: The example shown below (A) is NO GOOD. There should not be any clearance.

3. Push the lever assembly into the seat back, verifying that the front edge is securely engaged in the anchor.
