Subject: LED HEADLIGHT WARNING LIGHT FLASHES WITH DTC C0061:54	Bulletin No.: 09-012/18
	Last Issued: 03/22/2018

2018 CX-3 vehicle equipped with LED headlight auto leveling system

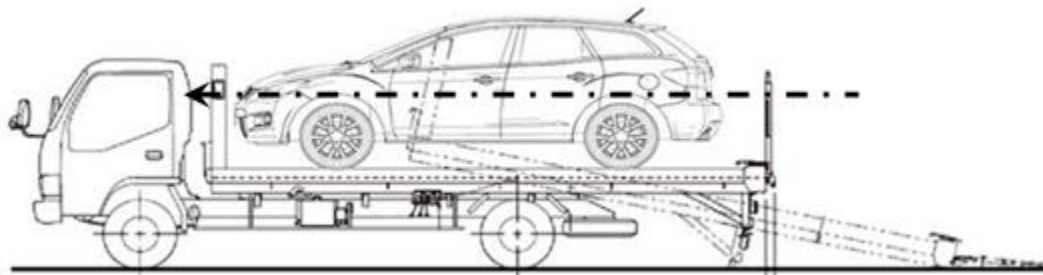
1. Loading Vehicle: When loading the vehicle onto the trailer, the ignition is turned **OFF** while the vehicle is level.

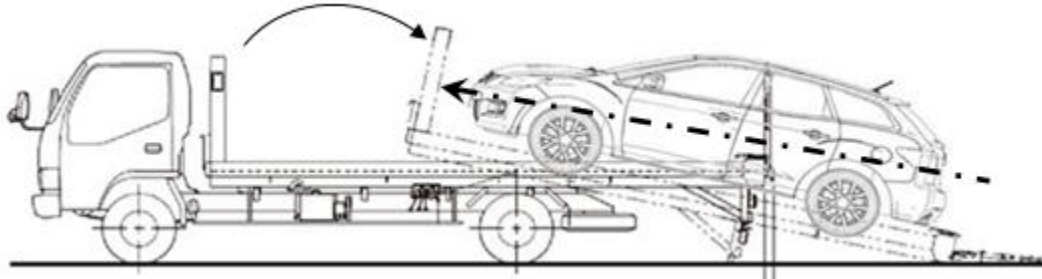
2. Unloading Vehicle: After sliding the carrier outward to unload the vehicle from the trailer, the ignition is turned **ON** while the vehicle is inclined.
