<b>Subject:</b> <b>FRONT SEAT CUSHION TRIM COMING OFF AT BOTTOM OF REAR SIDE - (MANUAL SEATS ONLY)</b>	<b>Bulletin No.:</b> 09-013/18
	<b>Last Issued:</b> 03/22/2018

2017 CX-5 vehicles equipped with manual seats with VINs lower than JM3KF\*\*\*\*\*170897 (produced before June 15, 2017)

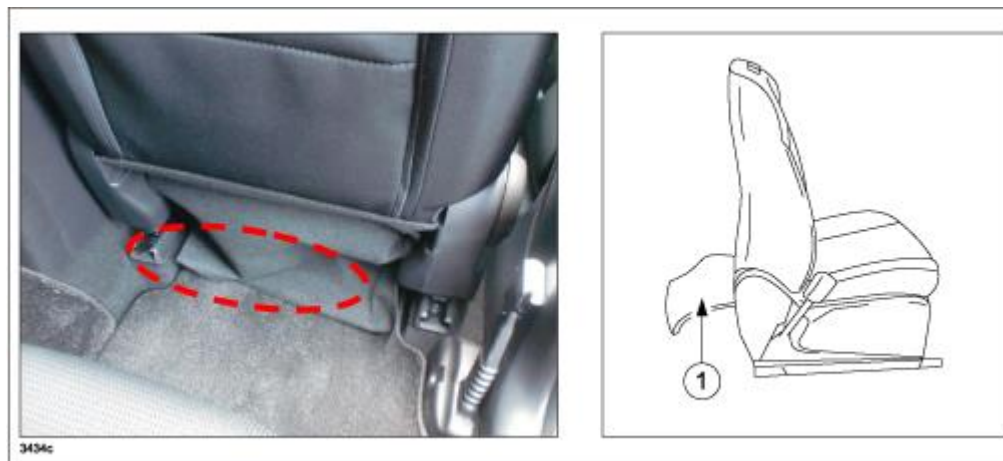
Some customers may complain about the driver and/or passenger rear side seat cushion trim (1) coming off the seat cushion frame (as shown below).

The front seat cushion trim (bottom rear) is attached to the seat cushion frame using a hook. The hook may slip out of the seat cushion frame due to insufficient strength. To eliminate this concern, a plastic tie-wrap has been added to increase the strength.

Customers having this concern should have their vehicle repaired using the following repair procedure.
