Technical Service Bulletin

WRINKLES ON LEATHER SEAT SURFACE OF NEW VEHICLE

Bulletin No.: 09-015/18

Last Issued: 03/22/2018

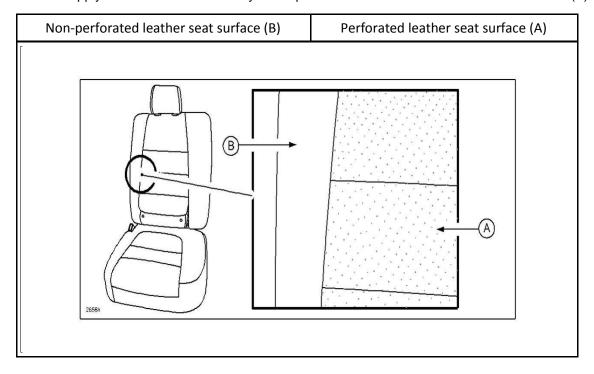
- A qualified upholstery repair specialist is required for this repair procedure.
- Always follow the manufactures instructions for the steamer and heat gun.
- Do not apply the steamer head directly to the perforated sections of the leather seat surface (A).

1. Use a clean lint-free cloth to cover all seat belt buckles.

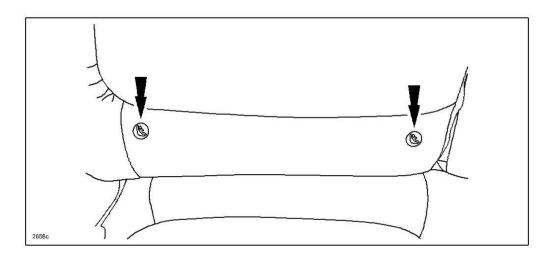
- Do not spray water on the seat belt buckles.
- Do not apply the steamer head directly on the latch anchor location buttons.

2. Choose one area at a time to work on. Apply the steamer head directly on the wrinkle until the upholstery material becomes warm. Move the steamer head in a outward motion (similar to ironing a shirt). Repeat until the wrinkles are removed to an acceptable level.

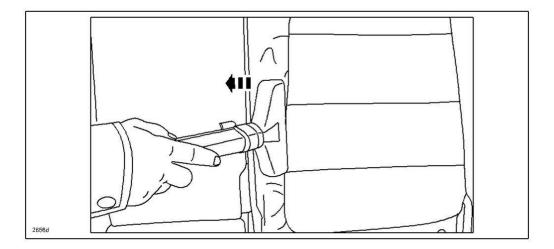
CAUTION: Do not apply steam directly on the perforated sections of the leather seat surface.

If necessary, use your hand to work out the wrinkles by applying firm pressure in a outward motion. This step can be repeated as long as the upholstery material is warm. If the upholstery material feels cool, reapply steam.

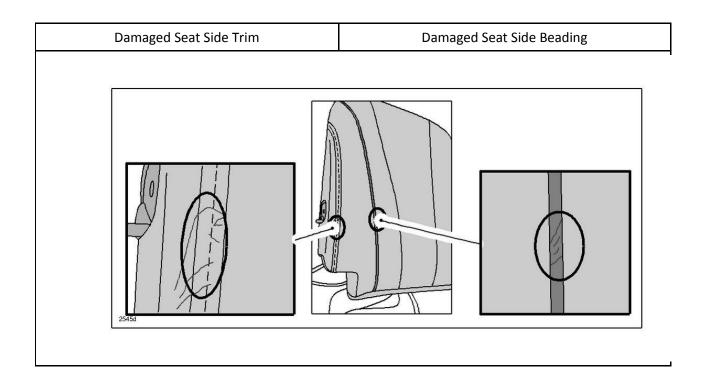
- Do NOT keep the steamer head at the same place for a long time.
- Do NOT run the steamer head without a water-soaked cloth especially over seat trim beading and seat side trim area.
- Seat damage may occur if the caution points above are nor followed as shown below.

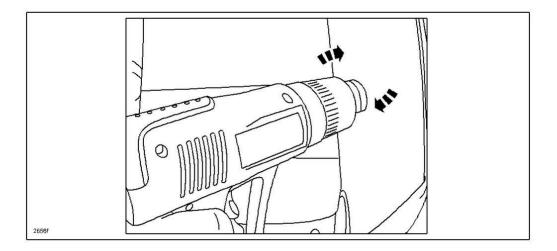
- Do not apply direct heat on the perforated sections of the leather seat surface.
- Do not apply direct heat on the upholsteries' stitching or beading.
- Do not apply direct heat on the latch anchor location buttons.

Hold the heat gun at least 5 inches away from the upholstery material. Apply heat in a circular motion.
