# Technical Service Bulletin

Subject: DRIVER AND/OR PASSENGER SEAT WARMER(S) INOPERATIVE - (CLOTH SEATS ONLY)	Bulletin No.: 09-017/18
	Last Issued: 03/26/2018

2013-2016 CX-5 vehicles equipped with cloth seats.

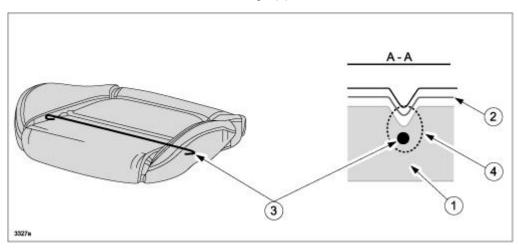
Some vehicles may exhibit inoperative driver and/or front passenger side seat warmer(s) in any mode (High, Mid and Low). This may be caused by repeated load applied to the seat cushion (1) while the seat is occupied. A section of the heater mat (2) just above the reinforcement rod (3) in the cushion pad contacts internal heater mat wire and causes damage (4).

2. Replace the seat cushion pad(s) according to the instructions on MGSS online FRONT SEAT CUSHION TRIM REMOVAL/INSTALLATION.

**NOTE**: A new seat cushion pad is available with a repositioned internal heater mat wire to prevent contact with the reinforcement rod.
