# Technical Service Bulletin

Subject: SPIDER WEB-LIKE CRACKING APPEARS IN CORNER(S) OF MAZDA CONNECT CENTER DISPLAY	Bulletin No.: 09-018/18	
	Last Issued: 03/26/2018

2016-2017 CX-3 2017 MX-5 2016 MX-5 vehicles with VINs lower than JM1ND\*\*\*\*\*\*119894 (produced before July 4, 2016)

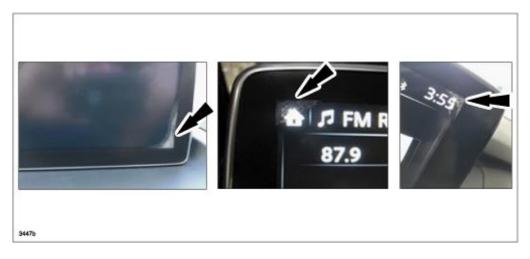
Some customers may complain about spider web-like cracking (as shown below) appearing in the corner(s) of the MAZDA CONNECT center display. The cracks are internal and cannot be felt by touch.

This concern may be caused by a lack of glue between the touch screen and the center display. To eliminate this concern in the future, the manufacturing process has been improved.

Customers having this concern should have their vehicle repaired using the following repair procedure.

- 1. Verify the customer concern.
- 2. Check if the screen is internally damaged (no external impact).
  - If YES, go to the next step.
  - If NO, this Service Information does not apply.
- 3. Replace the center display with a modified one according to the instructions on MGSS online:
  - CX-3 CENTER DISPLAY REMOVAL/INSTALLATION
  - MX-3 CENTER DISPLAY REMOVAL/INSTALLATION
