SERVICE BULLETIN

Classification: EL13-050b	Reference: NTB13-107b	Date: March 26, 2018
------------------------------	--------------------------	-------------------------

INTELLIGENT KEY NOT DETECTED / ENGINE WILL NOT START

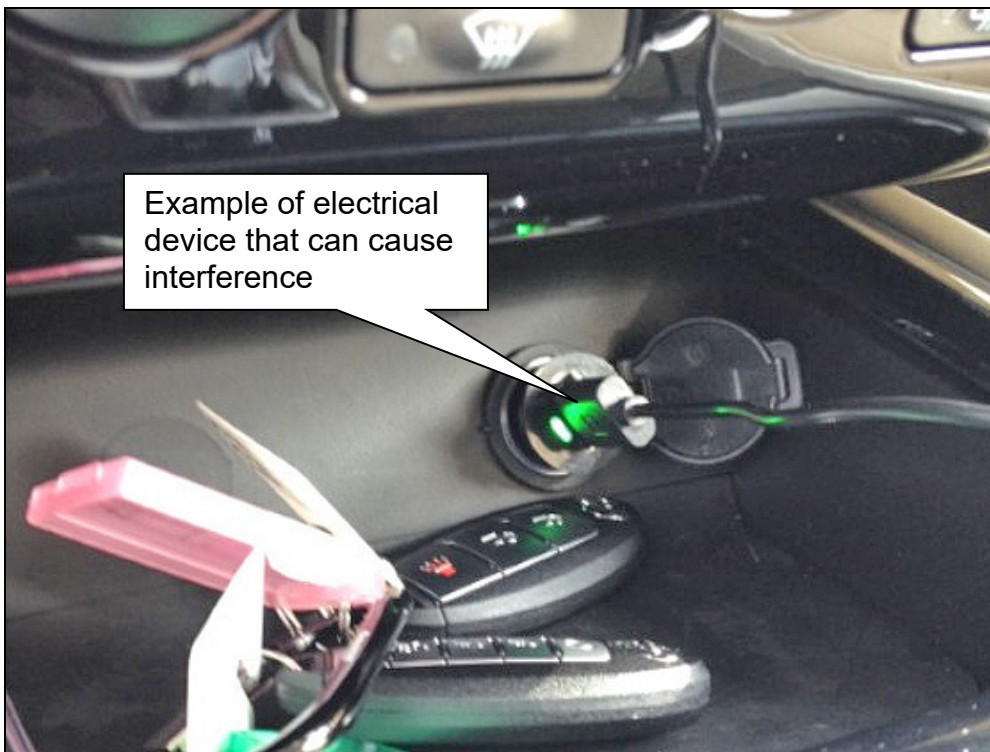
Figure 1

- Intelligent Key fob battery check:
 - Use Signal Tech II **IKEY Battery Test** to confirm battery state of charge.
- Location of Intelligent Key: An Intelligent Key should **not** be stored where the RF signal can be obstructed by nearby metal objects.
- Interference from other personal devices: Confirm the Intelligent Key is not placed in close proximity to phones, other Intelligent Keys, highway PASS Card, USB charger, Personal Computer (PC) charger, etc. that may be transmitting similar RF signals.
 - Technician should remove all devices from vehicle while diagnosing/duplicating the customer issue.
