N128NAS1

TECHNICAL BULLETIN

303-01A: Engine - INGENIUM I4 2.0L Diesel

Service Action: Balancer Shaft Whine

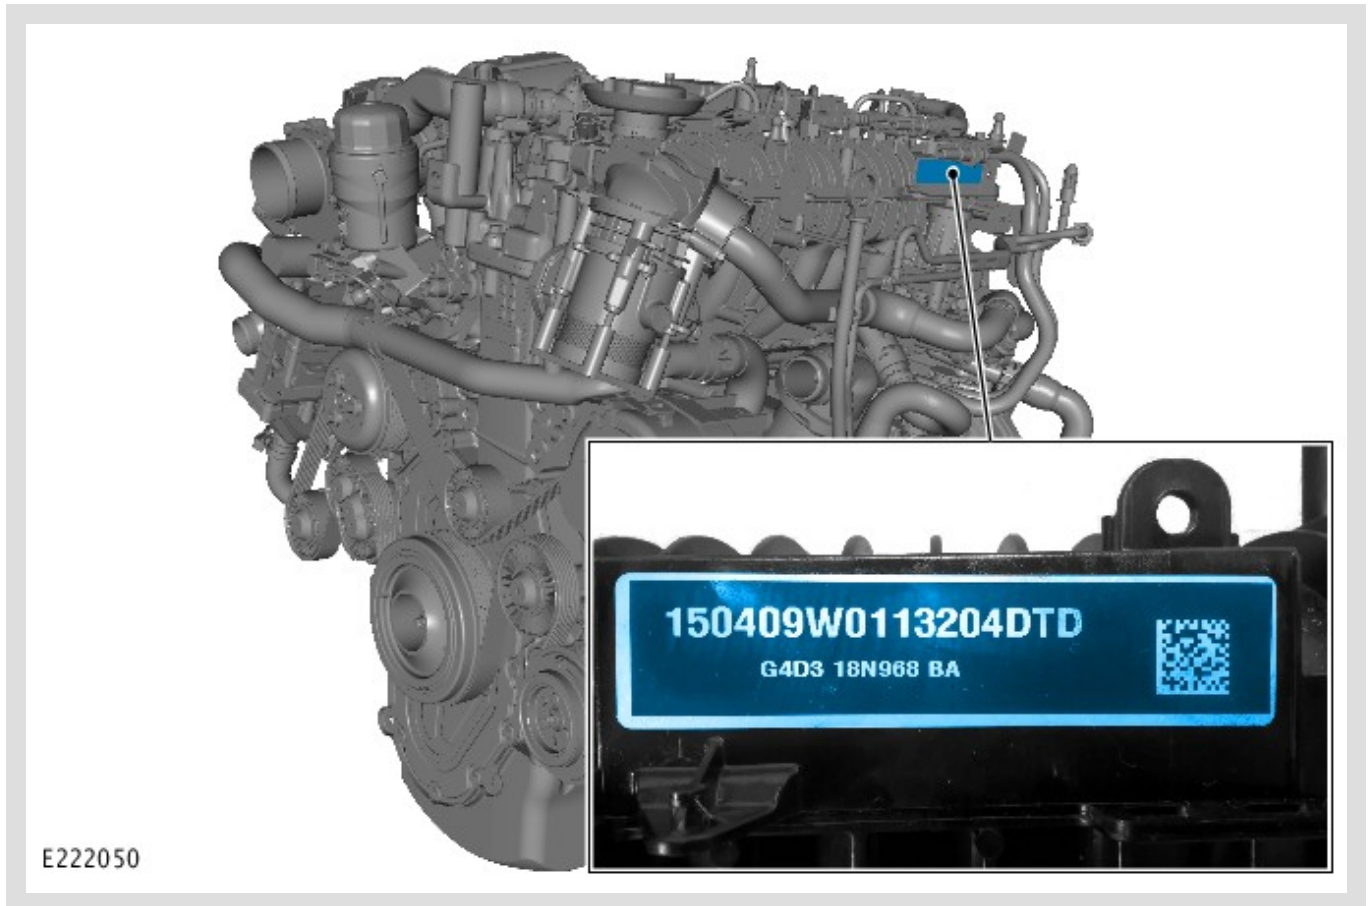
1

The engine build date is the first 6 characters (YY/MM/DD) of the engine serial number.

Locate and record the engine serial number.

- If the engine build date (first 6 characters of the engine serial number) is after **170817W0976204DTD** (2017 August 17), do not continue with this Workshop Procedure.
 - Submit a Technical Assistance (TA) request for further assistance.
- If the engine build date (first 6 characters of the engine serial number) is before **170817W0976204DTD** (2017 August 17), go to Step 2.
