## Use of MICHELIN® 315/80R22.5 X® MULTIWAY 3D XZE® LRL in Urban Application for Proterra

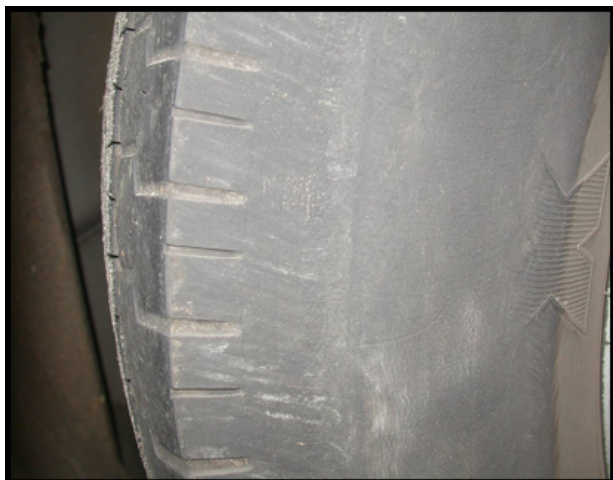
**WORN SIDEWALL LETTERING DUE TO SCRUB,  
ROTATION REQUIRED**

As sidewall depth indicators are not molded on the sidewall of the MICHELIN® 315/80R22.5 X® MULTIWAY 3D XZE® LRL, the following maintenance practices must be followed. Michelin recommends daily tire inspections. When the sidewall writing is worn off, rotate the tire from the right side of the vehicle to the left side of the vehicle. Additionally, the tire can be flip-rotated on the wheel so that the worn sidewall is fitted to the inside position.

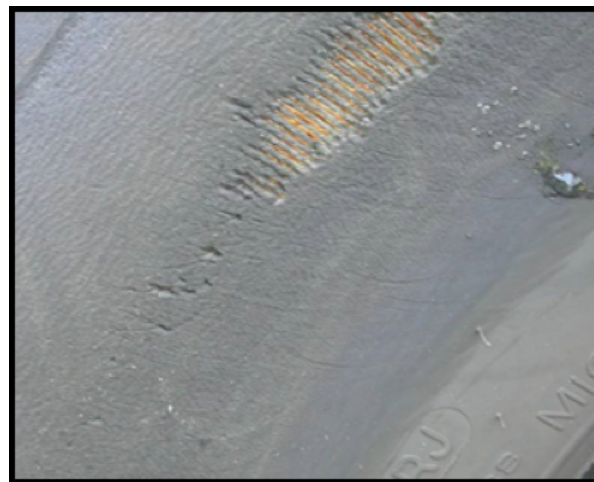
**CASING PLY CORDS EXPOSED DUE TO SCRUB,  
REMOVE TIRE FROM VEHICLE AND SCRAP**

Prior to rotating the tire sidewall, the sidewall should be examined to make sure there are no cords exposed or cuts deeper than 3 mm. If these conditions exist, the tire should be removed and scrapped.
