# Service Alert

| <b>Subject:</b><br><br><b>ENGINE NO START DUE TO BATTERY DISCHARGE</b> | <b>Service Alert No.:</b> SA-002/18 |
| | <b>Last Issued:</b> 02/02/2018 |

2017 MX-5 RF with VINs lower than JM1ND\*\*\*\*\*106475 (produced before May 16, 2017)

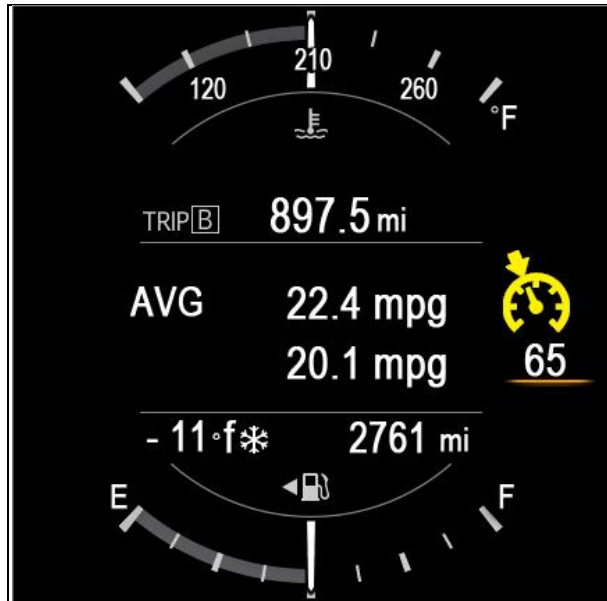
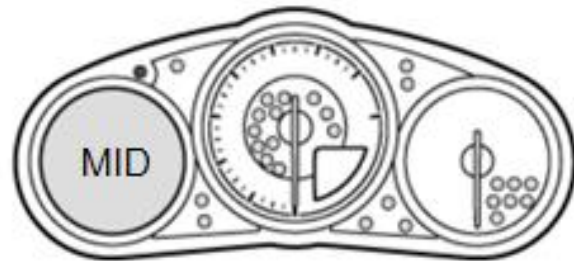
Instrument Cluster with MID

If the ignition is switched OFF while Cruise Control is ON (one of the Cruise Control indicators is ON in the MID), the microcomputer does not shift into the sleep mode and an operation current of 80 mA will continue to flow.

Cruise Control indicators is ON

To correct this concern, the software of the instrument cluster has been changed.
