# Technical Service Bulletin

<b>Subject:</b> <b>ENGINE MISFIRE DURING ACCELERATION WITH CHECK ENGINE LIGHT FLASHING AND DTCs P0302:00, P0303:00 AND/OR U0401:00</b>	<b>Bulletin No.:</b> 01-010/18
	<b>Last Issued:</b> 03/29/2018

2016-2017 CX-9 vehicles with VINs lower than JM3TC\*\*\*\*\*135222 (produced before Dec. 27, 2016)

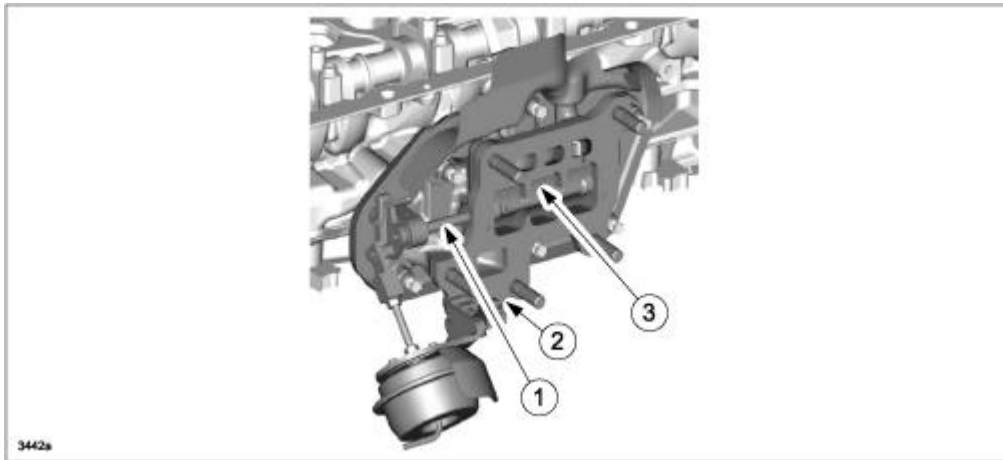
This concern may be caused if the exhaust manifold variable valve shaft (1) is out of alignment and/or the exhaust manifold variable valve housing (2) is out of shape. The exhaust manifold variable valve (3) then interferes with the housing and becomes stuck closed when the engine is hot.

To eliminate this concern in the future, the production processes and controls have been improved.

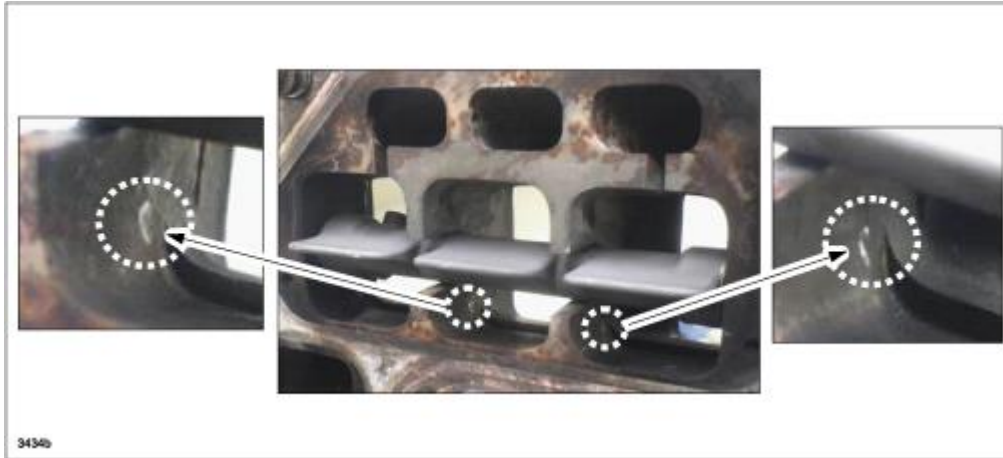
2. If one or both of the above conditions are met, remove the exhaust manifold and verify that there are contact mark(s) on the exhaust manifold variable housing caused by the variable valve, as shown below.

3. If contact mark(s) are found, replace the exhaust manifold with a modified one according to the instructions on MGSS online (EXHAUST SYSTEM REMOVAL/INSTALLATION [SKYACTIV-G 2.5T]).
