TO: Mazda Dealership General Managers, Service Managers, and Parts Managers
DATE: March 9th, 2018
SUBJECT: 2014 Mazda3 Front Power Window Regulator Cable
Special Service Program (SSP) SSPB4

**Special Service Program (SSP) B4
2014 Mazda3 Front Power Window Regulator Cable**

2014 MAZDA3 – FRONT POWER WINDOW REGULATOR CABLE SSPB4

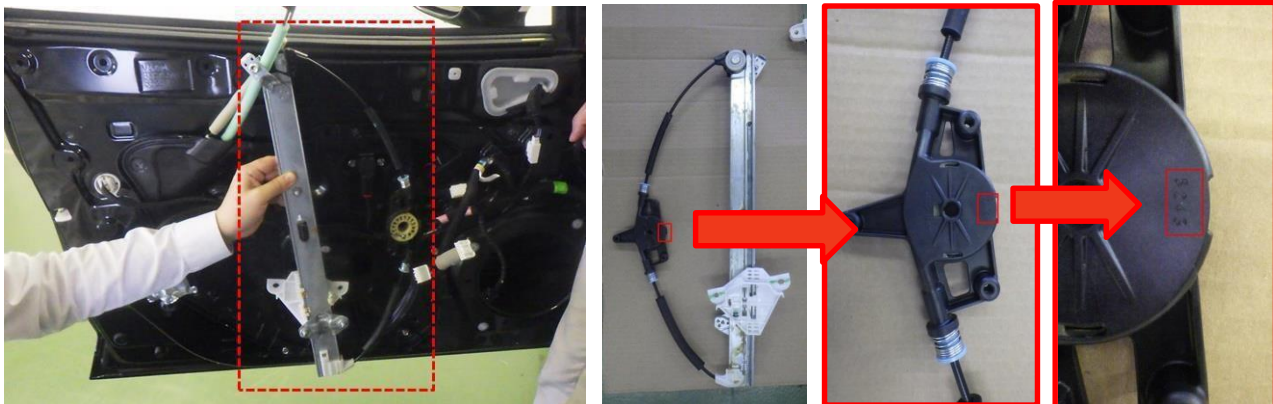
<Inspection Procedure>

12. Confirm the lot number on the front power window regulator.

- If the lot number is same with one of the below table, replace the front power window regulator with new one
- If the lot number is NOT same with one of the below table, no further action is required.

Part name	Part Number	LOT						
Driver's side ARM/BASE(Right side)	BJS7-58590	4113	4115	4118	4119	4120	4125	-
Passenger side ARM/BASE(Left side)	BJS7-59590	4114	4115	4118	4119	4122	4125	4126
