January 4, 2018

Attention: Mazda Dealership Sales and Service Managers

Subject: **Dealer Rework (DRW) 09 - 2018 Mazda MX-5 Power Window Switch Concern**

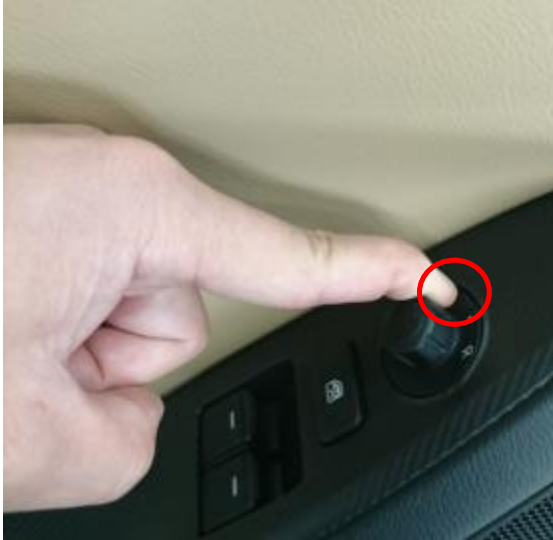
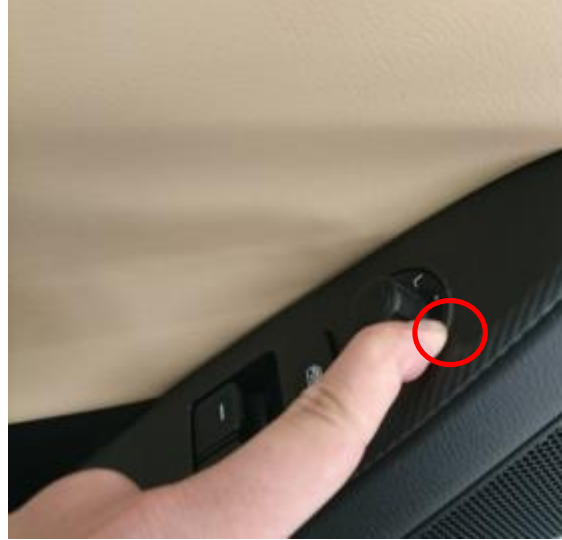
On affected vehicles, the driver power window main switch is not correctly assembled to the power window main switch door panel. There are 4 tabs (2 tabs on front side, 2 tabs on rear side) on the power window main switch affixed to the door panel. It is possible that 1 or 2 of the tabs are not locked, and there is a chance the switch will drop slightly when the power outer mirror switch is pushed.

When the power window main switch part is assembled to the driver-side door trim by a jig in production, the power window main switch could have been unintentionally pushed vertically due to the jig misalignment.

1. Push both side of the power outer mirror control switch (on the letter "R "and "L") by finger then check that the switch does not drop off from the original position.

Fail→Go to 【Removal / Installation procedure】 to remove the door trim and re-insert the power window main switch.

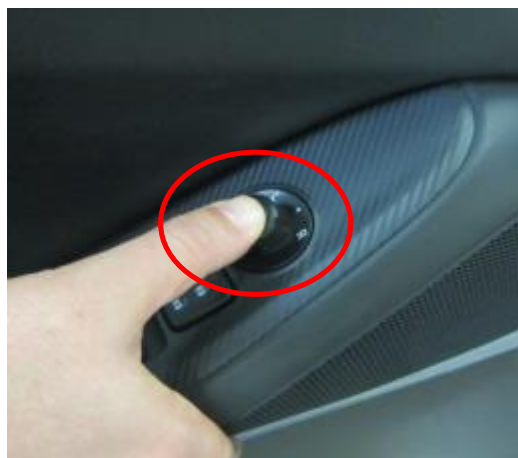
2. Push the power outer mirror control switch shown in the picture then check that the switch does not drop off from the original position.

Fail→Go to 【Removal / Installation procedure】to remove the door trim and re-insert the power window main switch.

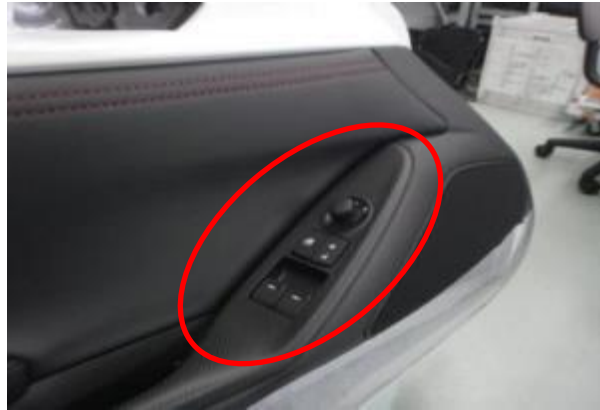
3. Check that there are no scratches around the area.
