# Service Alert

**MAZDA CONNECT NAVIGATION CANNOT FIND STREET ADDRESS  
WITH VERSION 59.00.540**

**Service Alert No.:** SA-012/18

**Last Issued:** 03/02/2018

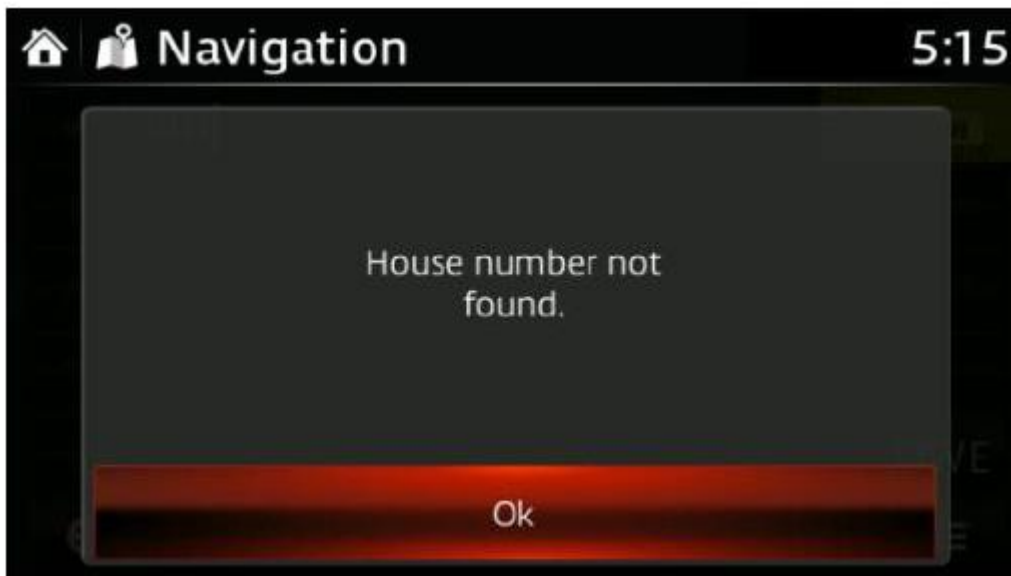
- A screen pops up that says "House number not found." After the user selects OK, the system finds the address or a nearby address.

This only occurs with MAZDA CONNECT software version **59.00.540**, which started being installed into vehicles in January 2018. The concern can be eliminated by installing MAZDA CONNECT software version **59.00.504**.

1. Check to see if the vehicle has MAZDA CONNECT software version **59.00.540**.

- YES - Use [TSB 09-017/17](#) to change the MAZDA CONNECT software to version **59.00.504**.
- NO - Troubleshoot the Navigation system using the instructions on MGSS.
