Subject: BLIND SPOT MONITORING (BSM) DOES NOT OPERATE AFTER REPAIR	Service Alert No.: SA-013/18
	Last Issued: 03/06/2018

2017-2018 CX-5

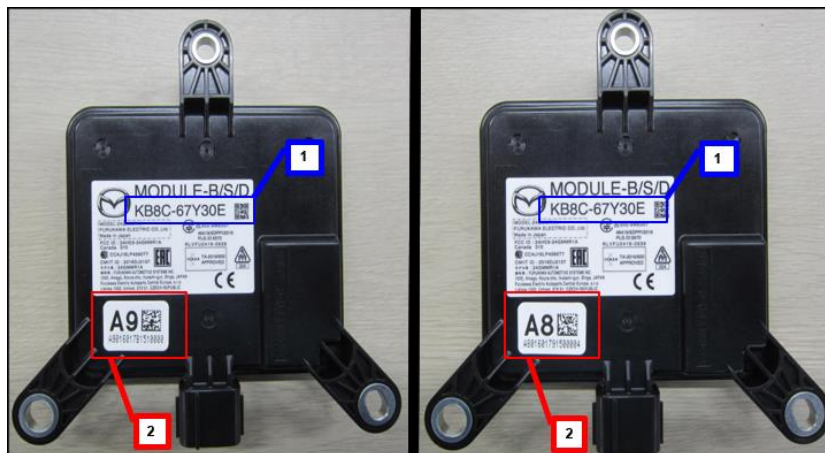
Some customer's may complain that the blind spot monitoring (BSM) is not operating, and the key ON bulb check is OK with no DTCs stored in memory. This issue could be caused by mis-matched BSM modules, especially if the vehicle was recently involved in an accident or work was done on the BSM system. To check if this is the issue, refer to the Repair Procedure.

1. Remove the rear bumper according to the instruction on MGSS (REAR BUMPER REMOVAL/INSTALLATION).
2. Inspect the labels (1) and (2) on the BSM modules (P/N KB8C-67Y30E).
 - If one module has 2 digit alphanumeric label with "A8" and the other has label "A9", replace the "A9" module with an "A8" module. "A9" modules have been quarantined and only "A8" modules are available from Parts Inventory.
 - If both modules have the same 2 digit alphanumeric label (both have "A8" or "A9" labels), this is not the issue. Refer to BSM troubleshooting procedures on MGSS.
