Service Alert

Subject: MAZDA RADAR CRUISE CONTROL (MRCC) DISABLED UNDER 20 MPH	Service Alert No.: SA-014/18
	Last Issued: 03/07/2018

- 2018 Mazda6 equipped with MRCC Stop & Go function
- 2017-2018 CX-5 equipped with MRCC Stop & Go function
- 2018 CX-9 equipped with MRCC Stop & Go function

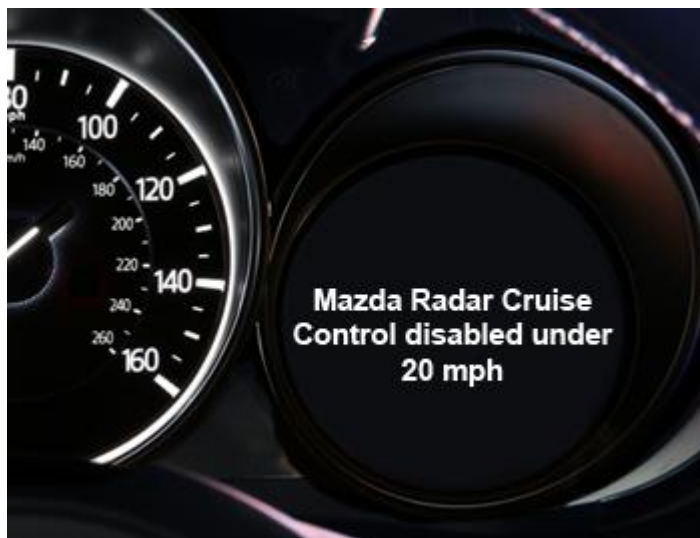
Some customers may complain about the following message displayed in the Multi-Information Display:

In the following cases, the MRCC with Stop & Go function system is canceled when the vehicle is traveling at 19 mph (30 km/h) or less:

- The Forward Sensing Camera (FSC) cannot detect target objects due to one of the following:
 - The windshield is dirty
 - The FSC lens is foggy
 - There is low visibility due to rain, fog or snow
 - It is at night and there is not enough light
 - There is direct or reflected sunlight on the FSC
 - There is problem with the FSC
- There is a problem with the AUTOHOLD control function.
- There is a problem with the electric parking brake (EPB).
