<b>Subject:</b> <b>IDS SOFTWARE VERSION 109.00 AND 109.01 ARE NOW AVAILABLE ON MGSS</b>	<b>Service Alert No.:</b> SA-017/18
	<b>Last Issued:</b> 03/28/2018

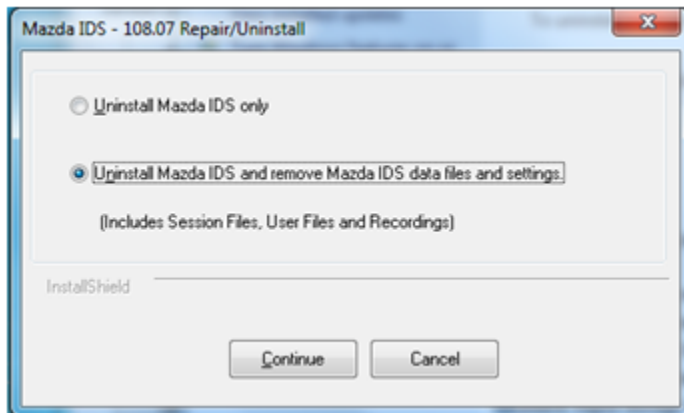
NOTE: You may see 'Selection not available' on IDS when a selecting 'Programming menu'

108.07 included a timer extension for Programming menu application that had to be installed before the expiration date of 3/27/18.

After the expiration, IDS can't accept the extension. To correct this, uninstall IDS and re-install IDS 108.00 >IDS 108.07 up-date. Select "Remove Mazda data files and settings" as shown below.
