# Technical product information

<b>Topic</b>	Convertible hood assembly - Service and repair procedures
<b>Market area</b>	Bentley: worldwide (2WBE),Hongkong-Macau (5HK)
<b>Brand</b>	Bentley
<b>Transaction No.</b>	2050102/1
<b>Level</b>	EH
<b>Status</b>	Approval
<b>Release date</b>

## Continental GT Convertible

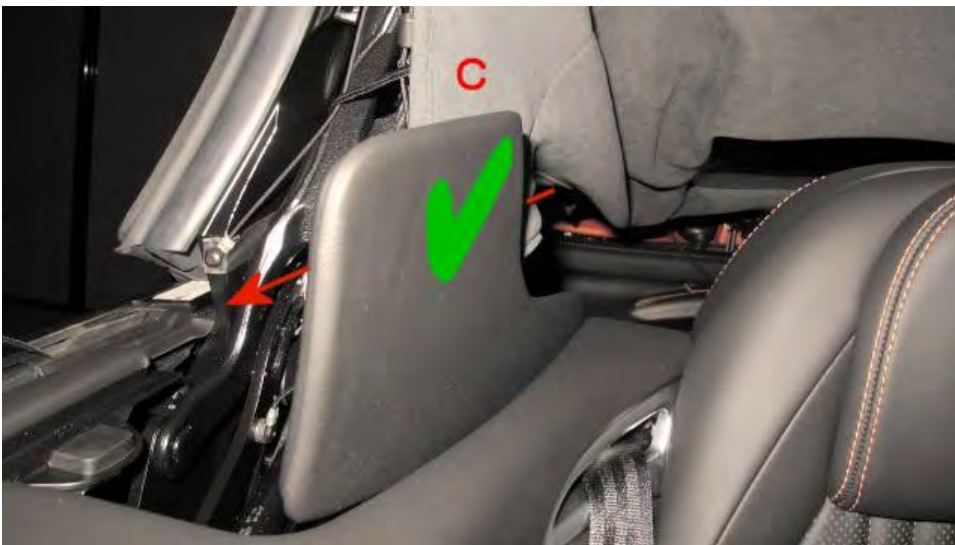
Figure 8

Therefore the following must be noted: The convertible hood should be closed in one continuous operation. Releasing the convertible hood function switch before the hood close cycle is complete should be avoided during normal operation. If the close cycle has to be interrupted for any reason such as when performing service repairs then the hood close cycle must not be continued, instead the convertible hood cycle should be reversed lowered back into the stowed position before the full close cycle is performed. Another method would be that if the hood is stopped mid cycle the hood operator **MUST** ensure the headliner is positioned manually outboard of the flipper door, as can be seen in figure 8, before restarting the hood to closure

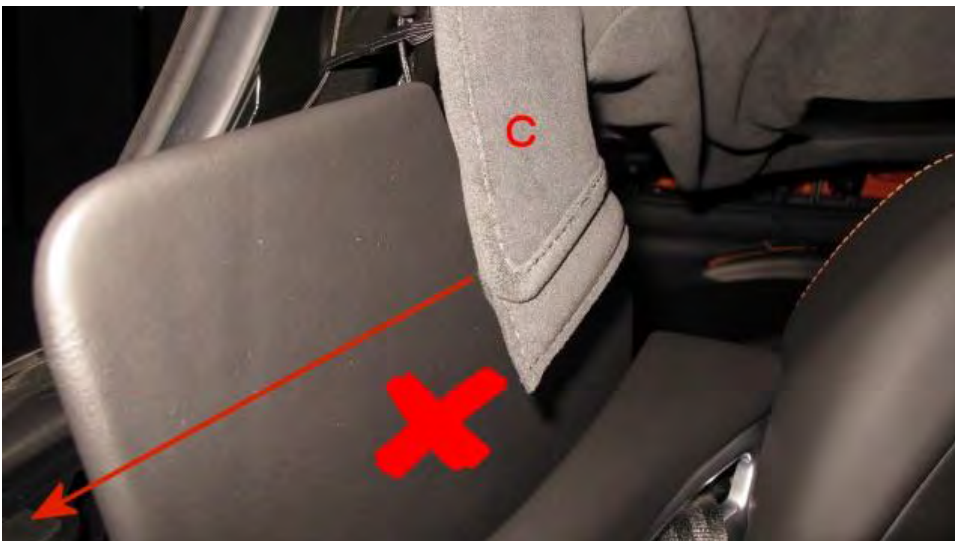
Figure 9

A relaxation of the tension across the headliner during a pause in the close cycle can result in the C post lower trim passing the wrong side of the flipper (see Figure 9). This will cause hood operation failure and damage to several components. This fault can occur on either side of hood assembly

If on completion of the repair the C post lower trim still tends towards passing the wrong side of the flipper (see Figure 9). Then consideration can be made to remove one of the shims from the mechanism (see Figure 10). Removing one shim will move the position of the flipper door. Note: the gap around the closed flipper door may need to be adjusted if a shim is removed. To carry out this operation the rear quarter trim panel (Rep.Gr. 70) will have to be removed and refitted

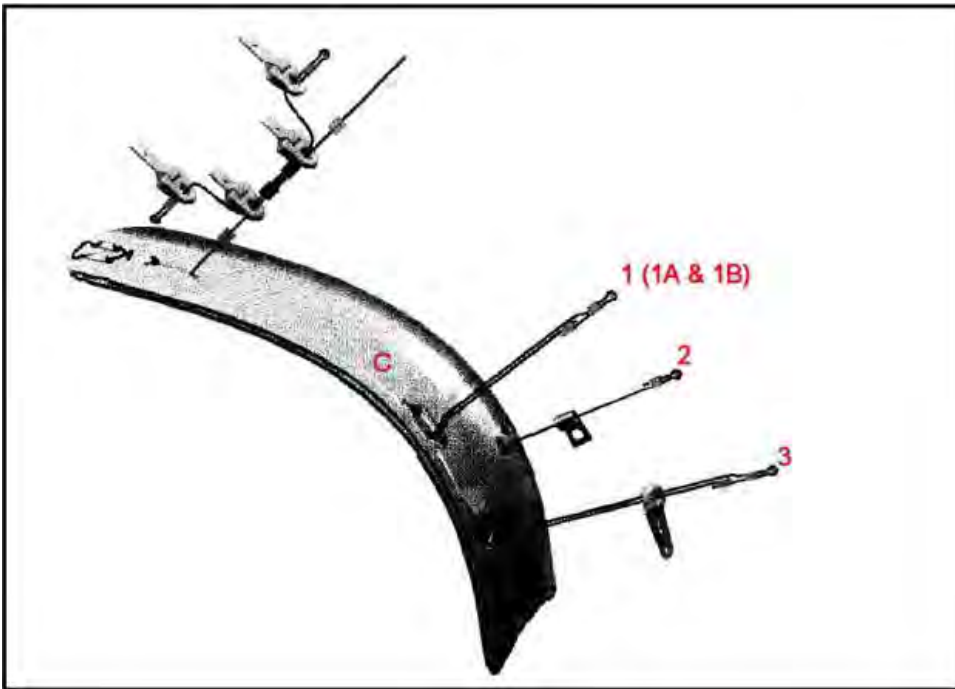
Figure 1 details the headliner tension cords / areas that can fail as a result of overstressing. The following measures show the detail of each of the headliner tension cords 1, 2 and 3 and their known tension cord and guide damage points to investigate

1. Double cord (two cords 1A and 1B)
2. Single cord
3. Double cord

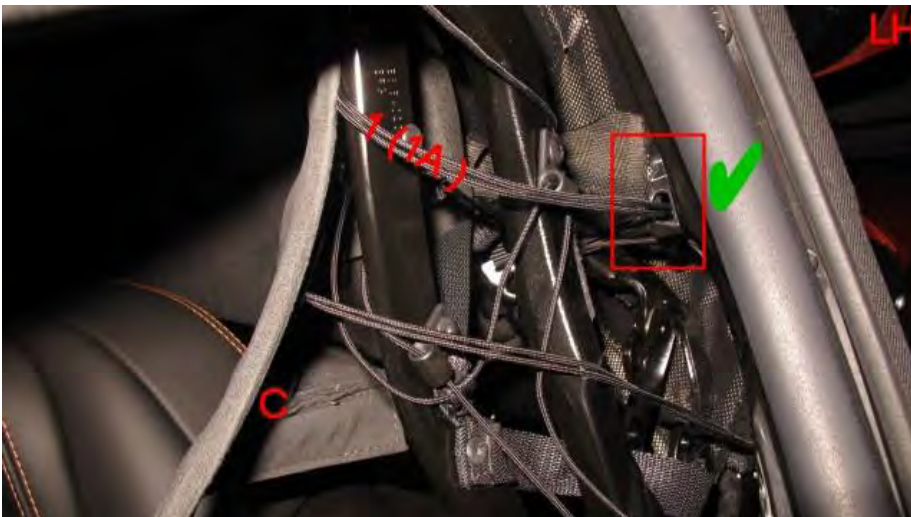
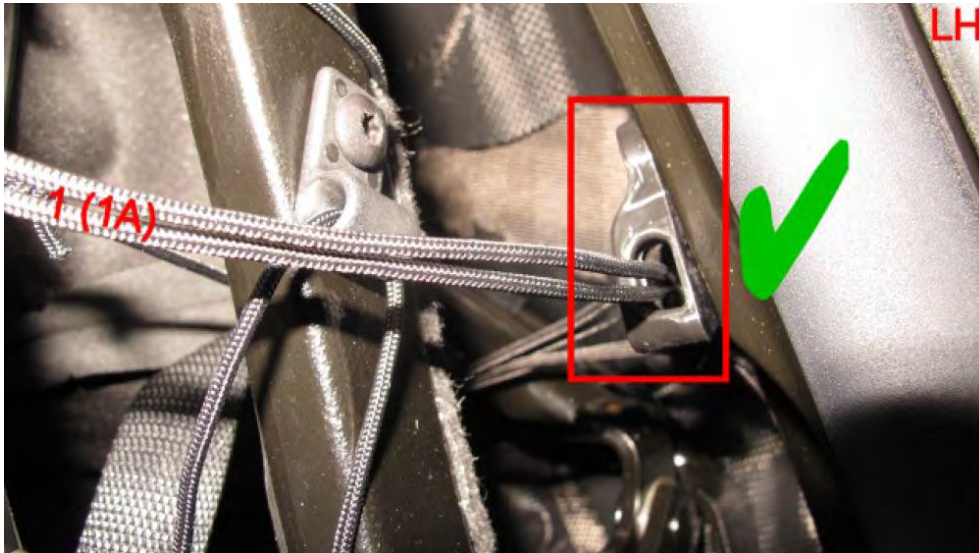
Frame cord guide is secured to frame with one rivet plus anti-rotation moulded peg. Figure 2 and 2a show the correct installation

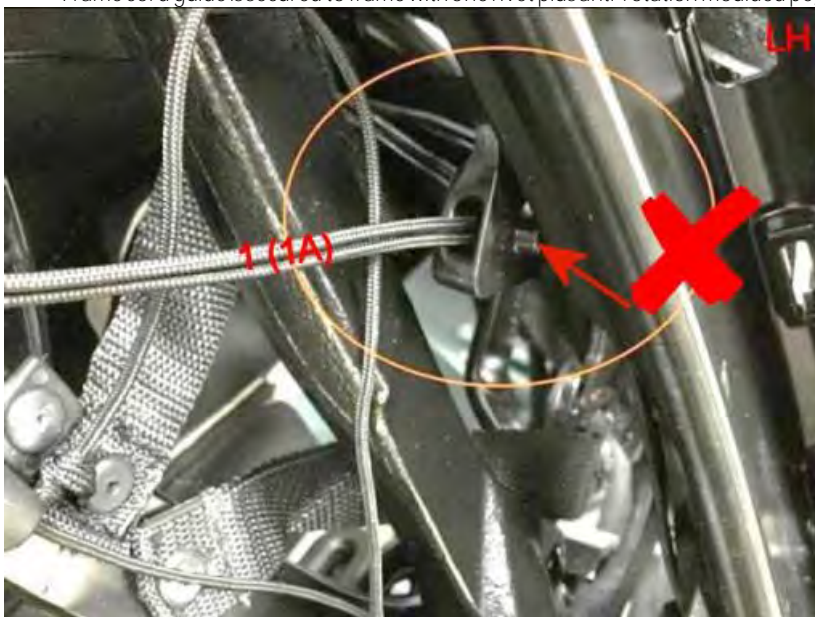
Figure 2b details the frame cord guide bent and pulled away from frame exposing the anti-rotation peg

Rectification: Un-knot cord 1 from C post trim, slide new frame cord guide into position and rivet to frame. The required parts, guide and rivet, are contained in convertible roof repair kit 3W7898025 (see Figure 2c)

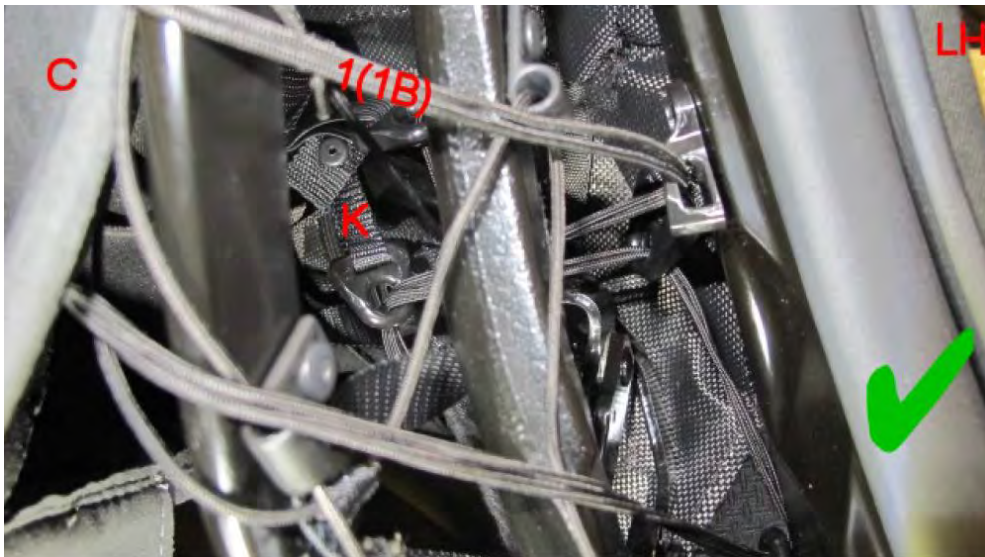
Cord guide assembly (K) location on bow 5. Figure 3 shows the correct installation with double cord 1 running through cord guide (K)

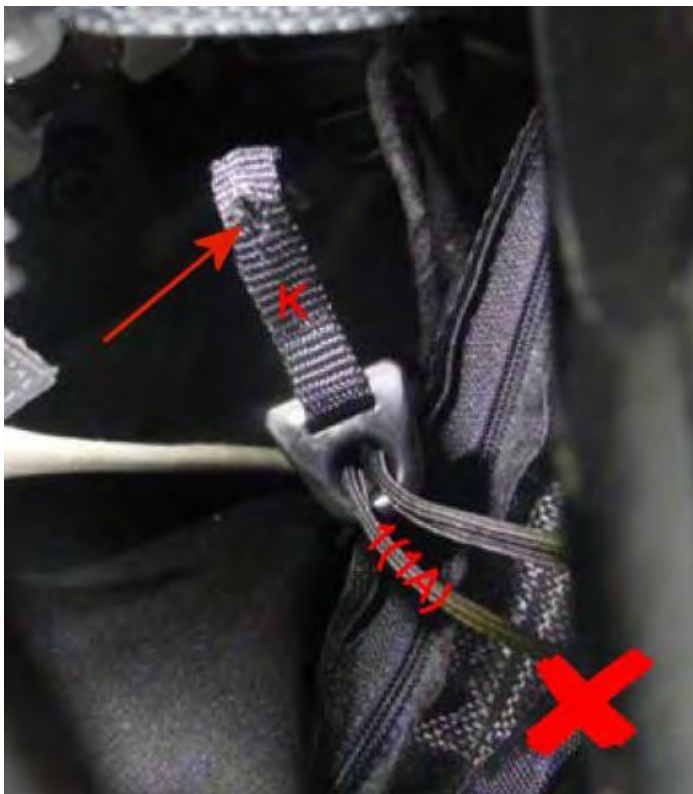
Figure 3a details guide webbing strap pulled off bow 5, either leaving the rivet in bow 5 or as shown in figure 3b the retaining rivet pulls out of bow 5

Rectification: The two twin cords that go through cord guide assembly (K) are anchored at a point (L) on the rear bow (M). Drill out rivet (L) at anchor point on rear bow (M). Remove **what's** remaining of the damaged cord guide assembly (K). Slide new cord guide assembly (K) over the two twin cords into position at bow 5 and rivet to bow 5.

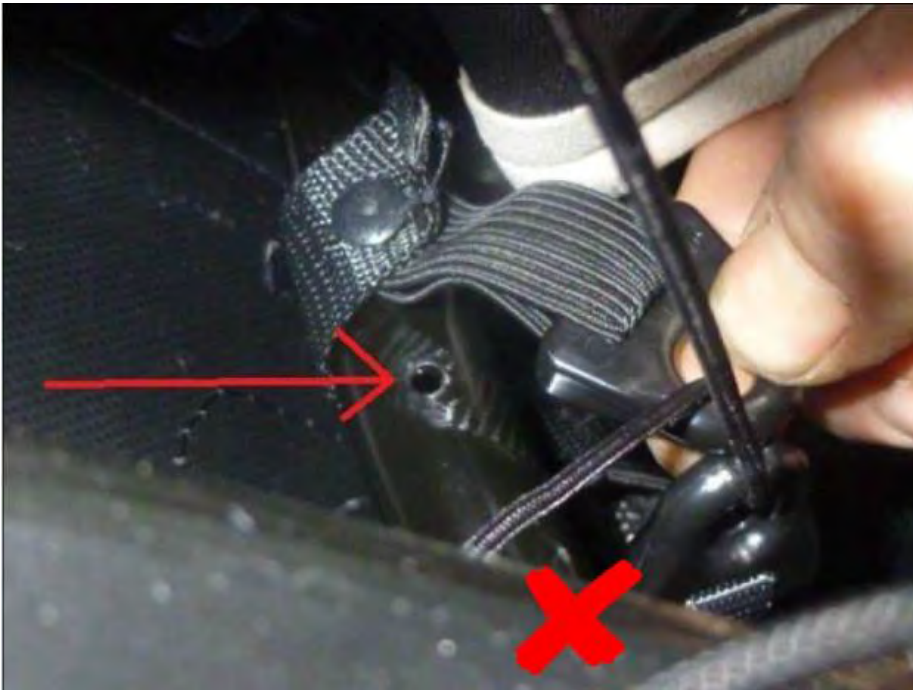
Figure 3b details bow 5 with retaining rivet pulled out of bow 5

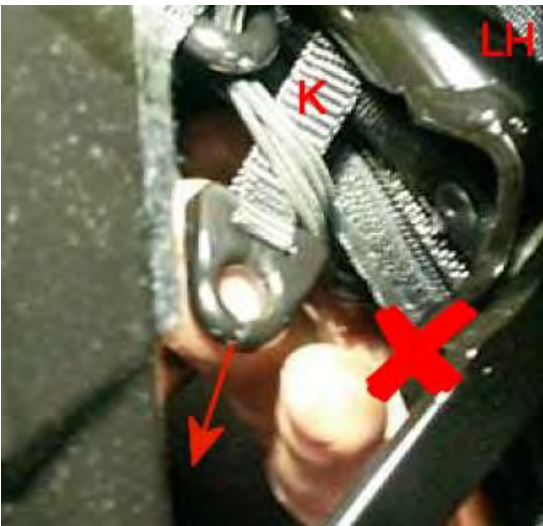
Figure 3c

In extreme cases the double cord 1 pulls through and splits the plastic loop of the guide cord assembly (K) (see Figure 3c)

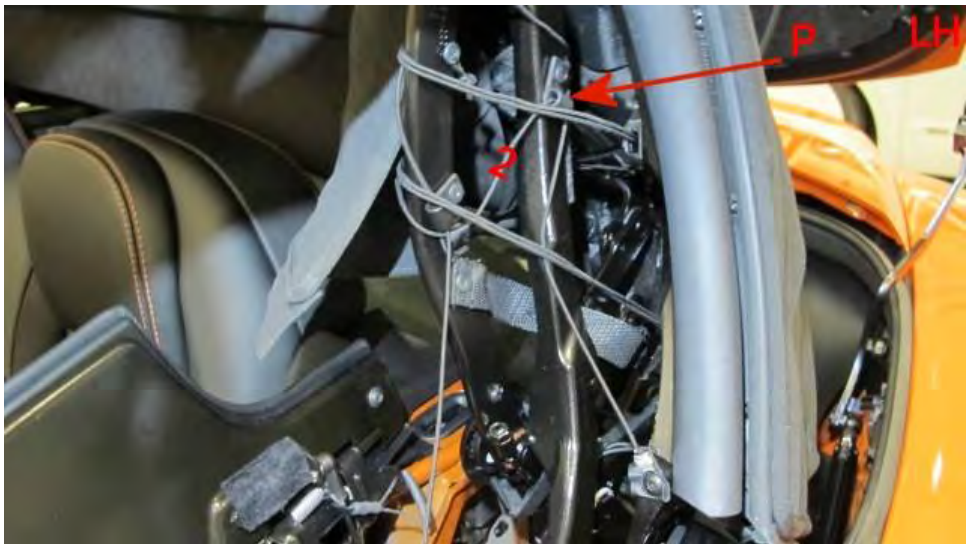
Figure 5 and 5a detail the location of single cord 2 and its associated cord guide (P) secured to the hood frame

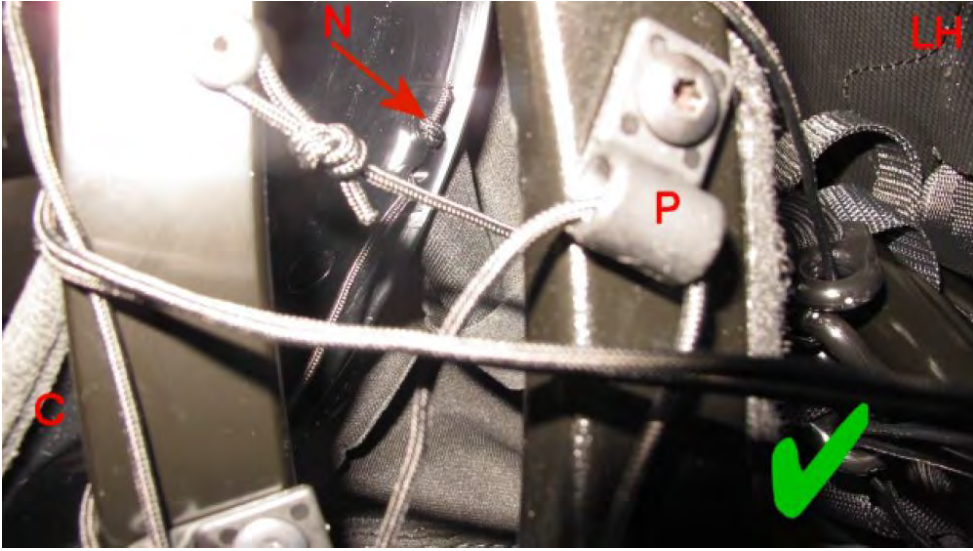
Frame cord guide location Figure 5a shows the correct installation with single cord 1 running through cord guide (P)

Rectification: Referencing figure 5a undo knot (N) cord 2 from C post trim, slide new frame cord guide (P) into position and screw to frame.

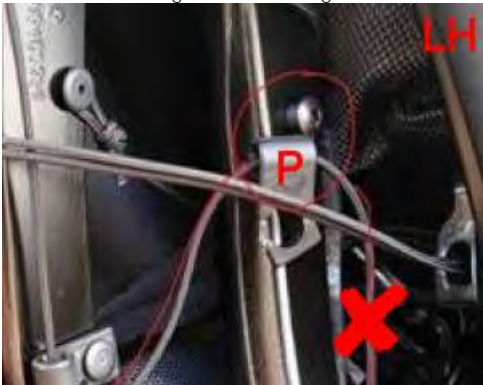
Figure 5b details plastic cord guide (P) stretched and broken off the securing screw which is still in the frame

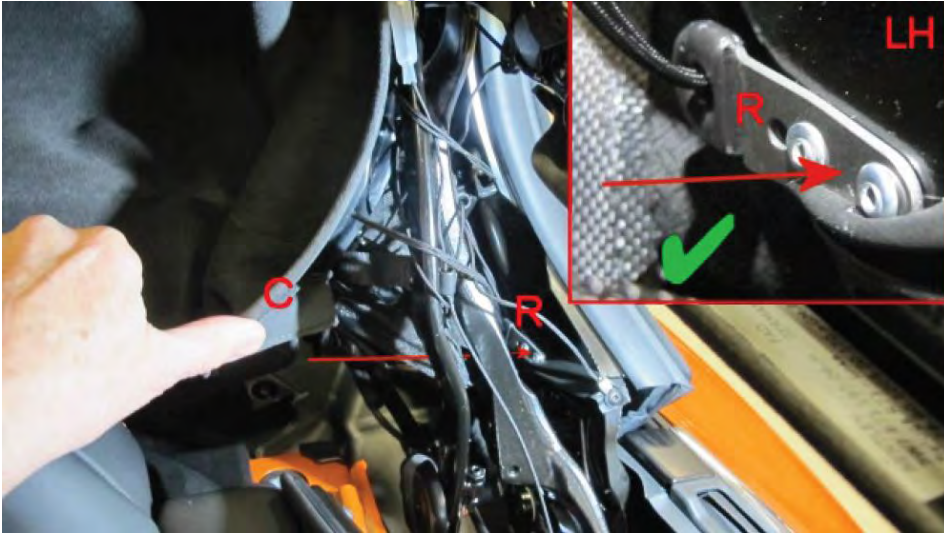
Two rivets secure the metal guide (R) to hood frame in C post area. Figure 6 identifies the location as viewed from inside the vehicle look back towards the left hand rear seat area

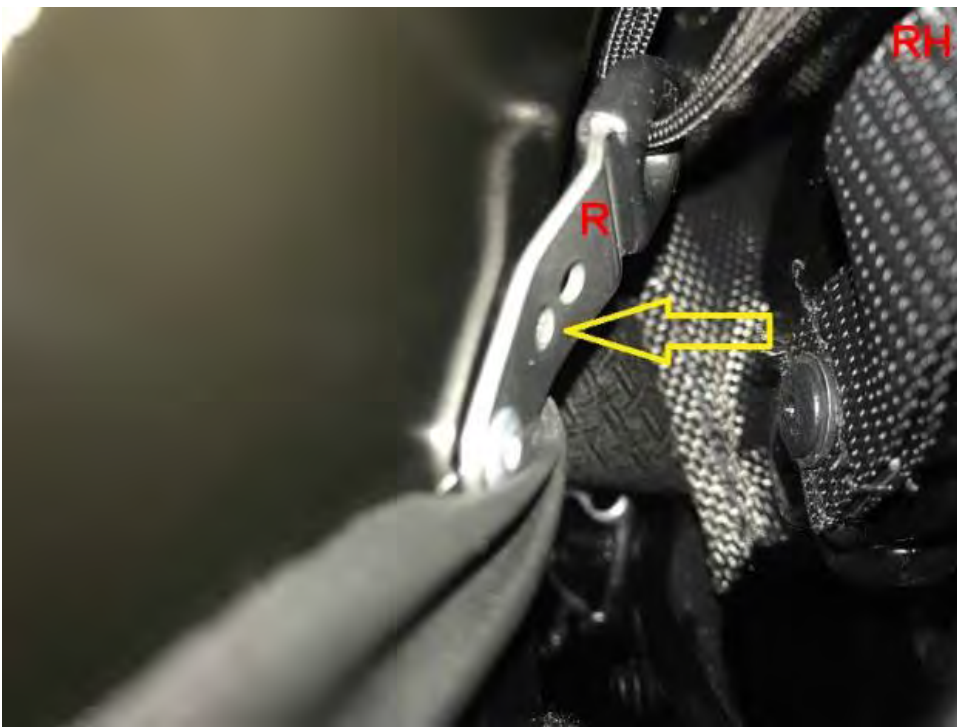
Figure 6a details a right hand frame cord guide that has been strained and as result one of the rivets has pulled out causing the guide to rotate around the remaining rivet putting the cord out of position

Rectification: Position hood referencing figure 6b to enable access to frame cord guide (R). Reposition and re-secure to the frame with new rivet (see Figure 6c)

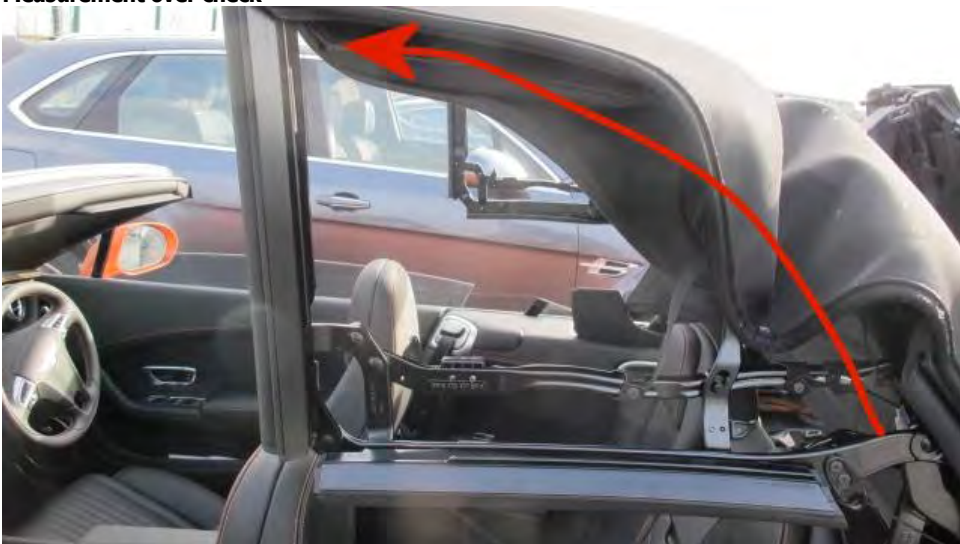
Figure 7

From the open position raise the hood out of the stowage area to the position shown in figure 7

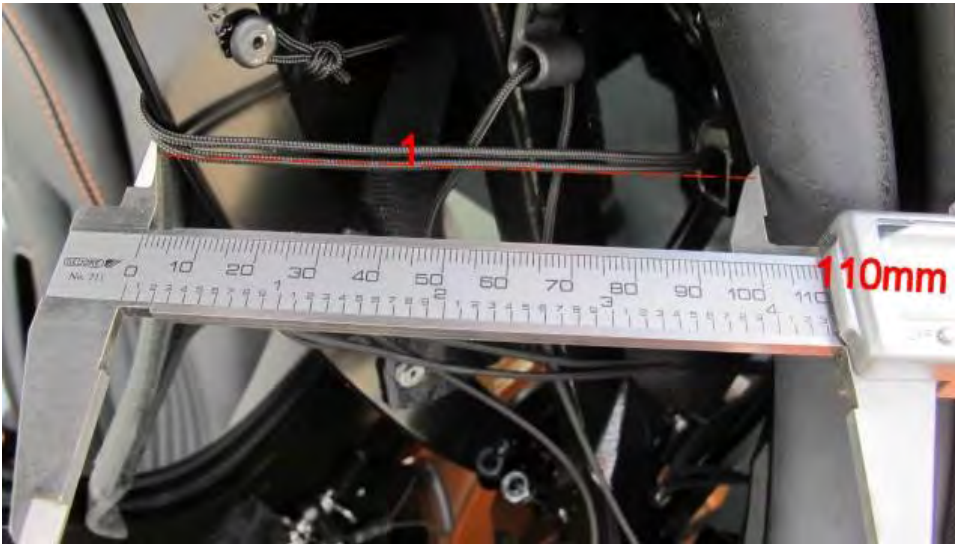
Figure 7a

As a rough guide, on a good car, the measurement between the C post trim and the hood seal along the centre line of the top cord will be around 110mm (see Figure 7a)

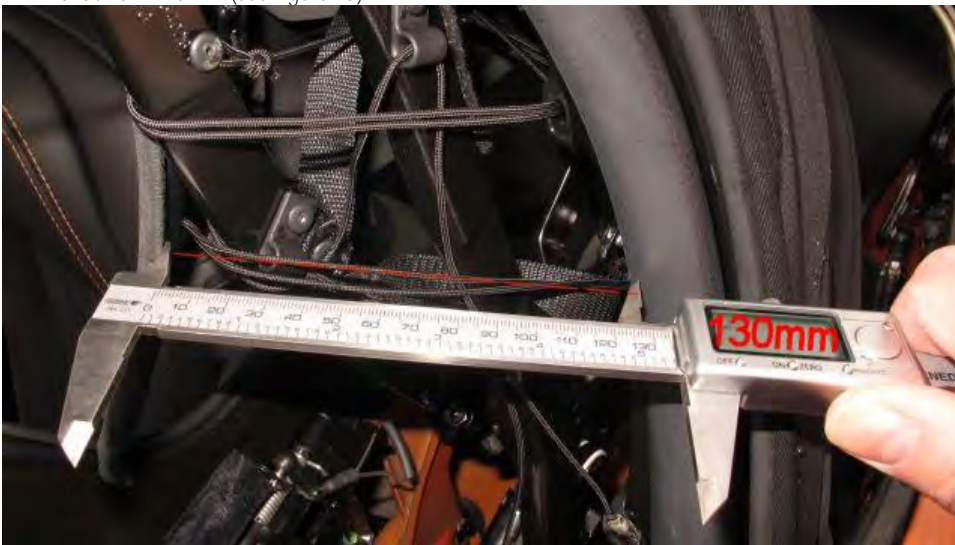
Figure 7b

Again as a rough guide the bottom cord on a good car would measure 130mm (see Figure 7b)
