JTB00528NAS3

TECHNICAL BULLETIN

501-25A: Body Repairs

'Creak' / 'Click' Noise From A-Pillar or Front of Roof Opening Panel

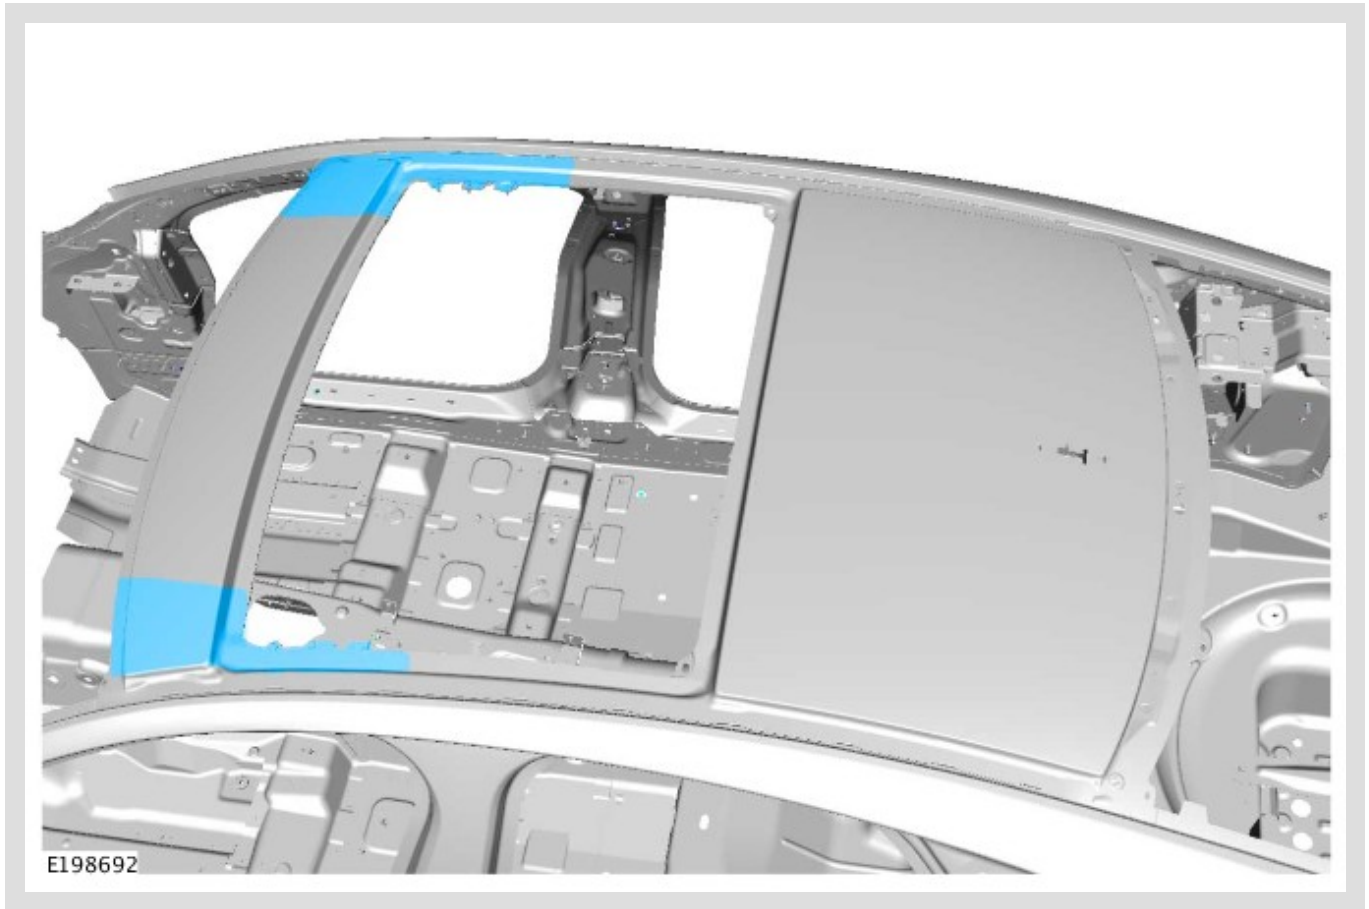
1

A 'click' / 'creak' noise may be evident from the top of the A-pillar area or the front of the roof opening panel.

This may be caused by E-coat bonding and panel interference, made worse by flexing of the panels.

Component location.
