SI M34 02 15  
Brakes

February 2018  
Technical Service

## VIBRATION WHEN BRAKING: DIAGNOSING AND REPAIRING

This Service Information bulletin replaces SI B34 02 15 dated May 2017

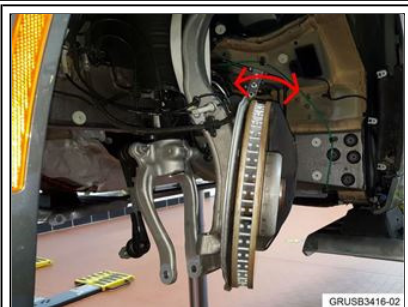
Excessive brake disc thickness variation

- Brake disc thickness variation is the result of lateral runout in the face of the brake disc.
- A brake disc with lateral runout while driving will slightly contact the brake pad once per revolution resulting in a thin spot on the brake disc.
- This consistent contact will eventually cause the brake disc to wear unevenly.

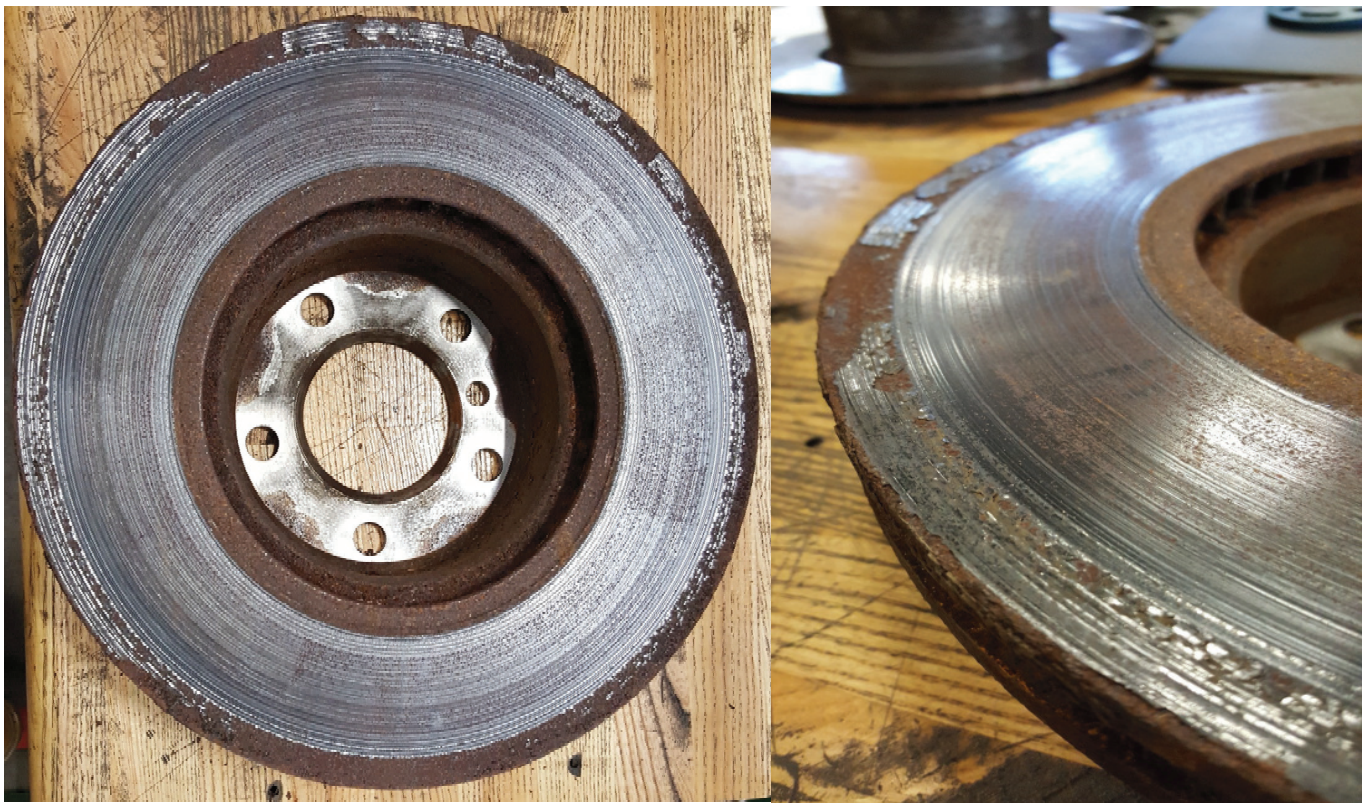
## CATEGORIZATION OF BRAKE DISC-CORROSION

**CATEGORY 3 – SEVERE CORROSION: RESURFACING NOT POSSIBLE.  
ROTORS MUST BE REPLACED**

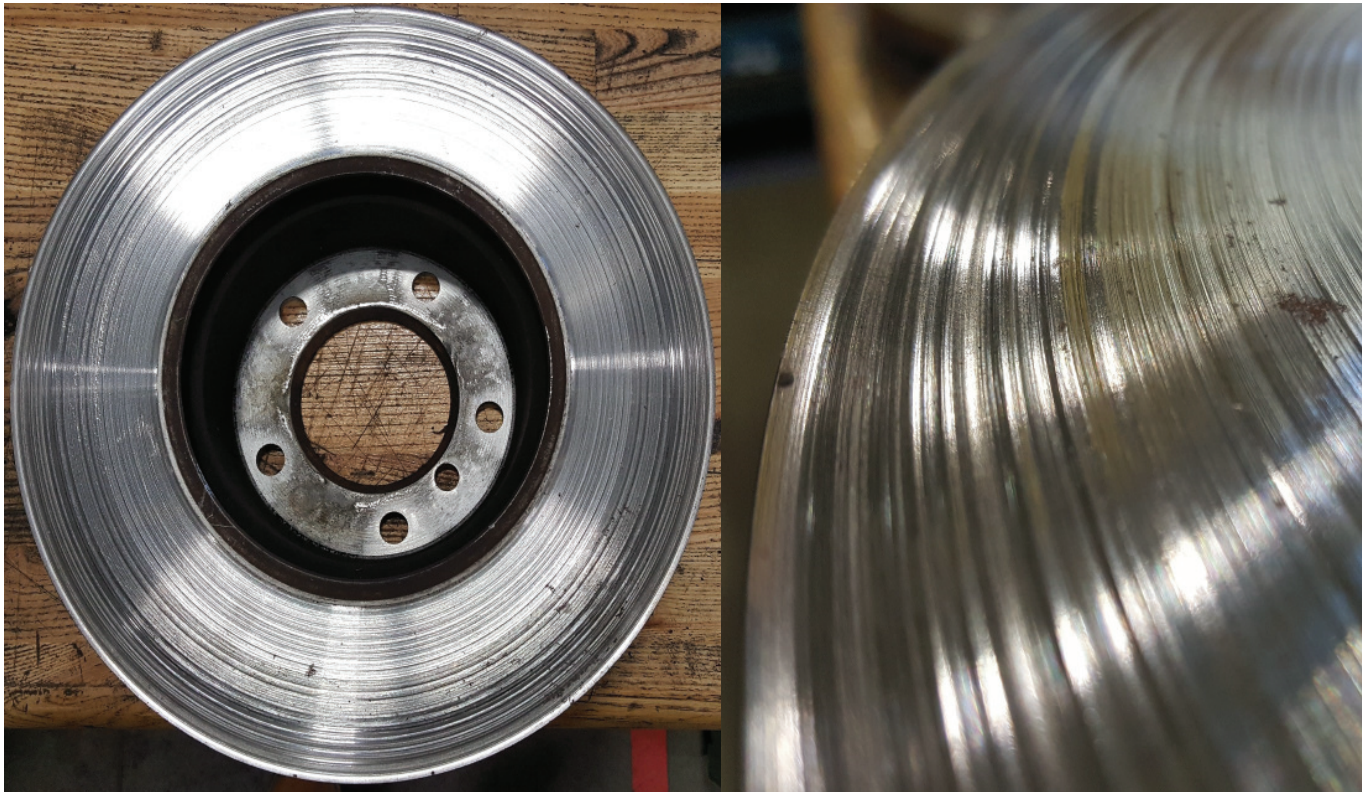
# CATEGORIZATION OF BRAKE DISC-GROOVES

## **CATEGORY 3 – DEEP GROOVES\* : RESURFACING NOT POSSIBLE, ROTORS MUST BE REPLACED**

\* - IF MEASURED ROTOR THICKNESS IN THE DEEPEST GROVE IS BELOW MINIMUM THICKNESS PLUS 0.5 MM
