## HORN DOES NOT WORK

This Service Information bulletin supersedes SI M61 02 16 **dated September April 2017**.

### MODEL

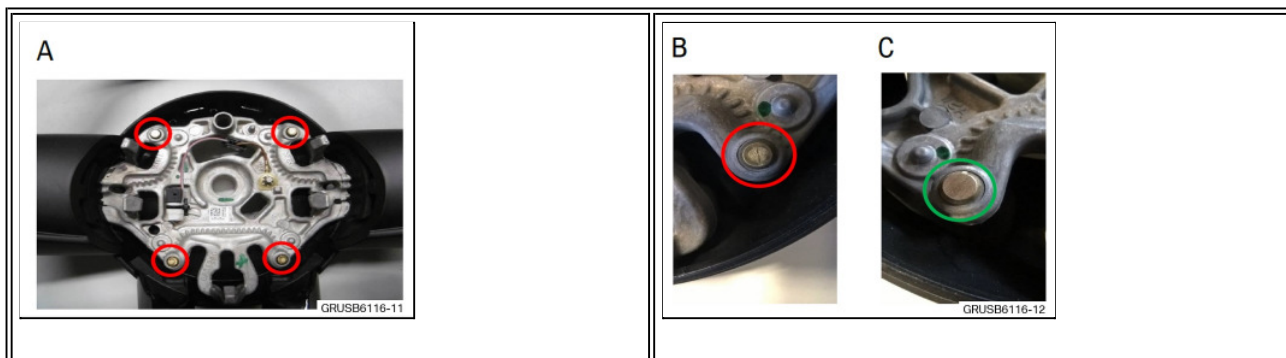
- Only F54, F55, F56, F57: Dissimilar metal corrosion between horn switch contacts and airbag unit.
- All models: routing of the connecting wires on the steering wheel incorrect

1. Remove the air bag unit in accordance with REP 32 34 020 "Remove and refit/replace the air bag unit."
2. Remove corrosion from all four contacts (see Figure A) using sandpaper of 400 grit or higher (see Figure B) until contacts are shiny (see Figure C). It is not necessary to clean the wire for the horn at the airbag unit.
