US 54380454-07

Rattling Noise from Timing Gear

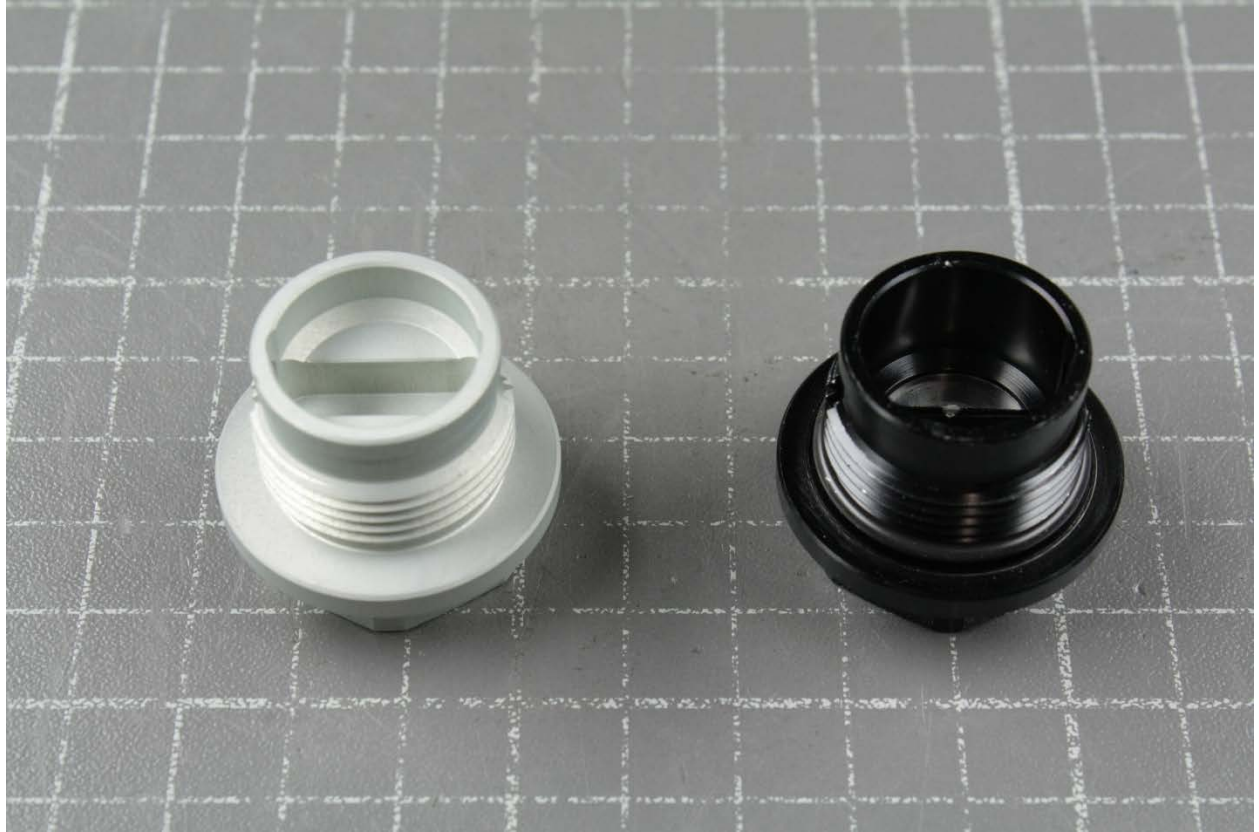
Rattling / chattering engine noise from the timing gear.

After approximately 9,000 mi, the timing chain (7 713 828) may wear to the point that the chain tensioners range of adjustment is no longer sufficient to accommodate the change in length.

In the event of a verified customer complaint;  
remove the black screw plug (11 31 7 718 69) and replace it with a silver screw plug (11 31 8 534 849).

See attached photos.

Note: The silver screw plug has a longer range of adjustment for the chain tensioner and installing it in conjunction with a new timing chain or one that does not exhibit signs of wear is not permitted.
