US 64010520-01

RDC sensor failure

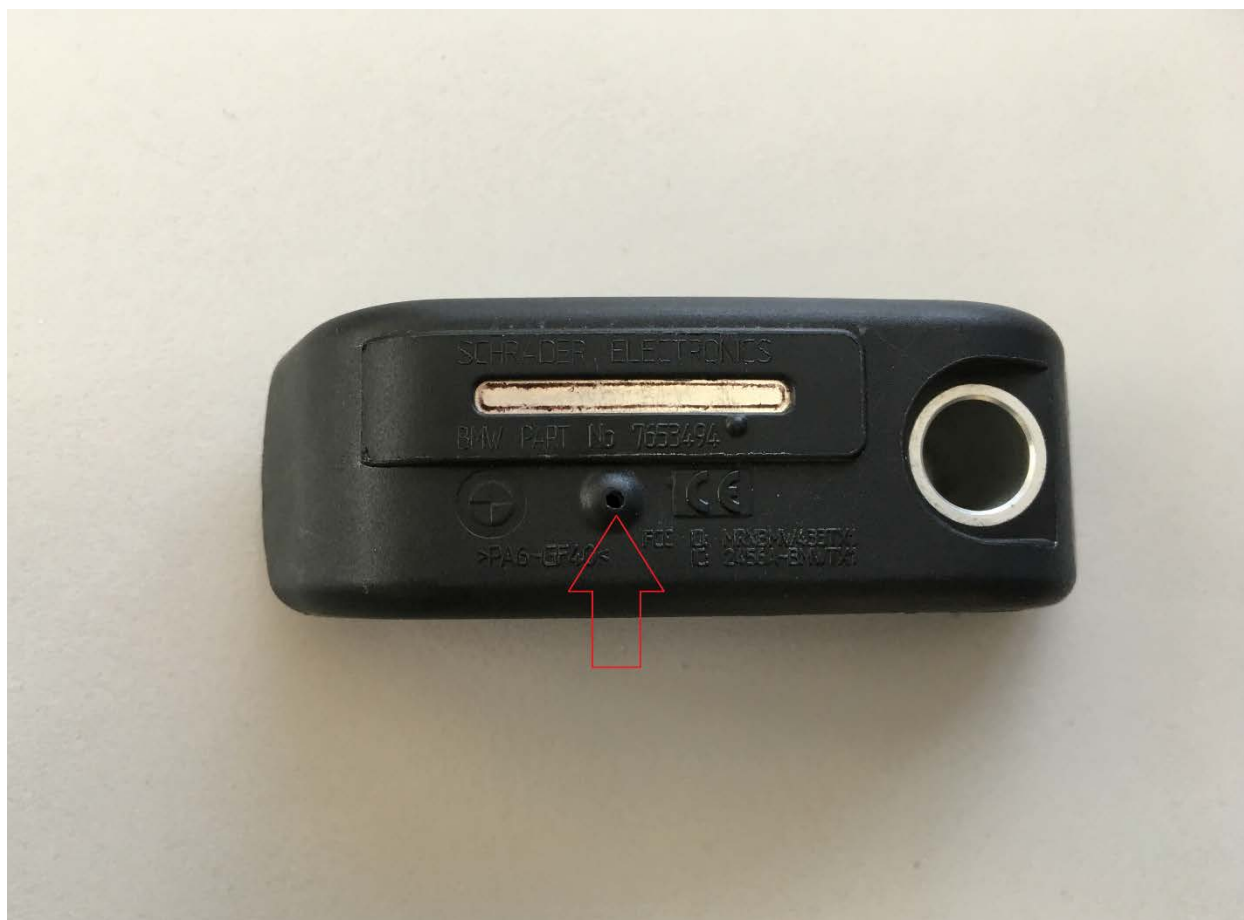
Contamination or obstruction of diaphragm of the RDC sensor

Location of this port is shown in the attachment.

During tire changes, ensure that tire lube or paste does not contaminant or obstruction the measurement port on the RDC sensor.
