SI B01 10 14  
Warranties

## ENGINE CAMSHAFT (VANOS) ADJUSTMENT UNITS: LIMITED WARRANTY EXTENSION TO 10 YEARS WITHOUT MILEAGE LIMITATION

This Service Information bulletin supersedes SI B01 10 14 dated February 2018.

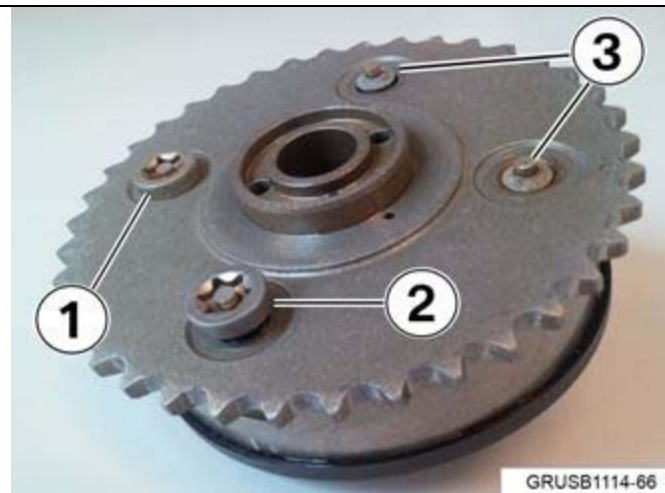
3. Evaluation of bolt:
- If any of the bolts were loose or broken during this procedure, the VANOS assembly will need to be replaced. Refer to step 14.
  - VANOS bolt is tight (1)
  - VANOS bolt is loose (2)
  - VANOS bolt heads have sheared off (3)
- Note: VANOS gear assembly removed from engine for clarity. Do not remove VANOS Gear Assembly

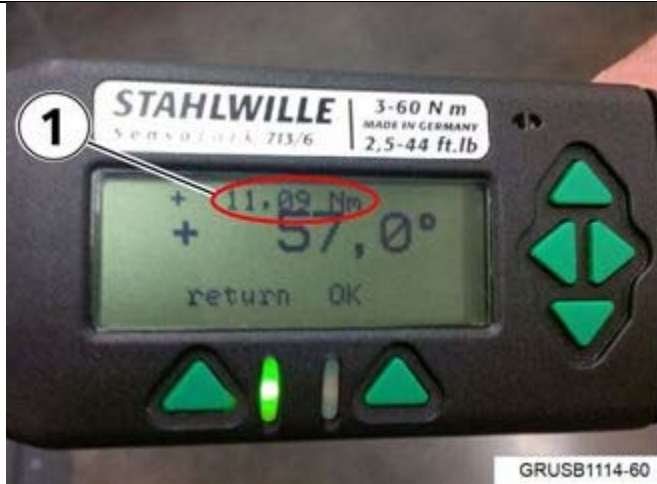
8. While performing the angle torque, the digital screen on the torque wrench will display the current Nm meter value. This value should be between **8 Nm-14 Nm**.

If the displayed value is not within the specification, the bolt will need to be removed and replaced with a new bolt again. Repeat as necessary.

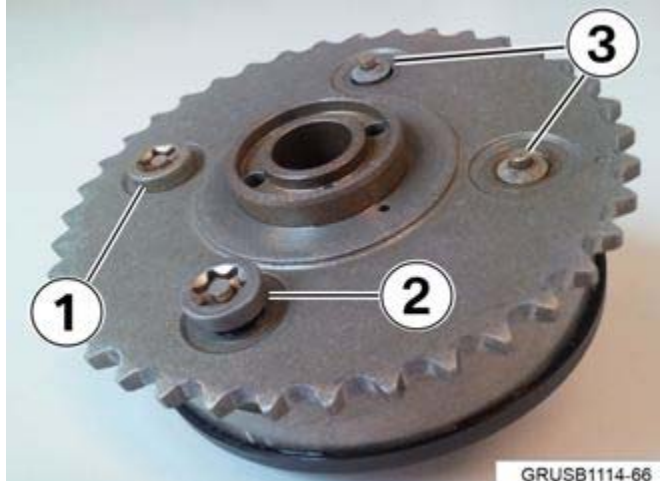
<p>GRUSB1114-66</p>	<p>10. Evaluation of bolt:</p> <p>If any of the bolts were loose or broken during this procedure, the VANOS assembly will need to be replaced. Refer to step 16.</p> <p>VANOS bolt is tight (1)</p> <p>VANOS bolt is loose (2)</p> <p>VANOS bolt heads have sheared off (3)</p> <p>Note: VANOS gear assembly removed from engine for clarity. Do not remove VANOS Gear Assembly</p>

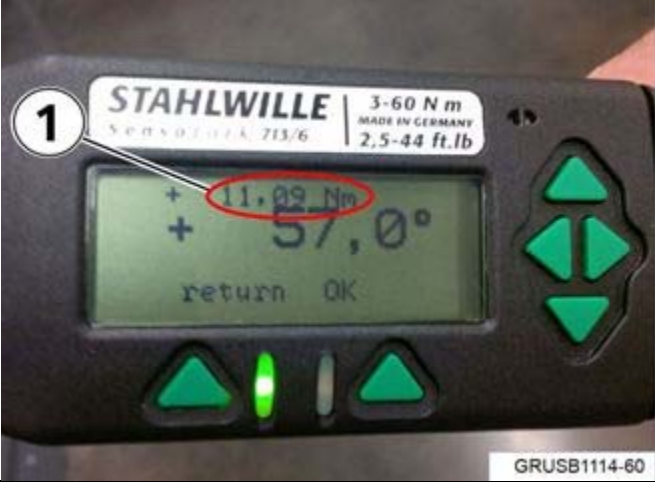
<p>15. While performing the angle torque, the digital screen on the torque wrench will display the current Nm meter value. This value should be between <b>8 Nm-14 Nm</b>.</p> <p>If the displayed value is not within the specification, the bolt will need to be removed and replaced with a new bolt again. Repeat as necessary.</p> <p>To reset the torque wrench and clear the screen to Nm again, just press the “MR” button to continue replacing additional bolts.</p>
<p><b>16. If any of the bolts were found loose or broken during this procedure, the affected VANOS assembly will need to be replaced. Refer to step 17.</b></p> <p>If no bolts were found loose, repeat steps 10-15 for the remaining 3 bolts on the applicable VANOS gear assembly. It is good practice to mark each bolt head with a felt marker as it is replaced, so one is not mistaken and removed again. Refer to step 18 when complete.</p>

<p>17. If any of the VANOS bolts were found loose or broken, that VANOS unit will need to be replaced. Refer to Repair Instruction 11 36 046, “Removing and installing or replacing intake and exhaust camshaft adjusters.”</p>	
<p>18. Reassemble the vehicle per the applicable repair instructions.</p>
