SI B11 09 16
Engine

N63, N63TU, S63 and S63TU Engines: Oil Leak from the Rear of the Engine and Transmission Bell Housing

This Service Information bulletin replaces SI B11 09 16 dated May 2016

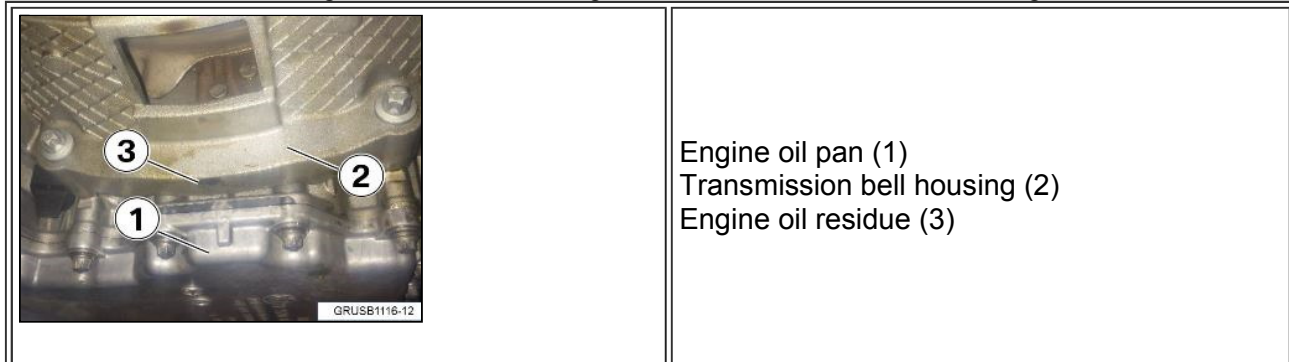
Customer complains that engine oil is leaking from the center of the vehicle. When verified, the engine oil residue can be seen leaking from between the engine and the transmission bell housing.

Refer to the attached procedure for diagnosis steps and repair procedures.

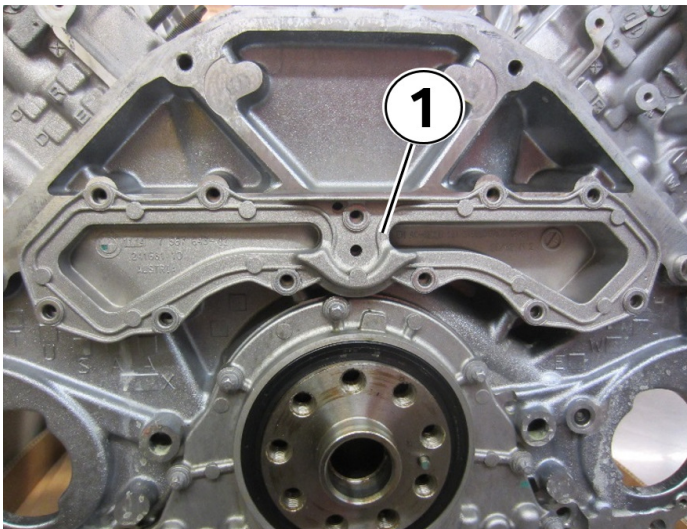
Once the bore scope has gone under the plastic reservoir tab then the engine valley drain hole (1) and surrounding area can be clearly inspected.

The dark material at the bottom of the photo is dust and dirt. This material appears to be reflective but it is dry.

11. If engine oil is found in this area then the root cause of the engine oil leak resides in the components on top of the engine i.e. turbocharger oil lines, turbo charger, etc. Further basic diagnosis will be needed to find the root cause this engine oil leak. Do not remove the transmission from the vehicle.

If no engine oil residue is found at the engine valley drain hole then the root cause of the engine oil leak will be inside the transmission bellhousing. The most likely cause will be a leaking engine oil galley plug located behind the engine cover, rear and or the crankshaft rear seal. Continue to step 12.

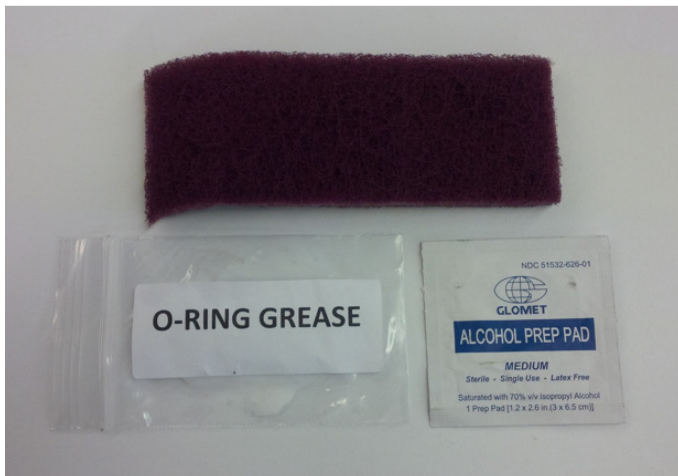
P/N 11 14 2 246 298 Updated End Cover, Rear Kit overview.

Additional sealed surfaced (3) to encapsulate the leaking engine oil galley plug.
