WATER LEAK IN LUGGAGE COMPARTMENT CAUSES AUTOMATIC TAILGATE TO FAIL

G12 (7 series)			
----------------	--	--	--

Water leak in luggage compartment repair attachment

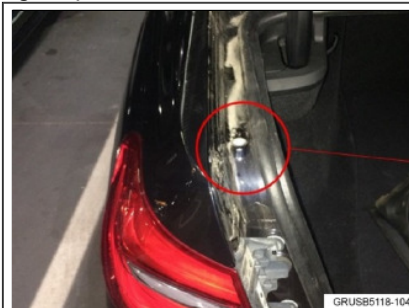
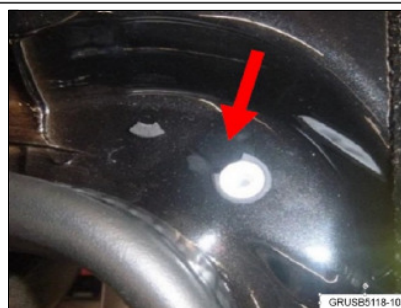
The foam seals of the trunk water channel clips may be missing or damaged, allowing water to damage the right spindle drive.

Inspect and replace any water channel clip with missing or damaged foam seals. Replace the right spindle drive, if damaged by water ingress.

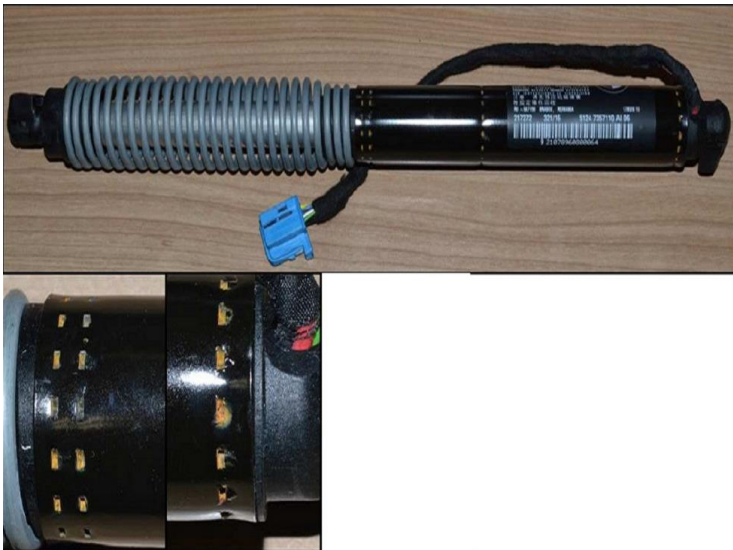
2. Inspect the right side trunk spindle drive for corrosion or signs of water damage as shown to the left. Inspect the left side tension spring for signs of corrosion.

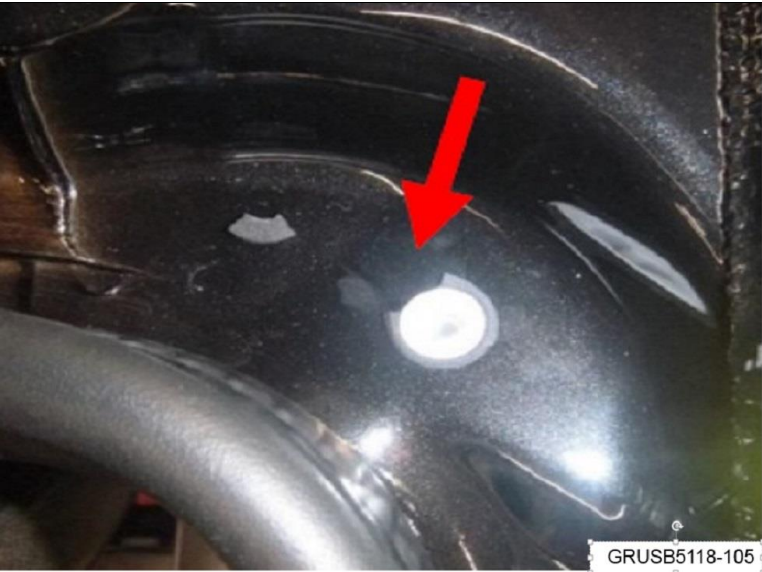
<p>GRUSB5118-105</p>	<p>5. With both water channels removed, inspect the foam sealing rings of all 4 retaining clips for damage.</p>

<p>6. If any retaining clip seals are damaged or missing, replace the clips.</p>

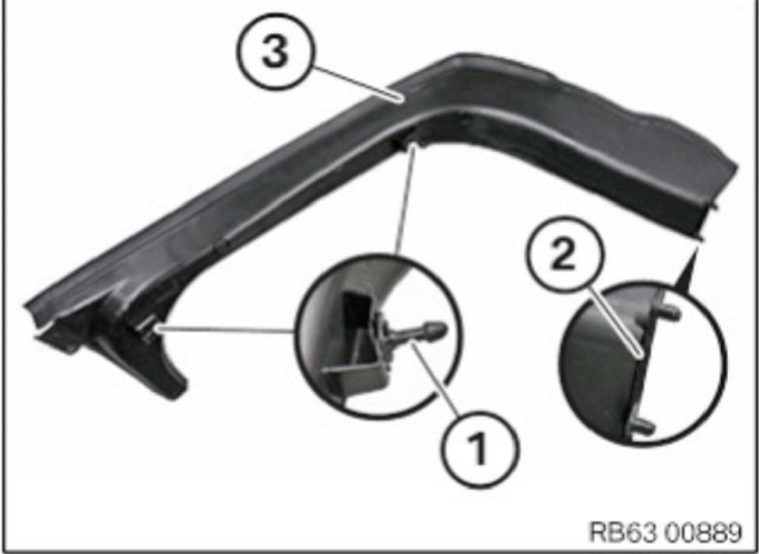
<p>7. Check the clips (1) and guides (2) on the water channels for damage. If water channel clips are damaged, the water channel must be replaced.</p>
