SI B51 03 18
Body Equipment

RATTLE NOISE FROM B PILLAR AREA WHILE DRIVING

G01 (X3)		
----------	--	--

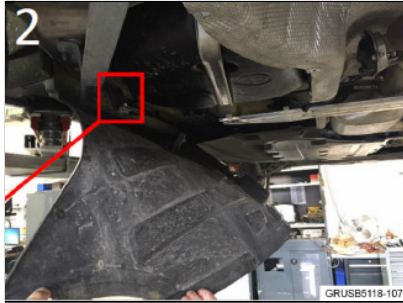
Note: The underbody panel does not need to be completely removed. It can be lowered to gain access without complete removal as shown in example photo 2.</p>

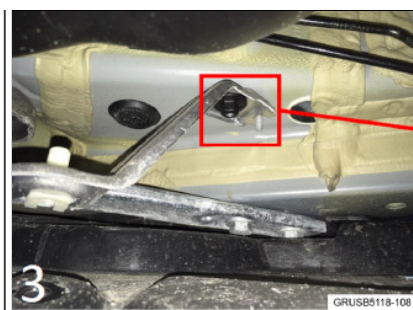
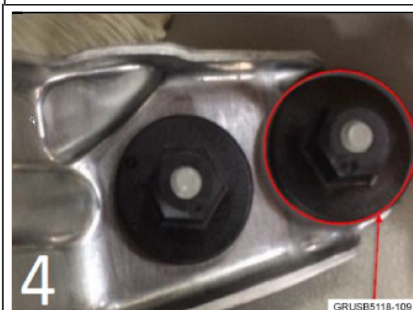
<p>2. Inspect the plastic nuts securing the underbody panel bracket in the area shown in photos 2&3. Photo 3 shows an example of a bracket that is missing 1 of the plastic nuts.</p>

3. If either bracket nut is found to be loose or missing, re torque or install the plastic nut to 2.6 Nm. There should be 2 plastic nuts installed for each bracket as shown in example photo 4.
