SI B54 02 18
Special Roofs

NOISES FROM THE C-PILLAR AREA OF THE CONVERTIBLE TOP

F33 (4 Series Convertible)	F83 (M4 Convertible)
----------------------------	----------------------

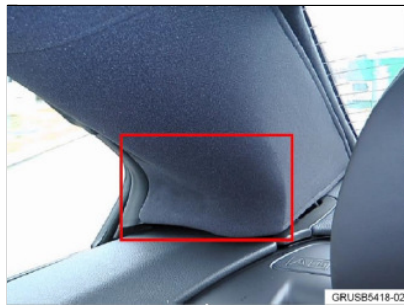
Cracking or clicking noises can be heard from the rear area of the convertible top (C-pillar area) when driving on uneven roads.

The C-pillar flap is contacting the convertible top linkage, causing noise in the area shown below.

Grease the interfering surfaces between the C-pillar flap and convertible top linkage.
