REPLACE BATTERY CHECK CONTROL MESSAGE DISPLAYED

This Service Information Bulletin supersedes SI B61 27 17 dated **October 2017**.

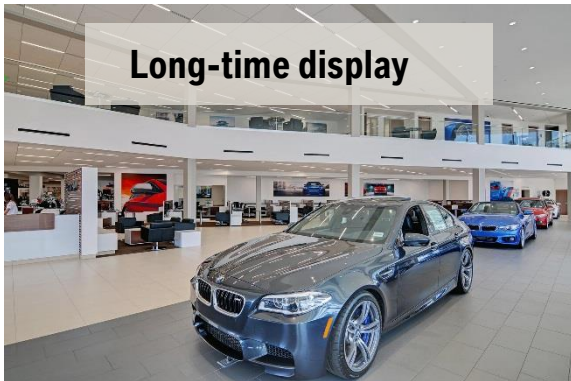
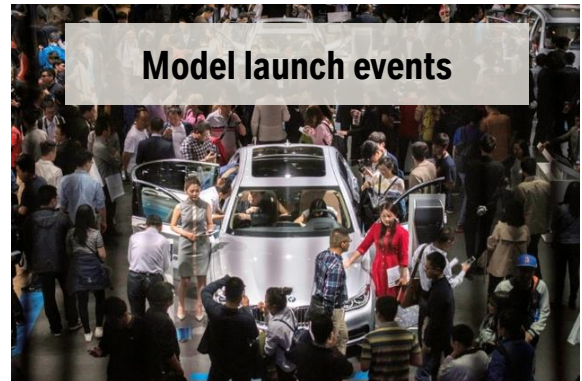
Showroom Mode activated via ISTA

Charger connected permanently Refer to SI B04 23 10

Charger DBL500

Charger with minimum 70 A
(e.g. DBL1600, MultiCharger 1500)
