GREEN BARS DISPLAYED IN CENTRAL INFORMATION DISPLAY WHEN CAMERA ACTIVE

| G30 (5 Series Sedan) | G32 (6 Series Gran Turismo) | F90 (M5) |

Produced between 10/1/17 and 2/2/18

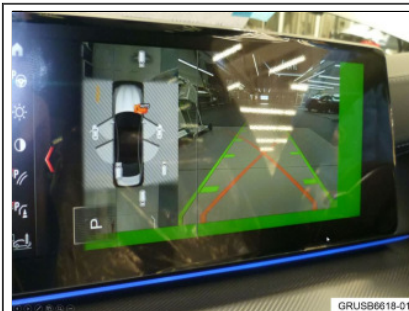
Wide green bar across bottom and up right side of Central Information Display (CID) when reverse gear is selected and the Surround View camera is active.

Software error in Surround View Camera control unit (iCAM2)

I-level S15A-17-11-520 to S15A-17-11-540

Reprogram vehicle with ISTA 4.09.3x (I-level S15A-17-11-541) or a more recent version.
