DOMETIC HEATING FURNACES

EN Furnace Limit Switch Service Bulletin

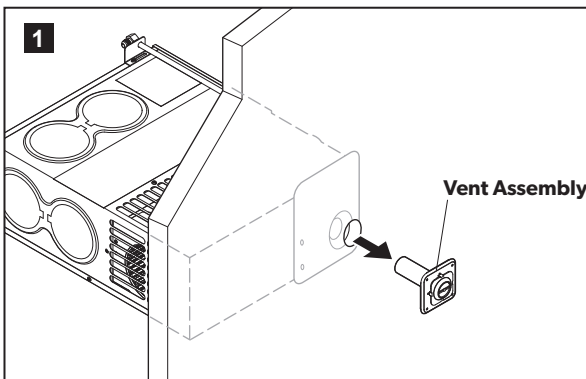
1.1 Removing the vent assembly

The cause of this nuisance issue is a mistaken omission of a plastic wire tie to suspend the heat exchanger limit switch wires up and away from the exhaust tube vent terminal. The omission of this component allows the limit switch wires to potentially melt on the vent terminal, shorting to ground, and causing either the fuse or circuit breaker in the circuit to blow, or the sail switch to become inoperative. **In ALL cases the safety devices in the system are performing as designed and prevent the furnace from operating.**

Dometic recognizes this nuisance tripping issue is an inconvenience to our OE and potential end-use customers and we apologize for the extra work that may result. In an effort to try and reduce the amount of work required to correct this mistake we have designed and tested a field repair for this occurrence which will be more expensive for Dometic but will make the field repair much easier. The repair will consist of sliding a 6" long, high-temperature rated, fiberglass sleeve over the exhaust tube after removal of the vent assembly. The field repair kit will be available within March, 2018. The field repair kit part # is 31389, Flat Rate Time is .5 and the fault code is 617.25.
