Service Update

18049 Intermittent Loss of Tail Lamps

Reference Number: N172131740

Make	Model	Model Year		RPO	Description
		From	To		
Cadillac	XTS	2018	2018

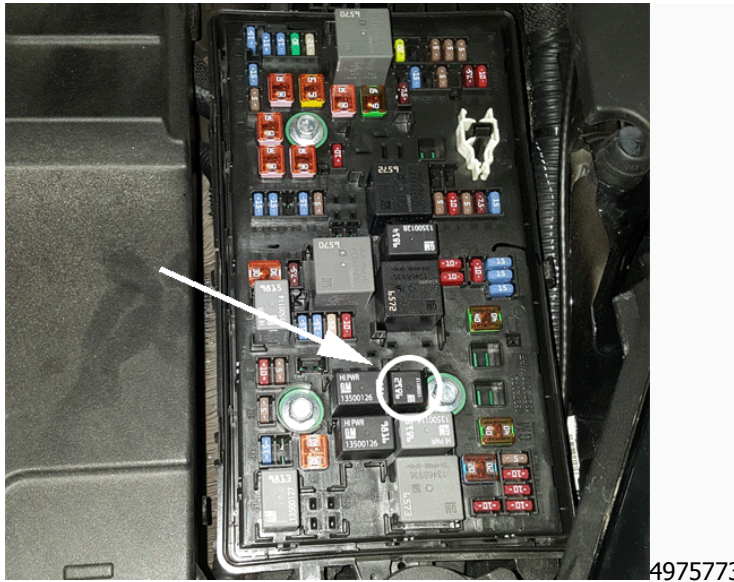
4975773

Condition	Certain 2018 model year Cadillac XTS vehicles may have a multi-use relay assembly that is not fully seated in the underhood buss electrical center. This can cause an intermittent loss of tail lamps.
Correction	Dealers are to remove, inspect, and if necessary, replace the multi-use relay assembly (tail lamp/park lamp).

4. Remove and inspect Micro Relay 11 for signs of arcing or damage (Tail Lamp/Park Lamp).
5. Reinstall (or replace if necessary) Micro Relay 11.
6. Perform a visual inspection of the fuse block to ensure all other relays are completely seated.
7. Reinstall the fuse block cover and close the hood.
